Fault Code: 294

Auxiliary Temperature Sensor Input 1 Circuit - Voltage Below Normal or Shorted to Low Source

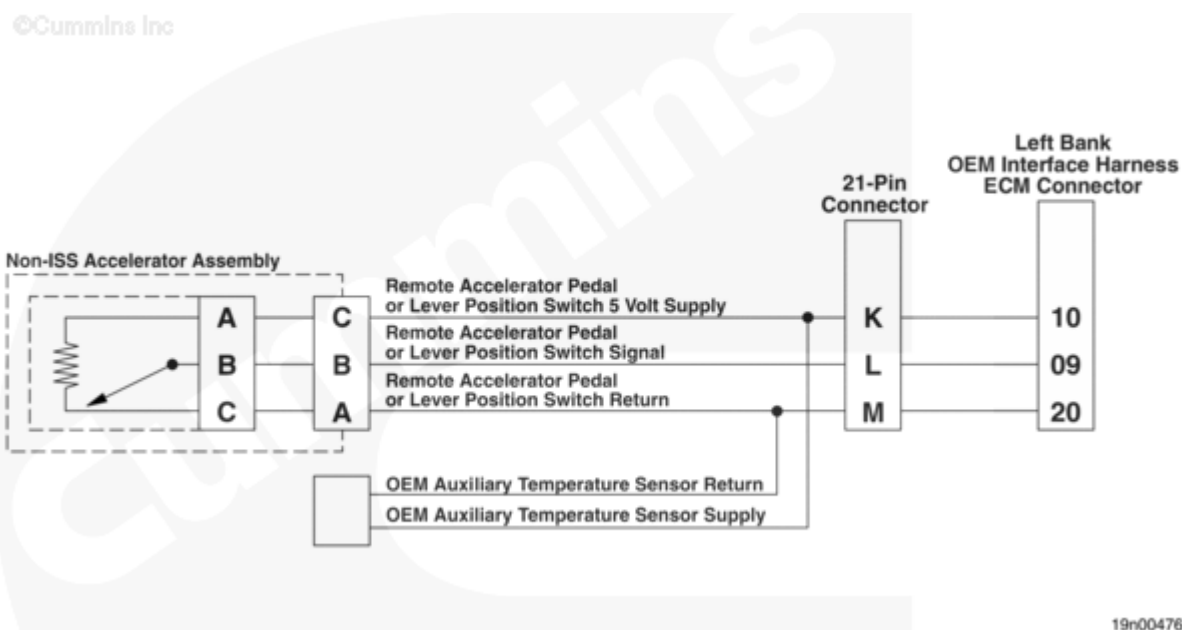
OEM Auxiliary Temperature Sensor Circuit

The OEM auxiliary temperature sensor supply is used by the engine control module (ECM) to monitor OEM auxiliary temperature. An OEM auxiliary temperature sensor that has failed low can be caused by shorts to ground or opens in the supply and return wires, or an internally grounded sensor.
