Intel® Ethernet Controller X710-TM4/ AT2

Specification Update

October 2019

Revision 1.0
615119-002

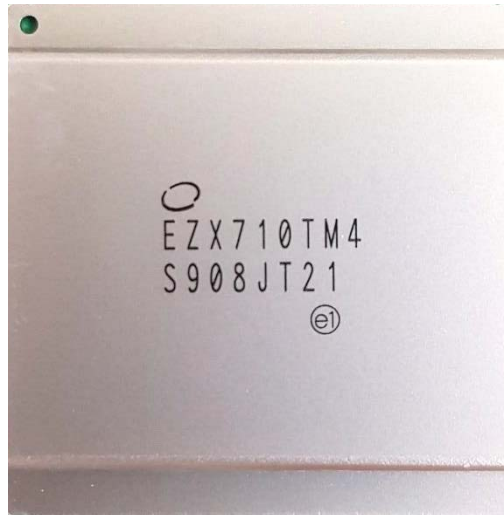
Figure 1-1 Example Component with Identifying Marks
