Fault Code: 226

Make-Up Valve Solenoid - Short Circuit

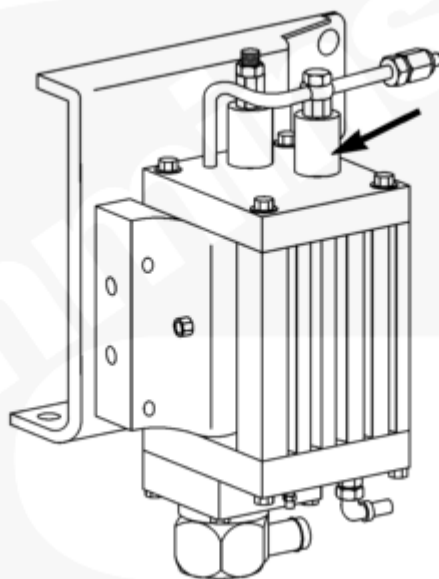
07800054

Codes	Reason	Effect
Fault Code: 226 PID(P): SPN: FMI: Lamp: Red SRT:	Make-Up Valve Solenoid - Short Circuit. The make-up solenoid is shorted.	The Centinel™ system will not operate.

The make-up valve solenoid controls the flow of oil within the oil control valve during the make-up cycle.

The make-up valve solenoid is located on top of the oil control valve. It is the valve that is fed by the lubricating oil bypass tube.
