Intel® 82574 Family Gigabit Ethernet Controller Specification Update

*February 2020
Revision 4.1*

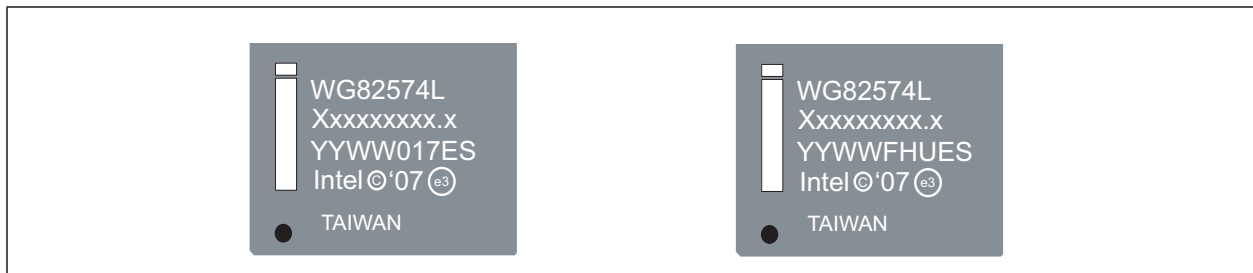
Figure 1. Engineering Samples Top Marking Example With Identifying Marks

1.3 Engineering Samples Marking Diagrams

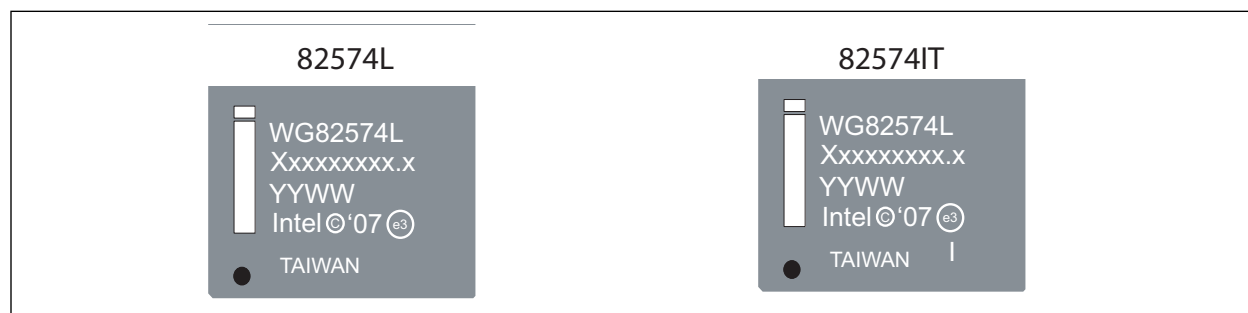
Figure 2. Production Top Marking Example With Identifying Marks

1.4 Production Marking Diagrams

1. See [Figure 2](#).
