Intel® Ethernet Controller X710/ XXV710/XL710

Specification Update

October 2019

Revision 3.7
331430-017

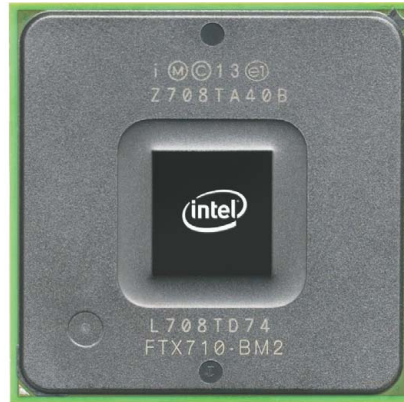
Figure 1-1 Example Component with Identifying Marks
