Fault Code: 664

Exhaust Gas Temperature Deviation High for Cylinder 7 - Data Valid But Above Normal Operating Range - Moderately Severe Level

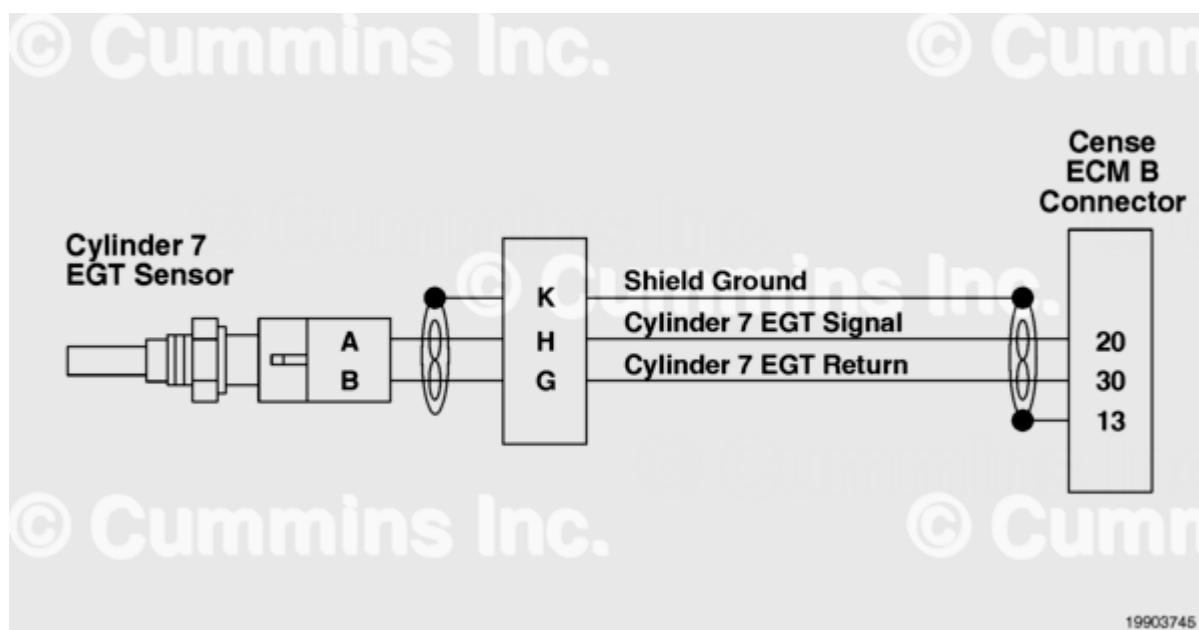
Exhaust Gas Temperature Sensor Circuit Cylinder 7

The exhaust gas temperature sensor circuit monitors exhaust gas temperature for cylinder 7 and passes the information to the CENSE™ engine control module (ECM) through the engine harness. The ECM monitors the temperature and compares it to the exhaust gas temperatures of other

The exhaust gas temperature sensor for cylinder 7 is located at the cylinder head-to-exhaust manifold interface.

Refer to Troubleshooting Fault Code t05-664 (/qs3/pubsys2/xml/en/procedures/81/81-t05-664.html)
