Fault Code: 711

Exhaust Gas Temperature Deviation High for Cylinder 2 - Data Valid But Above Normal Operating Range - Moderately Severe Level

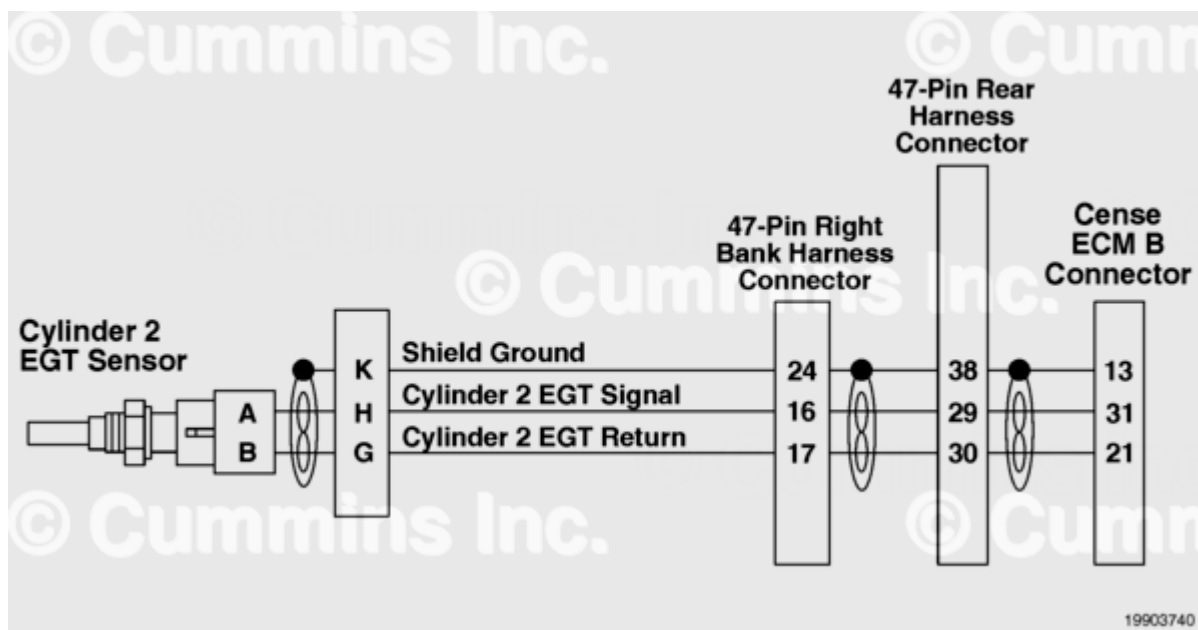
Exhaust Gas Temperature Sensor Circuit Cylinder 2

Codes	Reason	Effect
Fault Code: 711 PID(P): SPN: 1324 FMI: 0/16 Lamp: Amber SRT: CE-711	Exhaust Gas Temperature Deviation High for Cylinder 2 - Data Valid But Above Normal Operating Range - Moderately Severe Level. Cylinder 2 exhaust temperature is above the normal operating range.	No action taken.

The exhaust gas temperature sensor circuit monitors exhaust gas temperature for cylinder 2 and passes the information to the CENSE™ engine control module (ECM) through the engine harness. The ECM monitors the temperature and compares it to the exhaust gas temperatures of other

The exhaust gas temperature sensor for cylinder 2 is located at the cylinder head-to-exhaust manifold interface.

Refer to Troubleshooting Fault Code t05-711 (/qs3/pubsys2/xml/en/procedures/81/81-t05-711.html)
