Intel® 82580EB/82580DB Gigabit Ethernet Controller Specification Update

Networking Division (ND)

Revision 2.7
February 2020

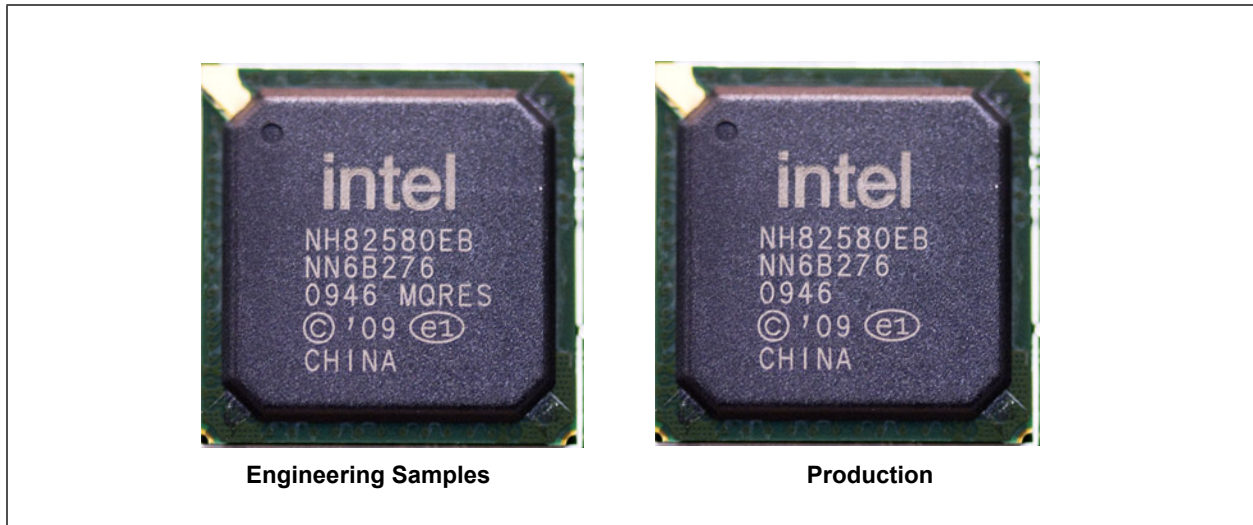
Figure 1. Sample Component Diagram Illustrating Identifying Marks

Refer to [Figure 1](#):
