### Glued Joint Inspection

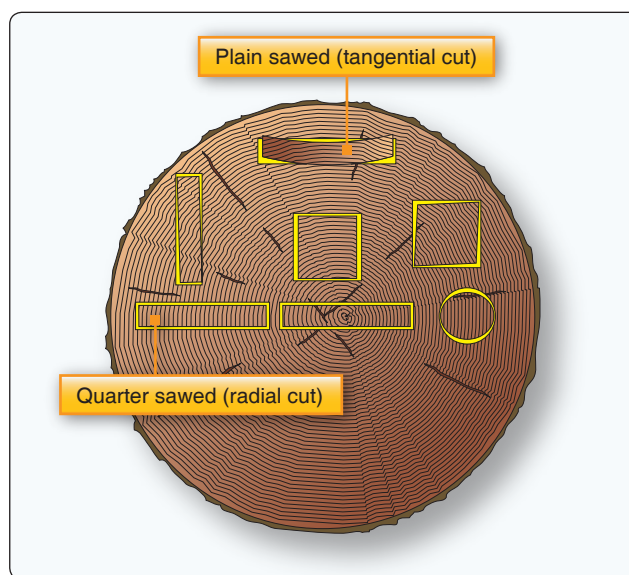
**Figure 6-5.** Effects of shrinkage on the various shapes during drying from the green condition.

The various cuts of lumber from a tree have tendency to shrink and warp in the direction(s) indicated in the yellow area around each cut in *Figure 6-5*.
