Technical Service Bulletin: TSB110218

Released Date: 12-Sep-2011

Improved Water Transfer Connection

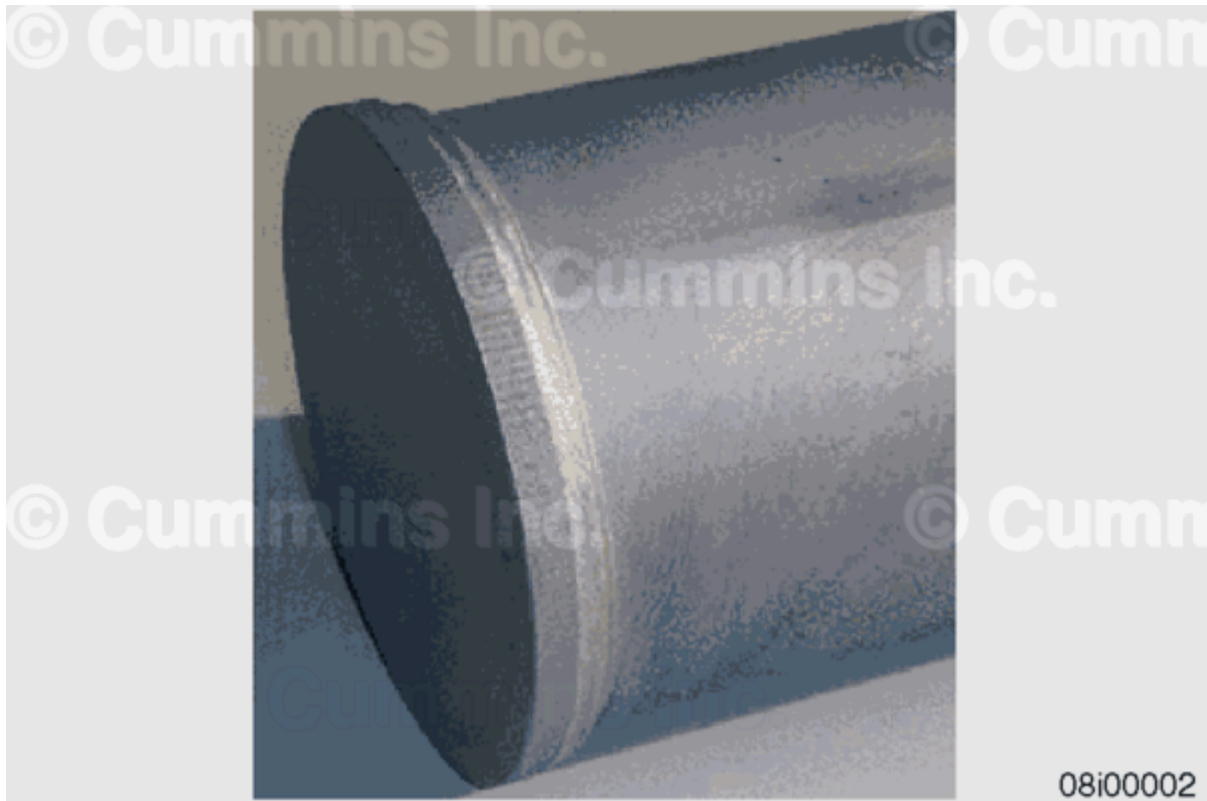
Figure 1: New End Cap

This document introduces a new water transfer connection for the K19 and QSK19 engines. The new water transfer tube, Part Number 5288358, obsoletes and supersedes the old tube, Part Number 3008862. The new tube has an improved cap design for increased durability. The new design has a cap that is fillet welded for more consistent manufacturing. See Figure 1.

The new tube design does **not** affect the removal or installation procedures.

The ESN first with the new water transfer connection is 37251078.
