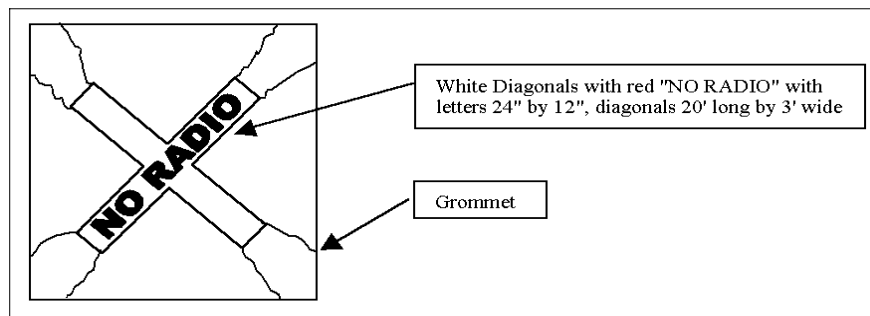
FIG 10-2-1
Closed Helideck Marking – No Radio

(2) Close the deck and make the radio warning clearly visible to passing pilots, install a temporary marking (described in subparagraph 10-2-1i1(b)) with the words “NO RADIO” stenciled in red on the legs of the diagonals. The letters should be 24 inches high and 12 inches wide. (See FIG 10-2-1.)

(1) When operating within 1,000 feet of a known perforation operation or observing the white X with red “NO RADIO” warning indicating perforation operations are underway, pilots will avoid radio transmissions from or near the helideck (within 1,000 feet) and will not land on the deck if the X is present. In addition to communications radios, radio transmissions are also emitted by aircraft radar,
