Fault Code: 555

Blowby Pressure - Engine Protection

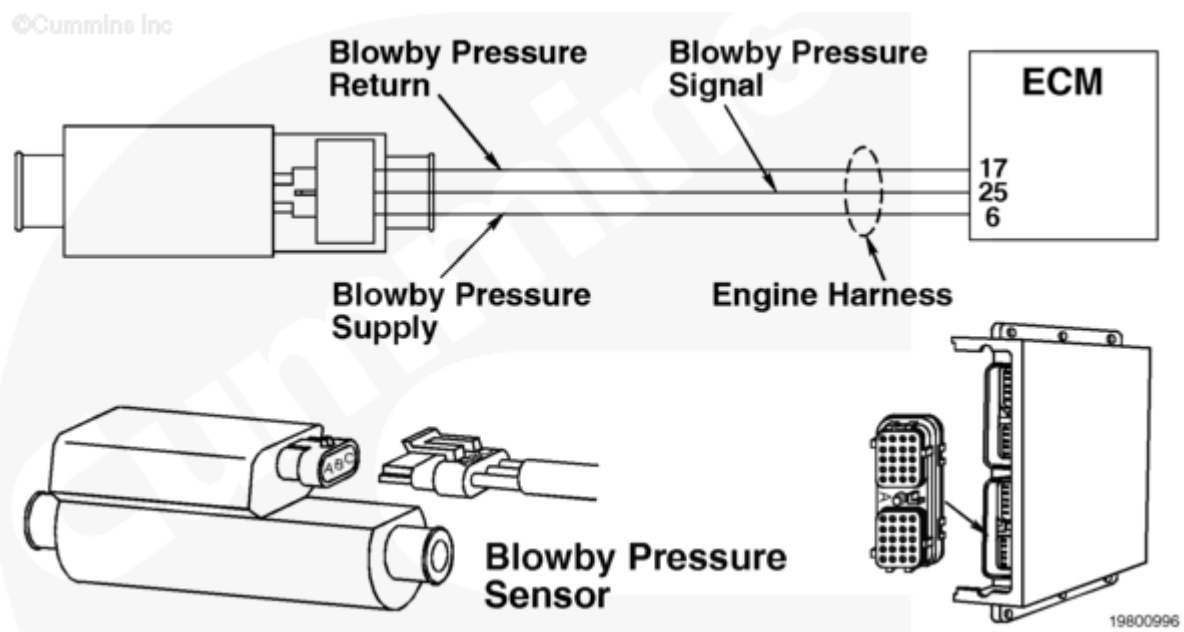
Blowby Pressure Sensor Circuit

Codes	Reason	Effect
Fault Code: 555 PID(P): P101 SPN: 1264 FMI: 0 Lamp: Engine Protection SRT: 00-676	High blowby pressure has been detected. Voltage signal at blowby pressure signal pin 25 indicates blowby pressure above 368 mm H ₂ O [14.5 in H ₂ O].	Calibration-dependent. Progressive power and speed derate and engine shutdown as pressure increases over thresholds.

The blowby pressure sensor is used by the ECM to monitor the engine crankcase pressure. The ECM monitors the voltage on the signal pin and converts this to a pressure value. The blowby pressure value is used by the ECM for the engine protection system.

- Confirm that the crankcase breathers and breather tubes are **not** obstructed.
