Technical Service Bulletin: tsb102558

Released Date: 21-Nov-2007

Revision, Clean and Inspect for Reuse Steps, Lubricating Oil Cooler and Lubricating Oil Thermostat Procedures

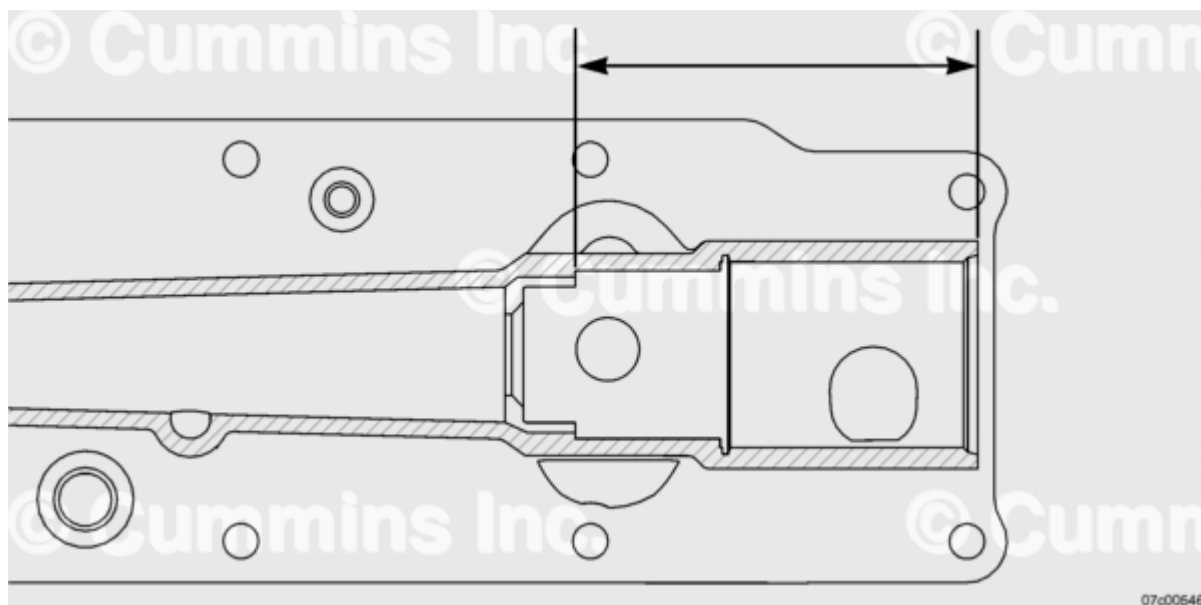
Shallow thermostat seat depth can lead to damaged oil thermostats and problems with oil pressure fluctuation. If the seat depth dimension is below the minimum specification, the oil cooler housing will need to be replaced.

Distance From Seat to Spot Face at End of Lubricating Oil Cooler Housing		
123.47 mm	Minimum Dimension	4.861 inch

Use this reference dimension for the following lubricating oil cooler housing part numbers: 4952496, 4952497, 4952507, and 4952508.
