Compression after ballistic impact response of pseudoelastic shape memory alloy embedded hybrid unsymmetrical patch repaired glass-fiber reinforced polymer composites

Journal of Composite Materials
0(0) 1–23

Abstract

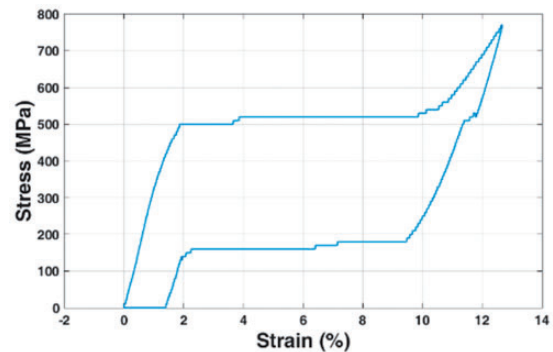
Figure 1. Stress–strain response showing hysteresis cycle of SMA.

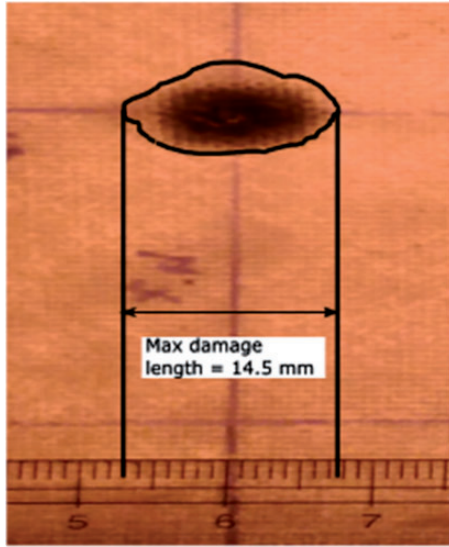
Figure 2. Maximum damage in GFRP parent specimen at an impact velocity of 70 m/s.

was measured using the scale (Figure 2). The maximum damage length in the parent laminates came out to be $14.5 \pm 0.2 \text{ mm}$. Since circular hole provides evenly curved boundary and optimal stress pattern around the hole periphery, the irregular damage area was dressed as a circular hole. Thus, to induce damage, a 15-mm diameter circular hole was machined at the center for all the glass/epoxy specimens using abrasive waterjet machining process.

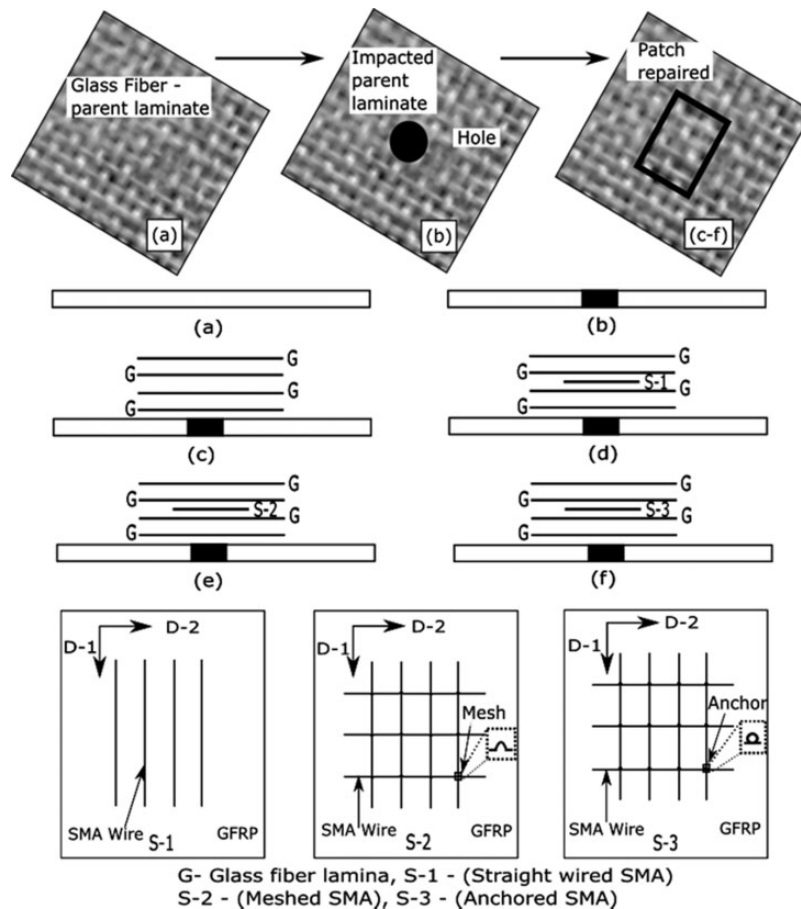
Figure 3. Schematic diagram of different specimens (a) GFRP parent, (b) damaged, specimen repaired using (c) GFRP, (d) straight-wired SMA, (e) meshed SMA, and (f) anchored SMA-based patches.

Four different types of the external patch were fabricated. Their configurations were conventional GFRP, straight-wired SMA, meshed SMA, and anchored SMA as shown in Figure 3. In the first configuration,

specimens were fabricated using only glass fiber and epoxy matrix. In the second (straight wired) configuration, four independent SMA wires of length 30 mm were embedded in between the middle GFRP layers as an embedment. In the third (meshed) configuration, a mesh of SMA wires or woven SMA wires was embedded in between the middle GFRP layers. In direction 1 (D-1), wires of length 30 mm were laid, then they were weaved or meshed by SMA wire from the perpendicular direction named as D-2. Similarly, last (anchored) configuration was also embedded in between the middle GFRP layers. In this configuration, SMA wires were laid in D-1 and they were anchored by SMA in D-2 with the help of tying knots around SMA in D-1 as shown in Figure 3. Nominal distance between the wires in both directions was maintained to be 4 mm, which had to be less than the projectile's diameter (8 mm).

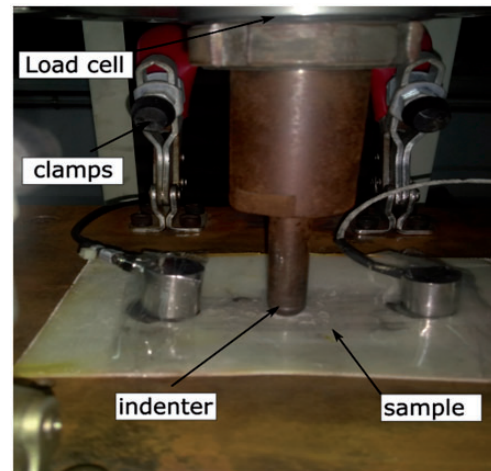
Figure 4. Specimen clamped in ASTM D 6264-98 indentation fixture.

According to ASTM standard D6264-98(04), quasi-static multiple indentation tests were carried out using Tinus Olsen Universal Testing Machine (UTM) of maximum load capacity 100 kN. Four corners were clamped tightly with the help of toggle clamps as shown in Figure 4. Incremental displacement steps of 2, 4, 6, 8, 10, and 12 mm were applied one after the other from the point where the indenter initially contacted the specimens. The feed rate was set as 1 mm/min.

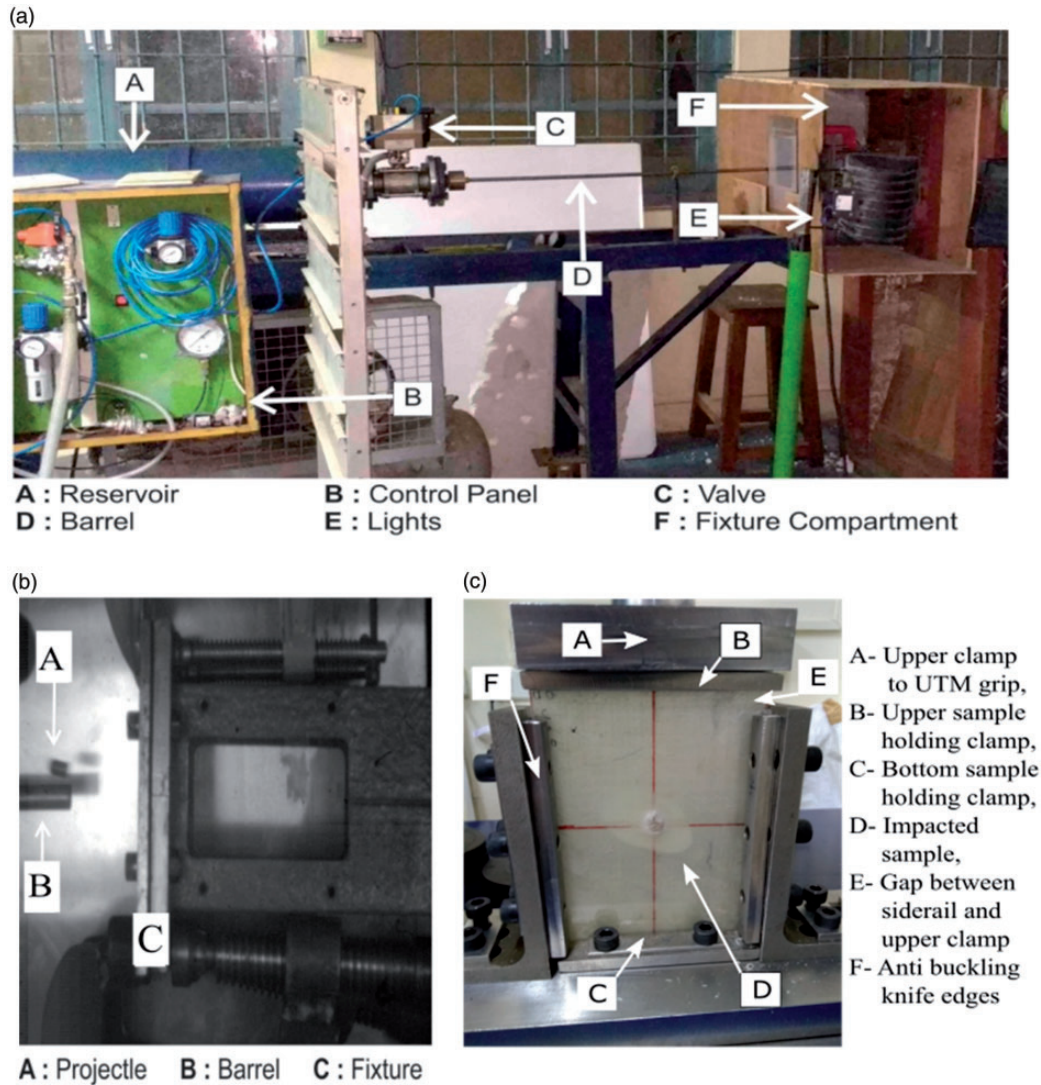
Figure 5. (a,b) High-speed gas gun set-up, (c) compression after impact (CAI) test set-up.

CAI tests were conducted on both repaired impact and repaired non-impacted specimens to find out the residual compressive strength and to characterize the failure modes. Figure 5 shows the placement of the CAI specimen in the ASTM D7137-12 CAI fixture. Tests were carried out in 50 kN maximum load capacity INSTRON 8801 UTM. According to ASTM D7137 a cross-head speed of 1 mm/min was maintained.

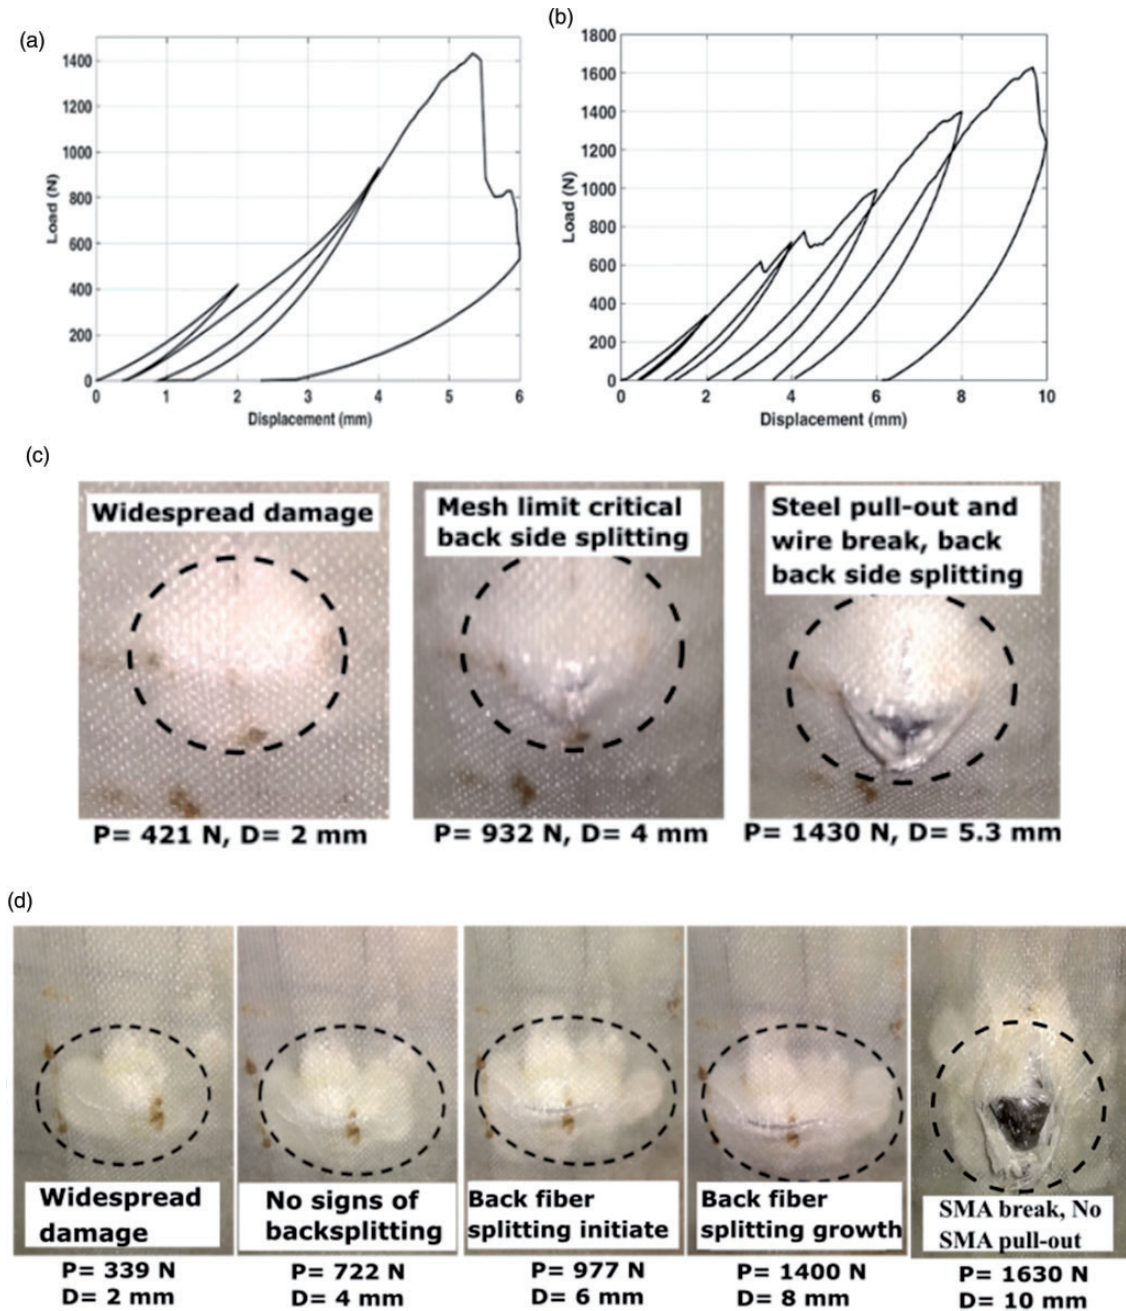
Figure 6. Preliminary test results on steel embedded glass/epoxy specimens showing (a) force–displacement curves, (b) indentation load, AE cumulative counts and AE event location vs. time curves and (c) photographic images of fractured steel embedded GFRP specimens and (d) photographic images of SMA-embedded GFRP specimens at various indentation cycles.

It was found that the ultimate failure load was the highest for steel embedment (1430 N) up to 3rd cycle, but its ultimate failure displacement was only 5.33 mm in comparison to anchored SMA configuration which was 10 mm. Also, for steel embedment maximum cycles to failure were three (Figure 6(a)), whereas it was five for SMA-embedded composite specimens (Figure 6(b)). Though, ultimate failure load was higher for steel wire embedment up to 3rd cycle, steel wire underwent permanent deformation earlier

than SMA wire. Once it underwent permanent deformation in the impact zone, steel anchors did not play any role in the energy absorption and further increase in the indenter load led to the fracture of steel wire (Figure 6(c)), leading to ultimate failure of the entire specimen. SMA wire was able to sustain the load due to its capability to undergo higher strains and reached the ultimate failure load of 1630 N in the 5th cycle (Figure 6(b,d)).

Thus, from the literature^{19,20} and from the above investigation (Figure 6), after establishing that SMA toughness is higher than steel, assessment of the impact response of SMA-embedded composite specimens was investigated.

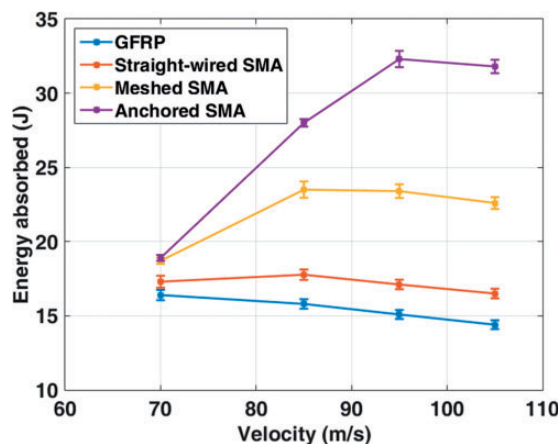
Figure 7. Energy absorbed vs. velocity curves for different types of patch at four different velocities.

After evaluating the speed of the impactor before and after impact with the help of a high-speed camera, the absorbed energy was plotted against the impact velocity for various specimens (Figure 7). It can be evidently noticed that the impact behavior changed significantly with the architecture of the SMA wire embedded in the external patch of repaired specimens and the impact velocity. Figure 7 implied that the perfect elastic rebound of the projectile did not occur for any of the specimens. Consequently, the kinetic energy of the projectile was transferred to the specimen for the contact duration of the projectile and was absorbed in the initiation and progression of damages.

So far, results have established that the energy absorption is the highest in the anchored configuration (Figures 7 and 9(d)), in comparison to the other two SMA configurations (straight-wired and meshed). In the previous section, it was already discussed that SMA was better in comparison to the conventional metal such as steel because of its high toughness. In this section, why anchored specimens showed a superior behavior is established.

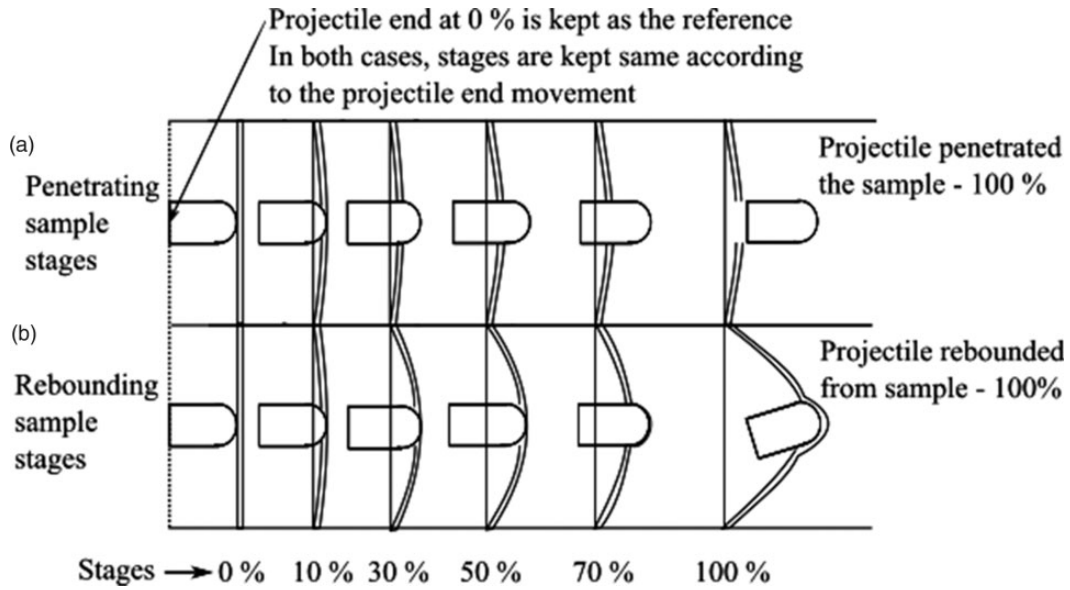
Figure 8. Schematic diagram of projectile motion stages for both (a) penetrating sample and (b) rebounding sample.

Figure 8(a,b) shows the stages of projectile movement in the penetrating as well as rebounding specimens. These stages were 0%, 10%, 30%, 50%, 70%, and 100%, respectively. These stages of the projectile movement were normalized according to the projectile end or tail movement with respect to its initial position at 0% penetration. At 100% of projectile movement, either projectile may penetrate the specimen for penetrating specimens (Figure 8(a)) or may have rebounded from the rebounding specimens (Figure 8(b)). It was done to compare the amount of energy absorbed at each stage by penetrating as well as rebounding specimens with respect to the time at the impact velocities of 70, 85, 95, and 105 m/s, respectively. These stages were referred to as a projectile movement in further explanations.

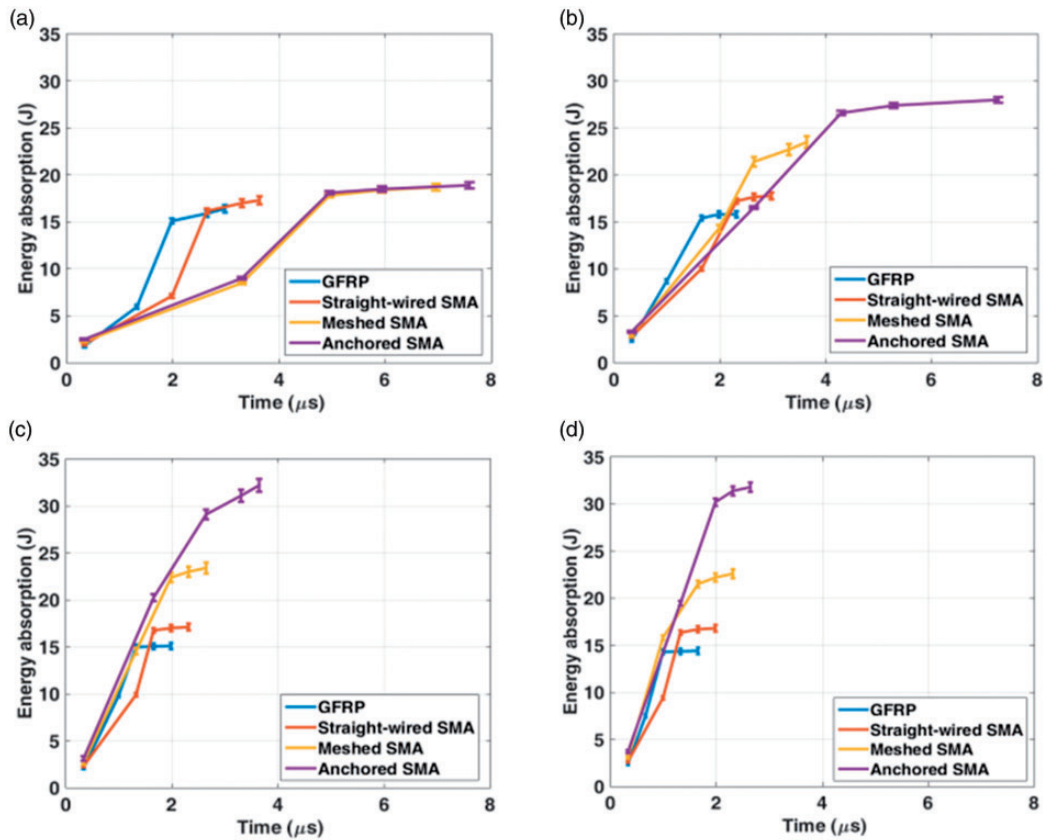
Figure 9. Energy absorption vs. time curves at five different stages of damage progression of different specimens at four different velocities: (a) 70, (b) 85, (c) 95, and (d) 105 m/s.

Figure 9(a–d) shows the energy absorption versus time plot for normal and various SMA-based GFRP specimens at respective stages of the projectile movement, impacted at velocities 70, 85, 95, and 105 m/s, respectively, for rebounding and penetrating specimens. For impact velocity of 70 m/s and projectile movement of 10%, both the normal and all the SMA-based specimens showed almost similar contact duration.

After the projectile movement of 50%, a considerable increment in the slope of the energy absorption versus time curve was noticed for normal and straight-wired specimens in comparison to meshed and anchored specimens at an impact velocity of 70 m/s (Figure 9(a–d)). The reason behind this observation was that, for normal and straight-wired specimens, the projectile movement of 50% resulted in penetration leading to critical fiber fracture damage mode (Figure 10(a)), which led to higher energy absorption. On the other hand, in the case of meshed and anchored

energy absorption versus time curve and a considerable decrease in the contact duration in comparison to 70 m/s (Figure 9(a,b)). This response owed to the reason that, in meshed specimens, the impactor extremely penetrated the specimen (i.e., predominant fiber breakage accompanied with the SMA pull-out in two directions at the impact point was observed; Figure 15(b), after

At an impact velocity of 105 m/s, the slope of the energy absorption versus time curve for anchored specimens after 50% projectile movement decreased than at earlier impact velocity (95 m/s; Figure 9(d)). Similarly, it decreased for all the other types of specimens also. This happened because, after ballistic limit (i.e. complete penetration), as impact velocity further increased, there was a decrease in the contact duration especially after 50% of projectile movement leading to specimen penetration (Figures 9(d) and 13(b)).

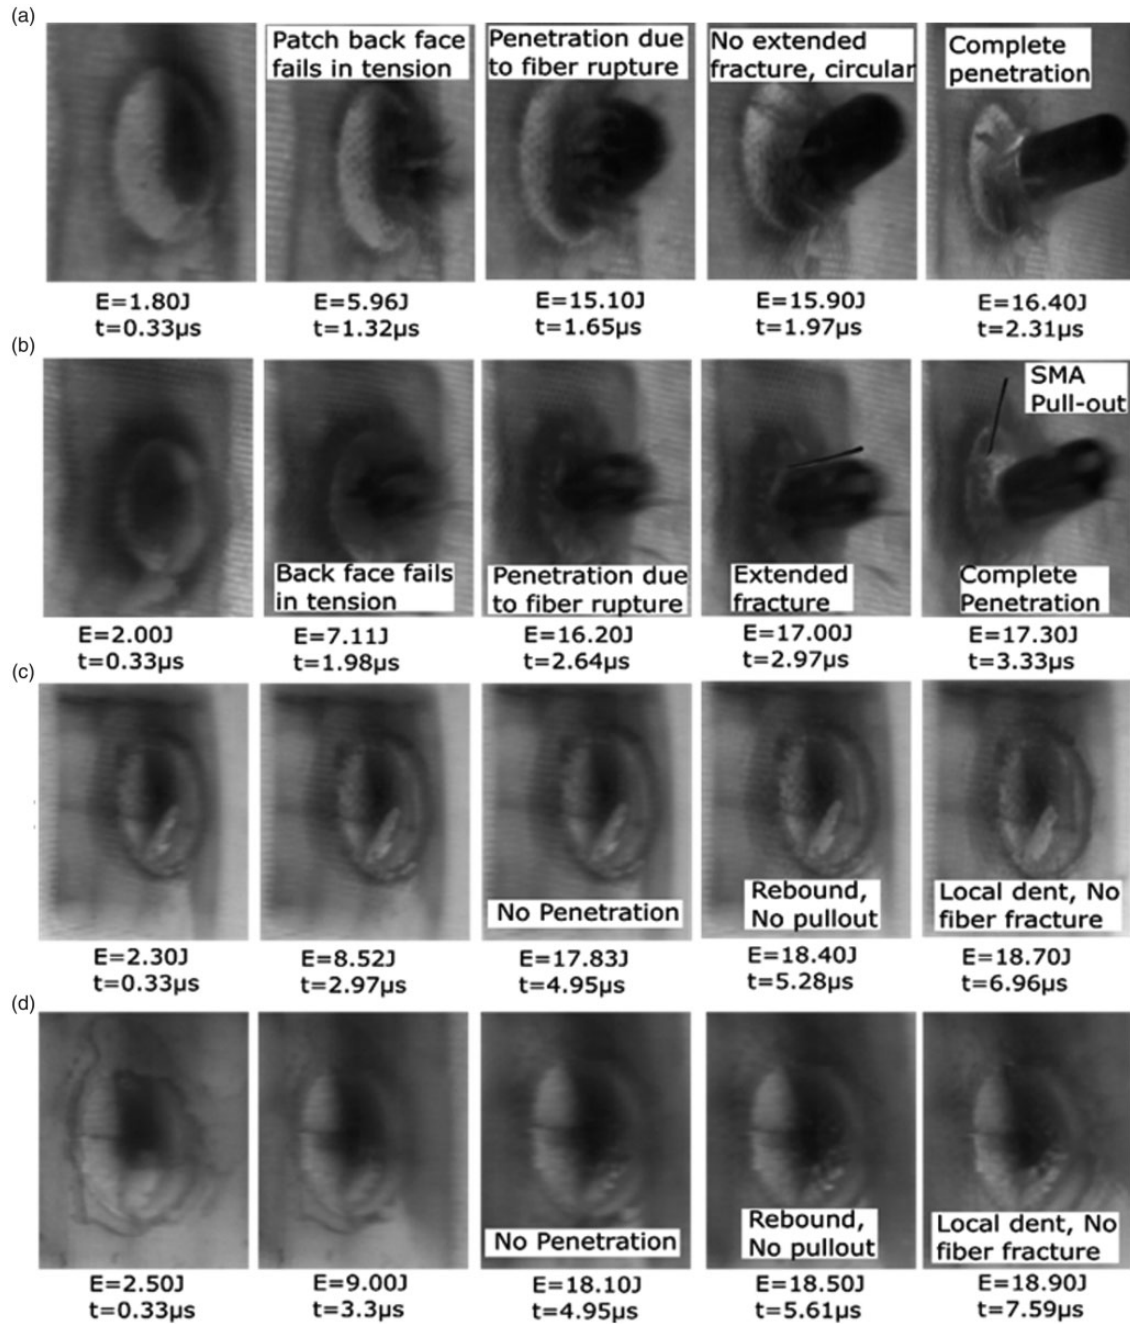
Figure 10. High-speed camera images (rear view) at five different stages of damage progression and their corresponding absorbed energy (E) of different specimens: (a) GFRP, (b) straight-wired, (c) meshed, and (d) anchored impacted at 70 m/s.

At an impact velocity of 70 m/s, after projectile movement up to 30%, contact duration of normal specimens increased marginally to offer ultimate absorbed energy and resulted in complete penetration (Figure 10), depicting poor impact response among all

the repaired specimens. This response was attributed to the characteristic energy absorption mechanism of brittle glass fibers in normal specimens,³⁶ which dissipated the impact energy by premature breakage of glass fibers beneath the spot of application of impact loads, as clearly confirmed by the high-speed camera images (Figure 10). These results could make clear why normal specimens showed least absorbed energy. Another possible explanation for this response was that, in the case of specimens repaired using SMA wires both SMA and fibers system control the penetration of the projectile by various additional energy absorbing mechanism, whereas in the case of specimens repaired using homogeneous glass fibers had insignificant control on the projectile penetration.

specimens, a local dent was observed in the primary impact site without any critical fiber fracture (Figure 10(c,d)). Quite contrary to the straight-wired specimens, by embedding the SMA wires in meshed and anchored architecture pattern into the external patches, it yielded superior resistance to projectile penetration for all stages of projectile movement (Figure 10(b–d)). Moreover, a similar absorbed energy versus time curve pattern was noticed among meshed and anchored specimens.

Anchored specimens can be considered as a combination of meshed specimens with knots. These meshes were able to restrict the penetration of indenter and delayed the critical fiber fracture (Figure 10(d)), unlike the normal and straight-wired specimens at all percentage of projectile movement, in addition to which knots further strengthened the GFRP and SMA bond by providing anchors at the knotting point (Figure 16(a), before impact) which controlled the premature pull-out of anchored SMA and further hold it in a position. As a result at 70 m/s, there was a local dent which was observed at the back face and failure mode was similar to that of meshed configuration (Figure 10(d)). This suggested that for complete perforation of the specimens, the applied impact velocity had to rise further, highlighting the superior toughness property. Hence, the ultimate contact duration at an impact velocity of 70 m/s was significantly higher for the meshed and anchored specimens rather than the normal and straight-wired specimens.

Overall, the results pointed out that embedding the SMA wire in the anchored pattern made the progression of premature fiber fracture difficult under impact loading (Figures 10, 11). At higher impact velocities, anchored specimens showed the excellent balance among fiber breakage and SMA/matrix pull-out (Figure 16(b), after impact and Figure 17(d), side-view). The positive role played by knots on anchored specimens on the local bending response is apparent in comparison to other SMA configurations (Figures 14–16(a,b), after impact and Figure 17(b–d), side-view). More specifically, specimens embedded with SMA wires which are anchored using knots (anchored specimens) provided the most optimistic drift as it illustrated the greater damage resistance. These remarks can give details why anchored specimens revealed the superior impact response than all the other specimens.

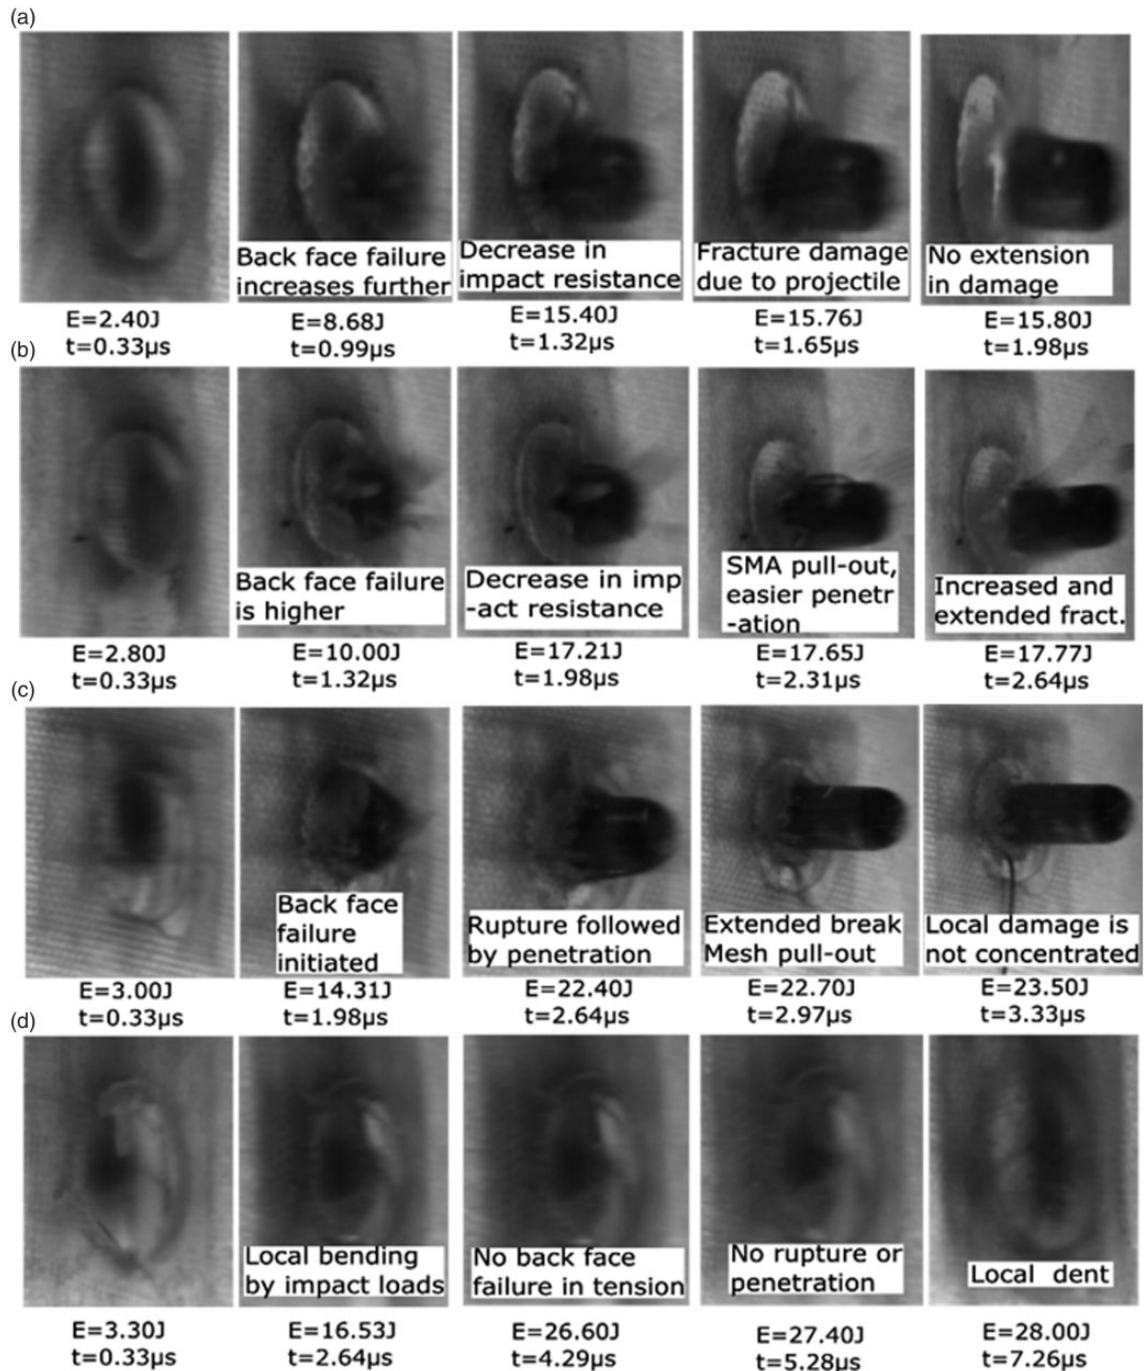
Figure 11. High-speed camera images (rear view) at five different stages of damage progression and their corresponding absorbed energy (E) of different specimens: (a) GFRP, (b) straight-wired, (c) meshed, and (d) anchored impacted at 85 m/s.

Critical debonding between SMA wire and matrix system resulted in higher stresses in the glass fibers thus leading to premature failure of meshed specimens (Figures 11(c) and 16(b), after impact and

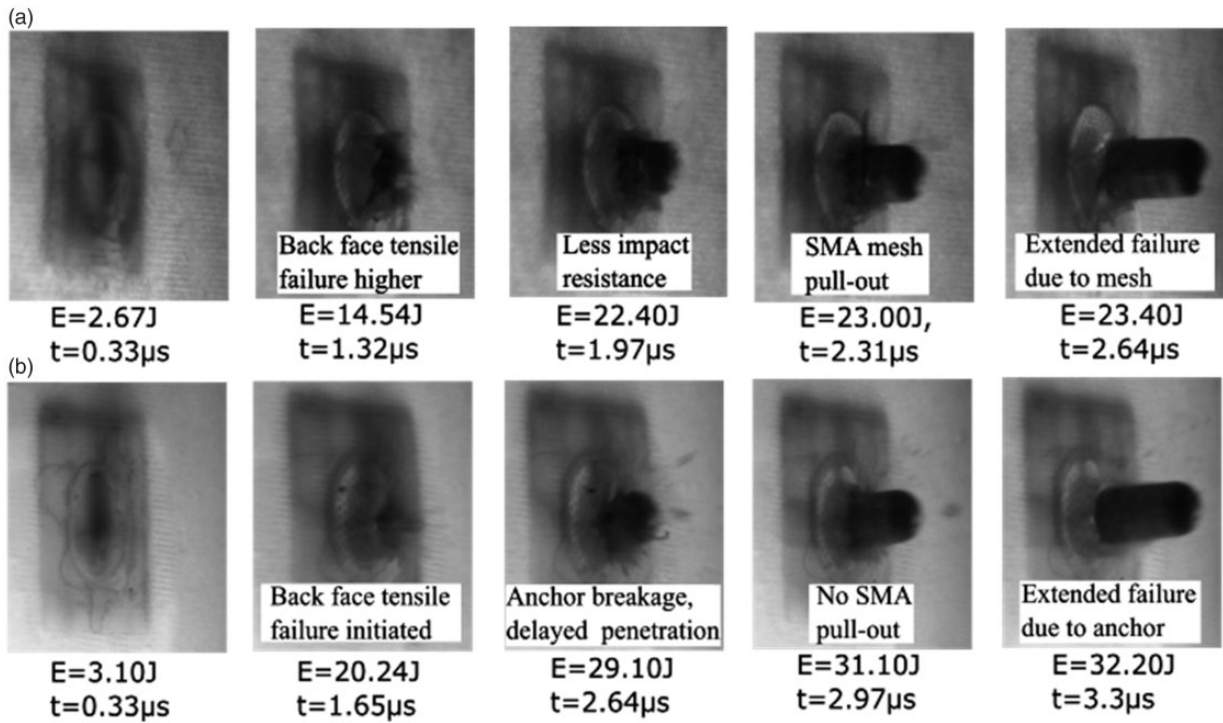
Figure 12. High-speed camera images (rear view) at five different stages of damage progression and their corresponding absorbed energy (E) of different specimens: (a) meshed and (b) anchored impacted at 95 m/s.

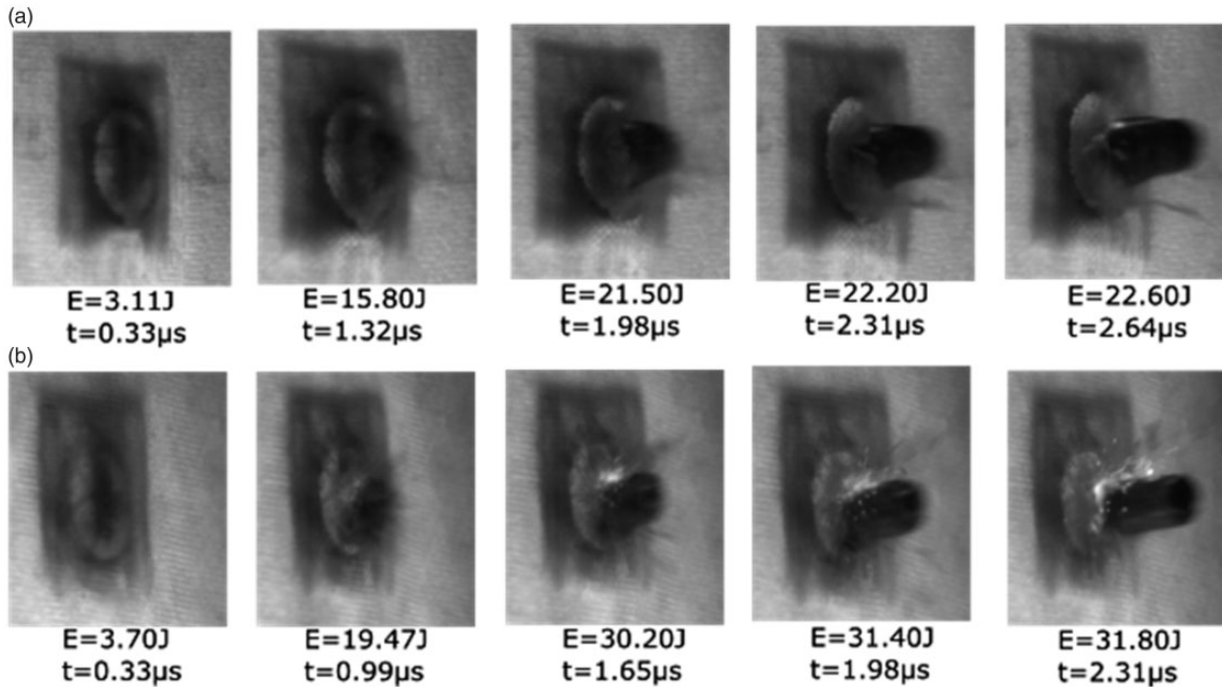
Figure 13. High-speed camera images (rear view) at five different stages of damage progression and their corresponding absorbed energy (E) of different specimens: (a) meshed and (b) anchored impacted at 105 m/s.

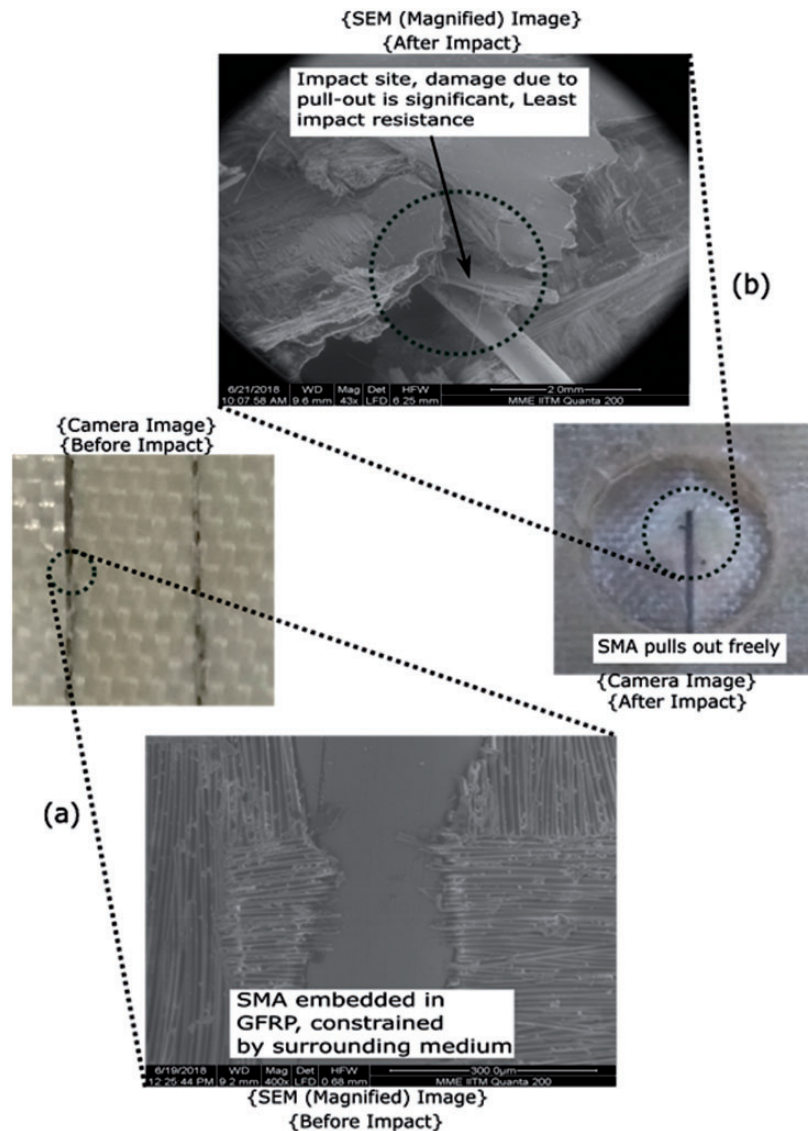
Figure 14. Straight-wired SMA-embedded patch repaired specimen showing (a) interaction between the wire and the matrix before impact and (b) damage modes after impact at the impact site using camera and SEM images.

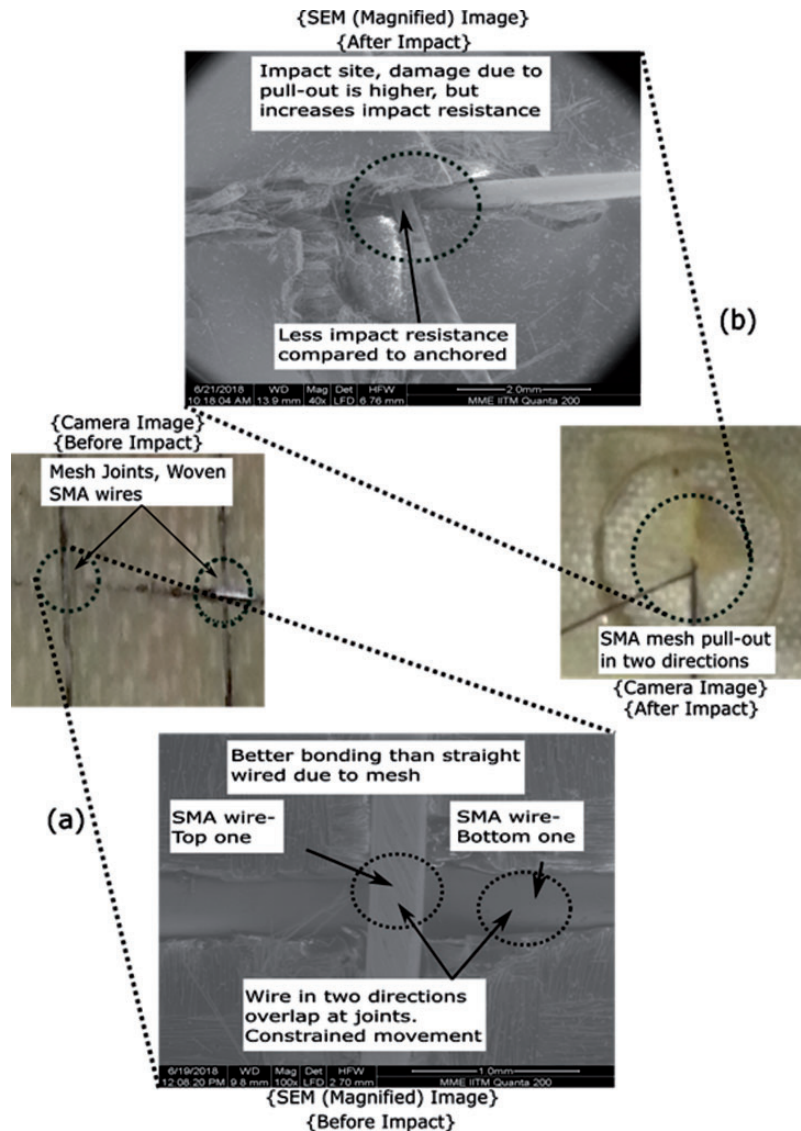
Figure 15. Meshed SMA-embedded patch repaired specimen showing (a) interaction between the wire and the matrix before impact and (b) damage modes after impact at the impact site using camera and SEM images.

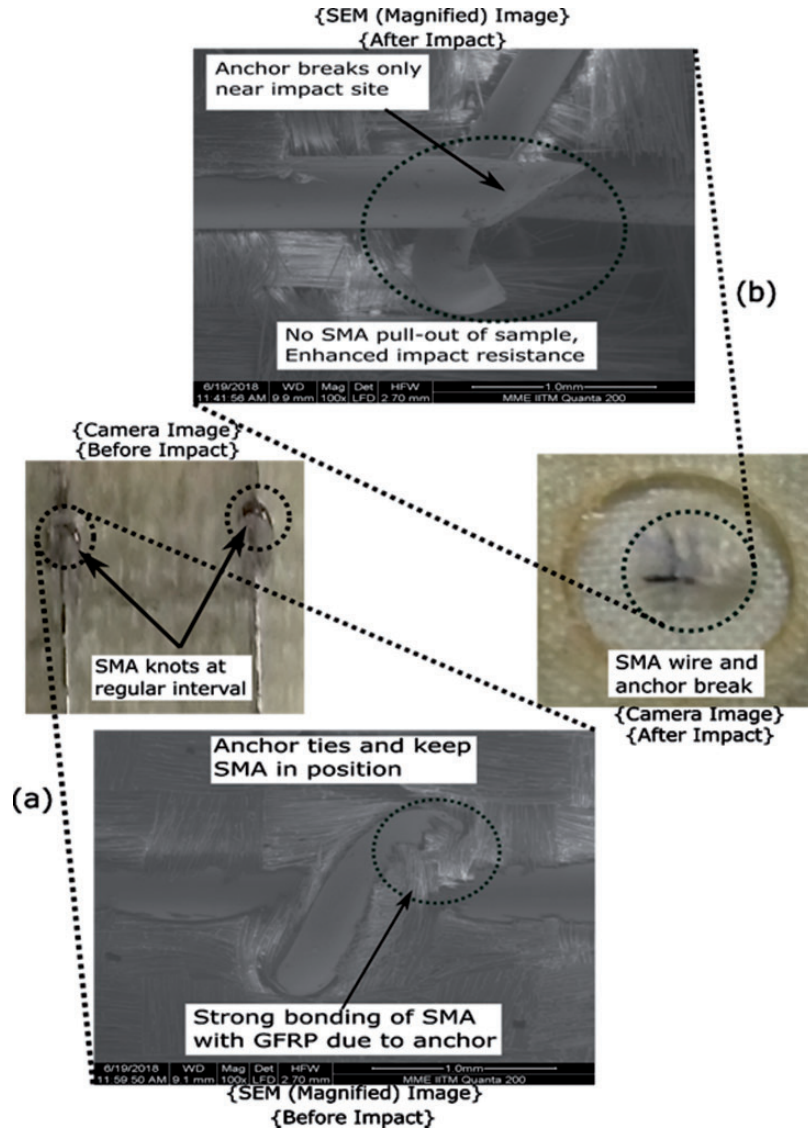
Figure 16. Anchored SMA-embedded patch repaired specimen showing (a) interaction between the wire and the matrix before impact and (b) damage modes after impact at the impact site using camera and SEM images.

side and top-view). As a result, as SMA pull-out was not allowed by other knots, this anchored SMA underwent tensile failure (fracture) at the impact point (Figure 16(b), after impact). As a result, the entire specimen was perfectly involved in the ultimate fracture process. Among various SMA-based specimens, anchored specimens were the only one to fail at higher impact velocity (Figure 12(b)) with a display of local elongation until SMA fractured. Thus, anchored specimen showed much higher improvement in energy absorption (Figure 6) and impact resistance (Figure 16(b), after impact and Figure 17(d), side-view), whereas all other specimens containing SMA wires showed a considerable pull-out and debonding of SMA from the matrix (Figures 14 and 15(a,b)) and Figure 17(b,c), side-view). These failure events, as a result, caused a significant increase in the slope of anchored specimens.

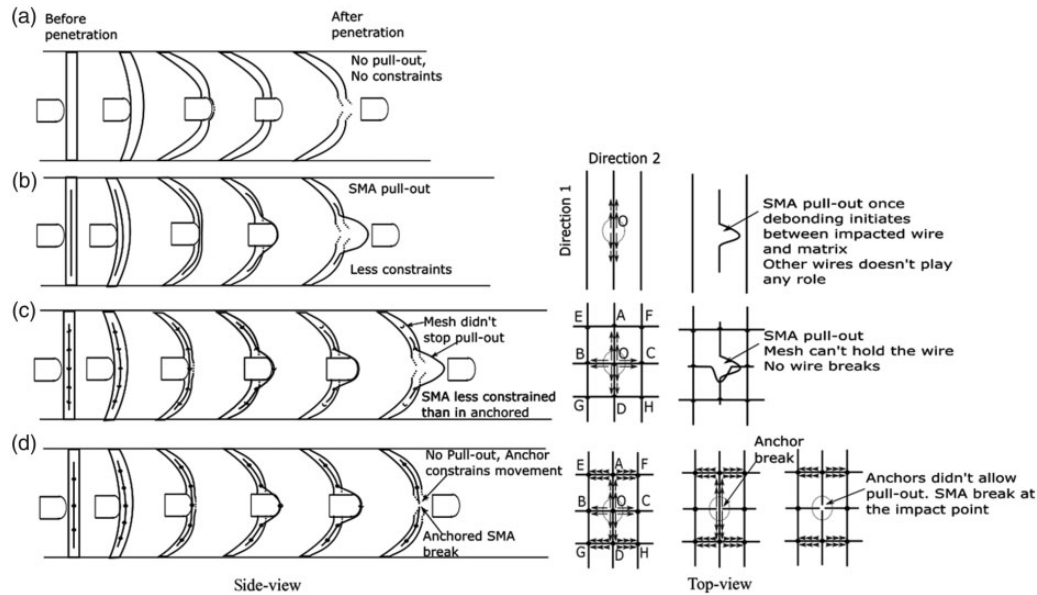
Figure 17. Schematic (side-view and top-view) diagram of the progression of damage in different repaired specimens: (a) GFRP, (b) straight-wired, (c) meshed, and (d) anchored impacted.

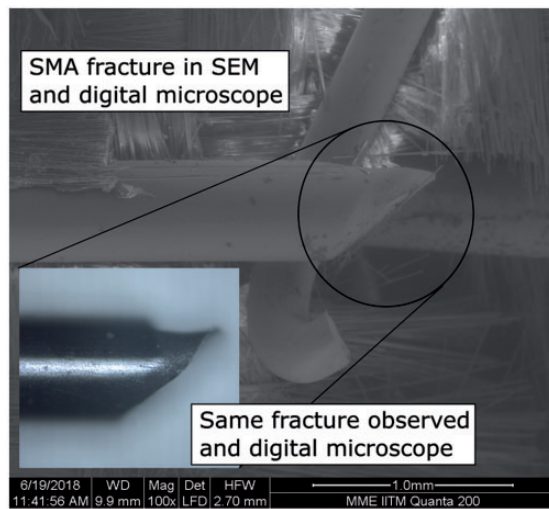
Figure 18. Fractured SMA wire at the point of impact.

It can be observed from the SEM image of the post-impacted anchored configuration, that SMA wire embedded in anchored configuration underwent fracture. SMA wire employed for the impact testing were such that they had high elongation to failure and high ultimate strength (Table 2) which led to increase in overall toughness. Thus, from Table 2 and Figure 18, it can be said that SMA wire in the anchored configuration had to undergo ultimate failure strain of 17.5%. Also, fracture is the ultimate failure stage and before that SMA would have undergone initial martensitic transformation followed by plastic yielding.

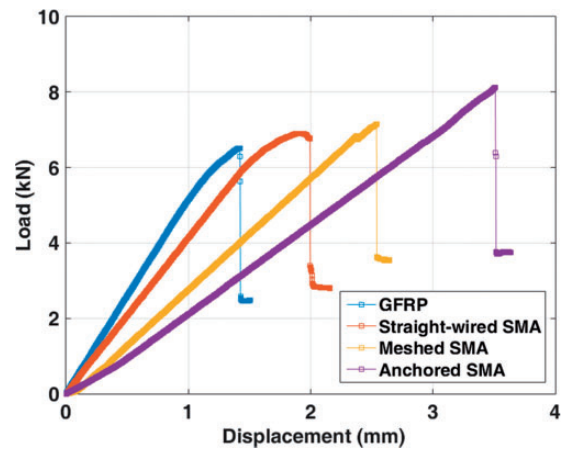
Figure 19. Load vs. displacement curves for non-impacted specimens.

SMA architecture pattern influenced the compression behavior of repaired composite laminates both before and after impact. Figure 19 illustrated the force versus

SMA embedment offered improved balance among ultimate compressive load, toughness, and ultimate displacement to failure among the repaired specimens (Figure 19). Repairing the damage glass/epoxy specimens using straight-wired, meshed, and anchored

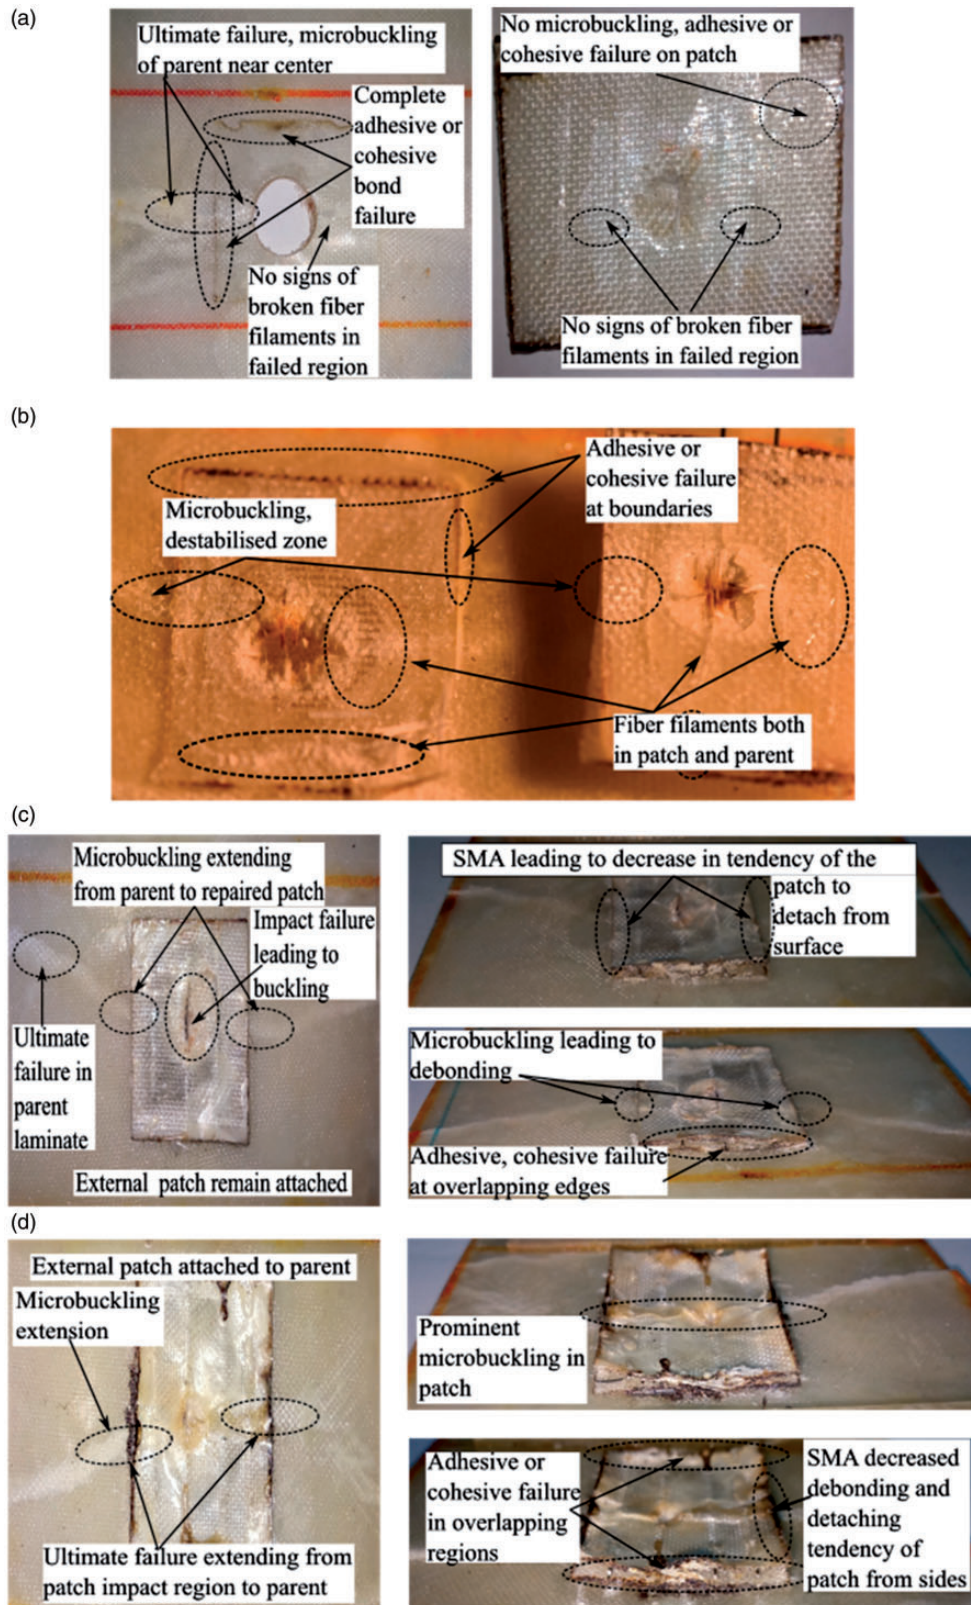
Figure 20. Photographic images of failure profile for various repaired specimens: (a) GFRP, (b) straight-wired, (c) meshed, and (d) anchored impacted.

Observations of surface fracture. The key phase in analyzing the performance of repaired laminates is to characterize the profile of the failure occurred in the fractured specimens. Figure 20 illustrates the photographic image of the failure profile for various repaired specimens. By and large, a major failure is generated in the mode of adhesive or cohesive failure and fiber micro-buckling (Figure 20(a–d)). It is illustrious that, under

interface failure. The lack of broken glass fibers (i.e., nonappearance of fiber/matrix debonding) on the surface of separated external patches additionally supported the existence of the adhesive or cohesive failure (Figure 20(a)). On one instance lacking the obstruction from the patches, the damaged parent laminate at once depicted ultimate rupture at the area most destabilized by the central hole. The chronology of failure mechanisms is as following: high stresses occurred in the patched area as the damaged specimens were repaired using normal GFRP patches characterized with brittle and low elongation features; subsequently, high shear stresses were generated in the adhesive layer³² and encouraged the complete separation of the patches with increasing load; and the ultimate rupture occurred almost instantly in the site most

destabilized by the central hole. This can clarify why the ultimate compressive load of high stiff normal specimens were lower than that of SMA-based specimens. An almost comparable failure profile was observed for the specimens repaired using straight-wired based external patches (Figure 20(b)). Although the ultimate rupture always occurred in the area most destabilized by the central hole, there was a small amount of fiber micro-buckling in the straight-wired patches which owed to the existence of fewer amounts of ductile SMA wires. This was because of the fact that the lower stiffness of the patch allowed the patch to deform along with the parent laminate.

different (Figure 20(c,d)). It is clear that there was no substantial adhesive or cohesive damage among the patch–parent interface after rupture. The ultimate rupture had always taken place in the site most destabilized by the central hole, but the external patches were damaged and remained attached to the parent laminate. Instead, a small amount of adhesive or cohesive failure can be noticed near the overlap edges of the external patches. Adhesive or cohesive failure progression from the overlapping edge to the central hole is highly restricted by the anchored and meshed patches (Figure 20(c,d)). The patches encountered with fiber micro-buckling at the middle were mostly connected to the transverse edge of the central hole. This was a further indication for restricted progression of failure

of adhesive or cohesive failure in the patch area; subsequently, as the lessening of the stress in the hole border was lower and redistribution of compression load into the destabilized zone was larger due to fiber micro-buckling, the specimen failed at the region most weakened by the central hole. Figure 20(c,d) depicts the fiber micro-buckling occurred in the parent laminate, initiating from the border of the hole across the width of the specimen, including a small amount of debonding/delamination and fiber micro-buckling of the external patches over and around the central hole. This might be accredited to the high ductile property offered

by the high amount of SMA wires in meshed and anchored specimens under compressive load. The lower optimum stiffness provided by anchored and meshed external patch restricted the adhesive or cohesive failure unlike high stiff normal and straight-wired specimens (Figure 20). On the other hand, in the case of anchored specimens, the presence of higher amount of ductile SMA wires further provided excellent cooperation between the external patch and the parent laminate, unlike other SMA-based repaired specimens. These characteristics thus enhanced the overall load carrying capability, toughness, and ultimate displacement to the failure of anchored specimens.

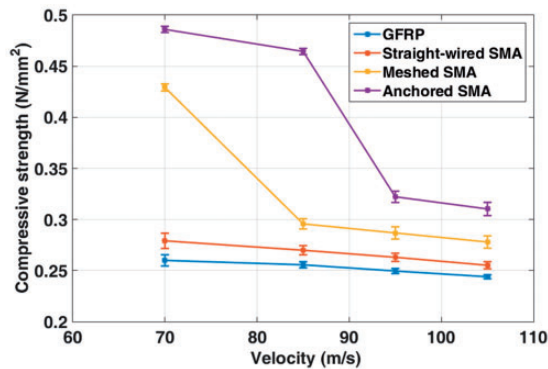
Figure 21. Compressive strength vs. velocity curve for different configurations of external patch repair.

Post-impact compression test. Figure 21 illustrates the ultimate compressive strength of impacted specimens at different velocities.

The percentage difference in ultimate compressive strength between meshed and anchored specimens was significantly lower than at impact velocity of 85 m/s (Figure 21—from 26% difference at 85 m/s to 1.5% at 95 m/s). The critical penetration occurred on the patch due to the impact event restricted effective transfer of compressive load from the parent laminate to the patch system at the damaged area. This was why the ultimate compressive load of anchored specimens nearly approached that of meshed specimens at an impact velocity of 95 m/s.
