Technical Service Bulletin: TSB170115

New Turbocharger Oil Drain Tube

- QSB6.7 CM2150 B109

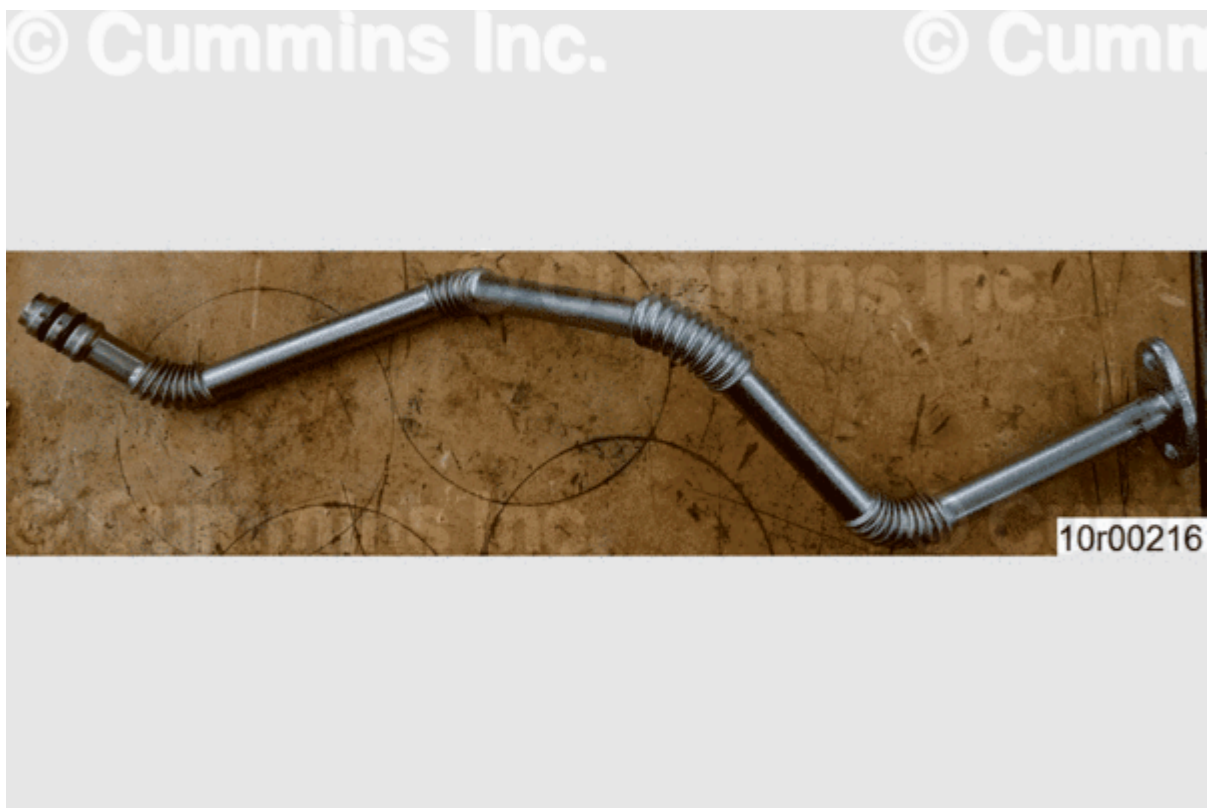
Path of turbocharger oil drain tube was changed to correct interference issues.

Figure 1: Existing Turbocharger Oil Drain Tube, Part Number 3975076.

Figure 2: New Turbocharger Oil Drain Tube, Part Number 5368665.

A new turbocharger oil drain tube part number is available.
