Technical Service Bulletin: TSB240060

Released Date: 19-Mar-2024

New Rocker Lever Cover Part Number

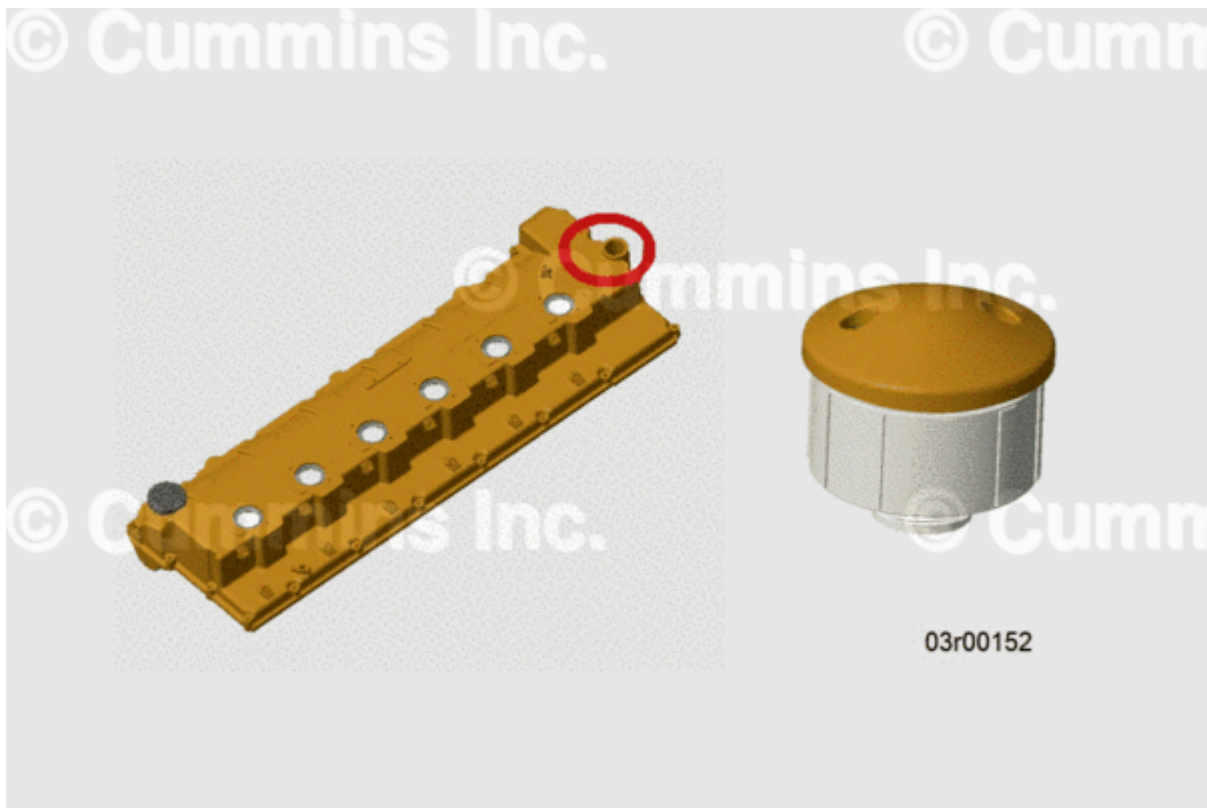
The position of the lubricating oil filler cap at the rear of the rocker lever cover is occupied by a new pressure relief valve.

Figure 1, Rocker Lever Cover, Pressure Relief Valve, and Pressure Relief Valve Location.

If using a new rock lever cover, Part Number 6462747, a pressure relief valve, Part Number 6471803, should be ordered together.
