Fault Code: 293

OEM Temperature Sensor Circuit

Overview

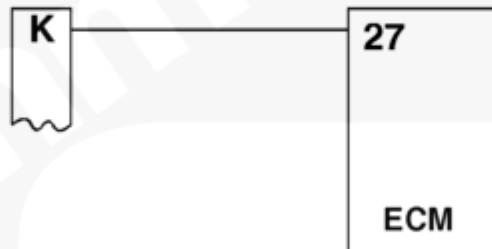
Codes	Reason	Effect
Fault Code: 293 PID(P): P223 SPN: 1083 FMI: 3 Lamp: Yellow SRT:	VDC detected at the OEM temperature sensor signal pin 27 of the OEM interface harness indicates the sensor has failed high.	No engine protection for OEM temperature.

The OEM sensor signal is used by the ECM to monitor the OEM temperature. The OEM temperature is used by the ECM for the engine protection system. A sensor that has failed high can be caused by opens in the signal or return wire, voltage shorts in the signal or return wire, or a faulty sensor.

Refer to Troubleshooting Fault Code t05-293 (</qs3/pubsys2/xml/en/procedures/19/19-t05-293.html>)
