Fault Code: 349

Frequency Accelerator Circuit

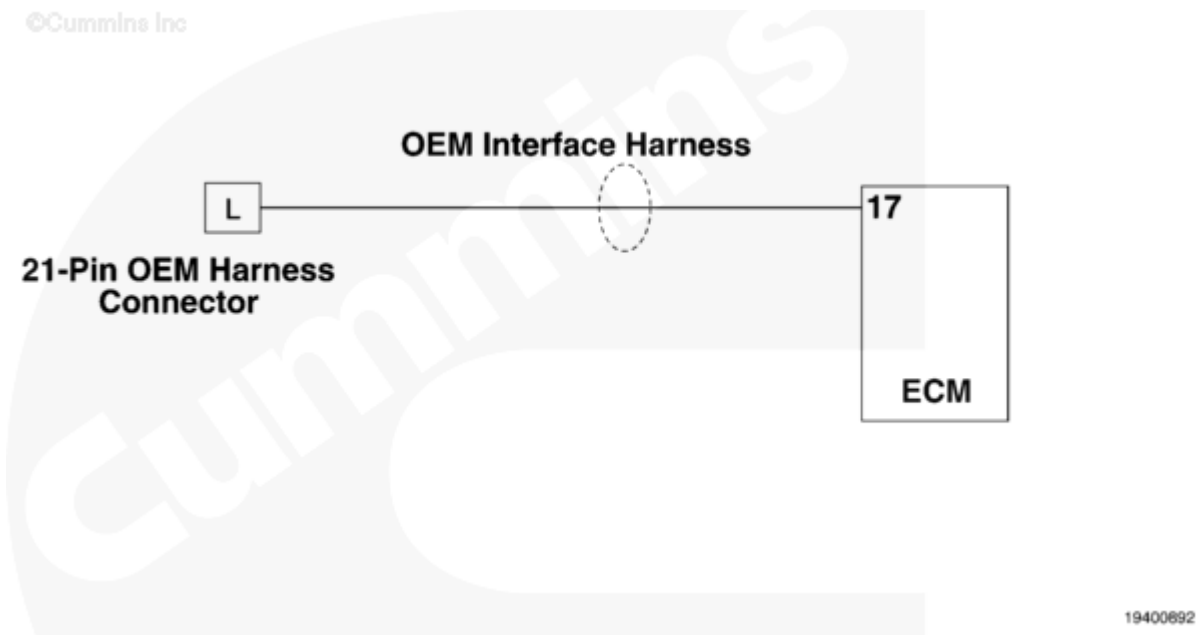
Codes	Reason	Effect
Fault Code: 349 PID(P): P91 SPN: 191 FMI: 0 Lamp: Yellow SRT:	A frequency of greater than a calibrated threshold has been detected at frequency accelerator signal pin 17 of the OEM interface harness.	Calibration-dependent power and speed derate.

The frequency accelerator provides the driver's accelerator command to the ECM through the OEM harness and the OEM interface harness. The ECM uses this signal to determine the fueling command.

Refer to Troubleshooting Fault Code t05-349 (</qs3/pubsys2/xml/en/procedures/19/19-t05-349.html>)
