SAFETY MATTERS

Safety and Quality Assurance

Number 1, June 2015

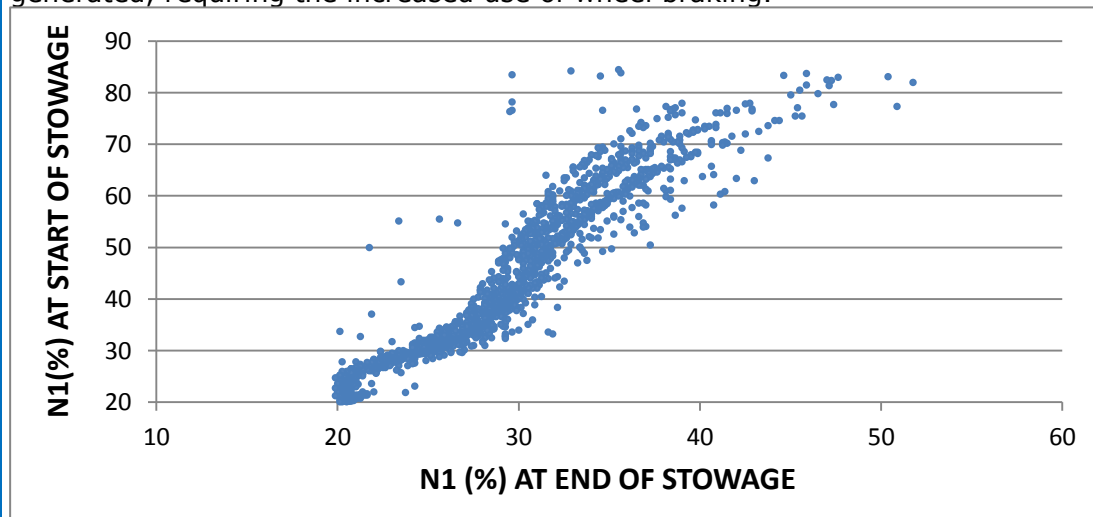
Flight Data Analysis, Trends:

After using thrust reverse during landing, some crews rapidly close the reverse thrust levers, while the engine N1 has not stabilized at idle yet. This action results in the reverser sleeve being closed and extra forward thrust is generated, requiring the increased use of wheel braking.
