# STM32F105xx and STM32F107xx Errata sheet

## STM32F105xx and STM32F107xx revision Z connectivity line device limitations

This errata sheet applies to the revision Z of the STMicroelectronics STM32F105xx and STM32F107xx connectivity line products. This family features an ARM™ 32-bit Cortex®-M3 core, for which an errata notice is also available (see [Section 1](#) for details).

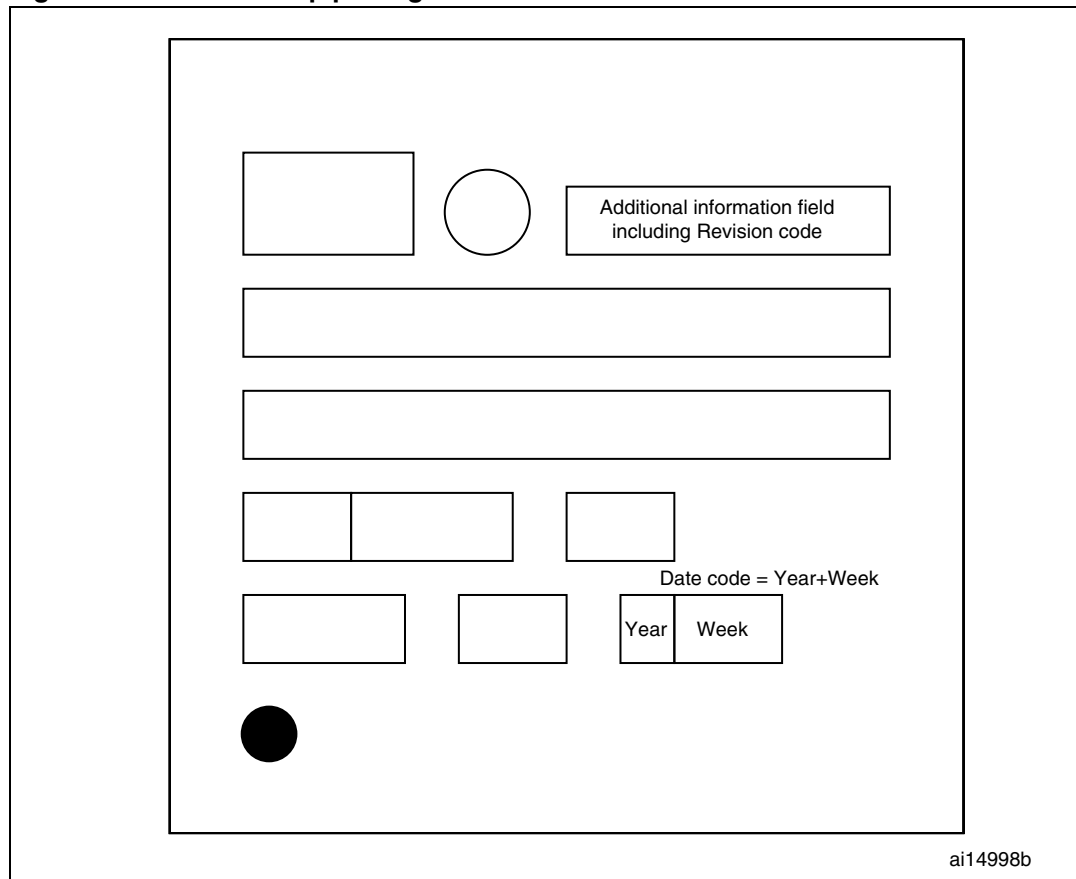
**Figure 1. LQFP100 top package view**

[Figure 1](#) and [Figure 2](#) show the marking compositions for the LQFP100 and LQFP64 packages, respectively. The only fields shown are the Additional field containing the revision code and the Year and Week fields making up the date code.
