Fault Code: 1422

Timing Rail Number 2 Driver Diagnostic

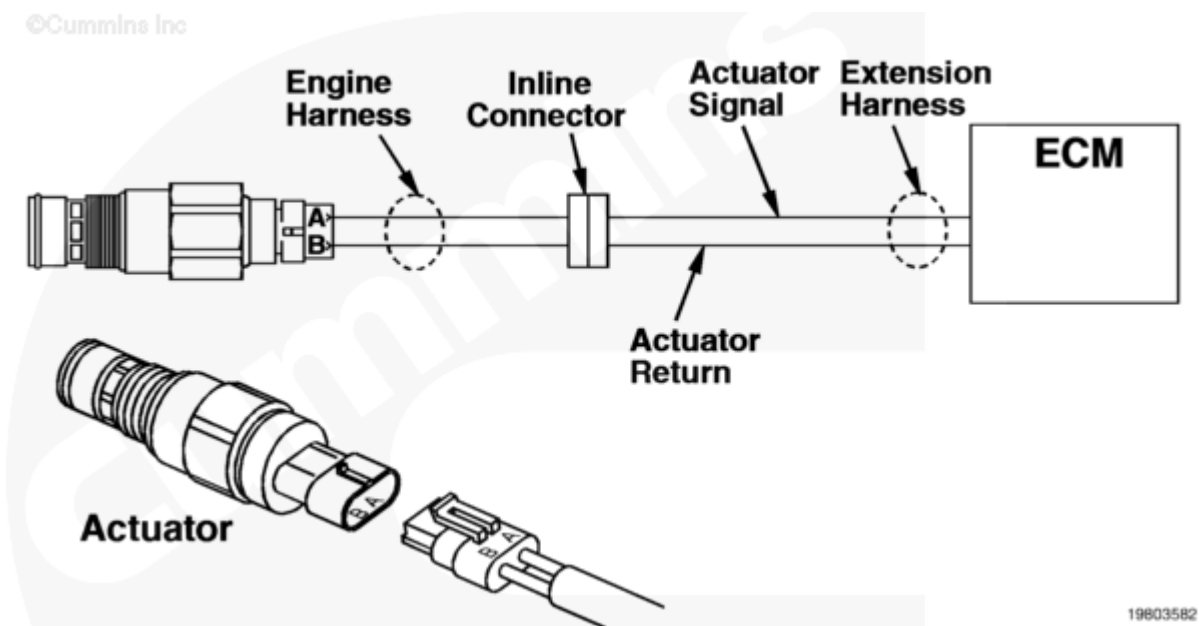
Timing Rail Number 2 Actuator Circuit

The ECM checks the timing rail Number 2 actuator driver to sustain correct operation. The timing rail Number 2 actuator is actuated by the electronic control module (ECM) to control fuel metering. Each fuel actuator is connected to the ECM by a supply and a return wire. An electrical pulse is sent to the fuel actuator from the ECM on the supply wire and returns to the ECM on the

return wire. Each solenoid valve is normally closed, and it is **only** opened by an electrical pulse from the ECM during metering. The ECM monitors the voltage, no voltage will trip Fault Code 1422, and can be caused by shorts, opens, or a failed fuel pump actuator driver in the ECM.

The possible failure modes are open circuit, short to ground, high actuator resistance, and loss of boost voltage inside the ECM.

Refer to Troubleshooting Fault Code t05-1422 (</qs3/pubsys2/xml/en/procedures/01/01-t05-1422.html>)
