Fault Code: 1459

Generator is Absorbing Power From the Electric Bus - Data Valid But Below Normal Operating Range - Most Severe Level

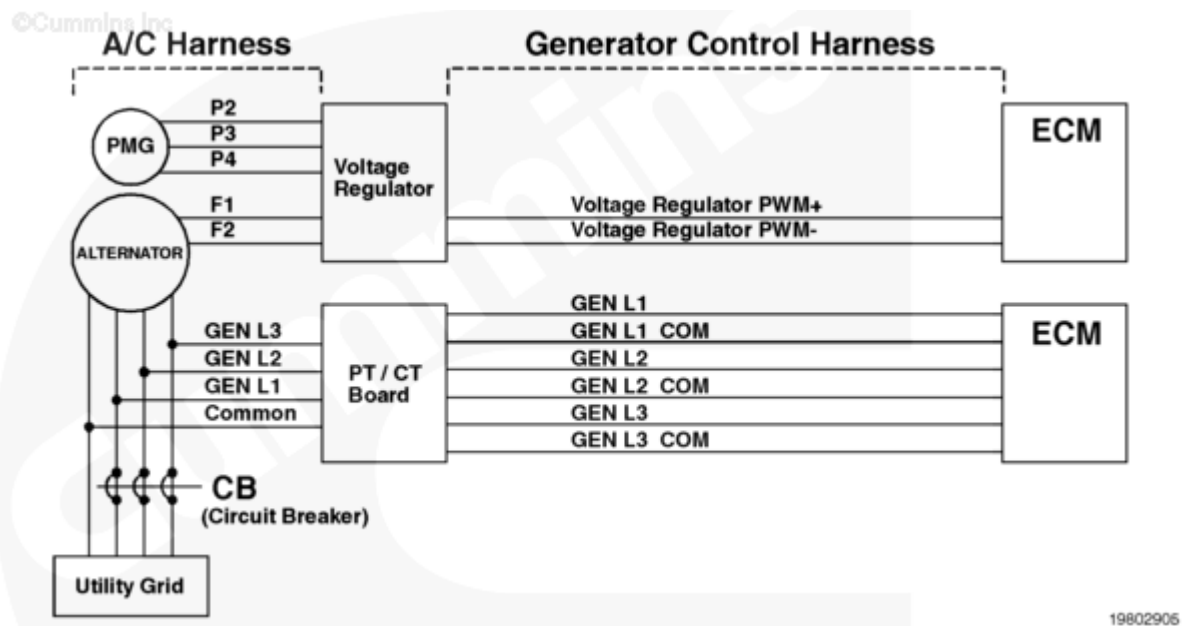
Generator Circuit

Under normal operating conditions, the generator set connects to the bus. Generator set is producing power, and when it connects to the bus, power is added to the main electric bus. When some events occur, a condition can occur when the generator set is no longer producing power for the electric bus, but rather is drawing power from the electric bus. This condition is called reverse kW.

The system (electric bus) is driving the engine using the alternator as a motor.

If the problem occurs at initial start-up, verify proper connection of the generator's current transformers.

Verify proper connection of load-sharing lines.

Verify that the generator is operating at the correct frequency and voltage.

Verify that there are no new fuel system problems that are causing the engine **not** to be able to pick up the load.
