MediaKind RX1

Version 14.1.0.3

Release Notes

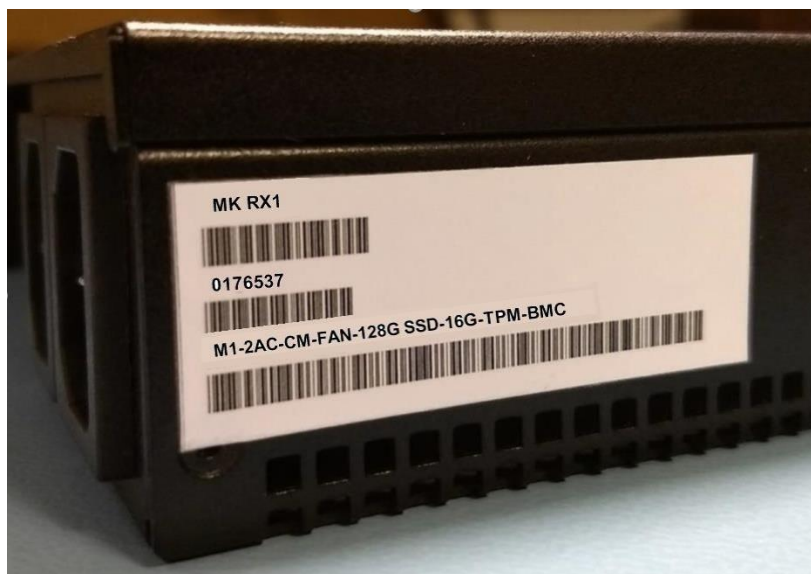
Check the sticker on the side of the unit

On the side of the unit, there should be a "side label" showing the variant of the M1 server:

Manufacturer Part #	Description	Side label	Side label M1 variant text
VEGA-7010-0A02ERE	2AC WITH CONFIDENCE MONITOR – 8GB – REVISED FAN – 64GB SSD	MFCP - M1	M1-2AC-CM-FAN-64G SSD-8G
VEGA-7010-0A02ERE	2AC WITH CONFIDENCE MONITOR – 8GB – REVISED FAN – 64GB SSD	MK RX1	M1-2AC-CM-FAN-64G SSD-8G
VEGA-7010-0A04ERE	2AC WITH CONFIDENCE MONITOR – 8GB – REVISED FAN – 128GB SSD	MK RX1	M1-2AC-CM-FAN-128G SSD-8G
VEGA-7010-0A0ARE	2AC WITH CONFIDENCE MONITOR – 16GB – REVISED FAN – 128GB SSD	MK RX1	M1-2AC-CM-FAN-128G SSD-16G
VEGA-7010-0A08ERE	2AC WITH CONFIDENCE MONITOR – 16GB – REVISED FAN – 128GB SSD – TPM	MK RX1	M1-2AC-CM-FAN-128G SSD-16G-TPM
VEGA-7010-0G00ERE	2AC WITH CONFIDENCE MONITOR – 16GB – REVISED FAN – 128GB SSD - TPM - BMC	MK RX1	M1-2AC-CM-FAN-128G SSD-16G-TPM-BMC
