Fault Code: 423

Fuel Timing Pressure or Timing Actuator Stuck

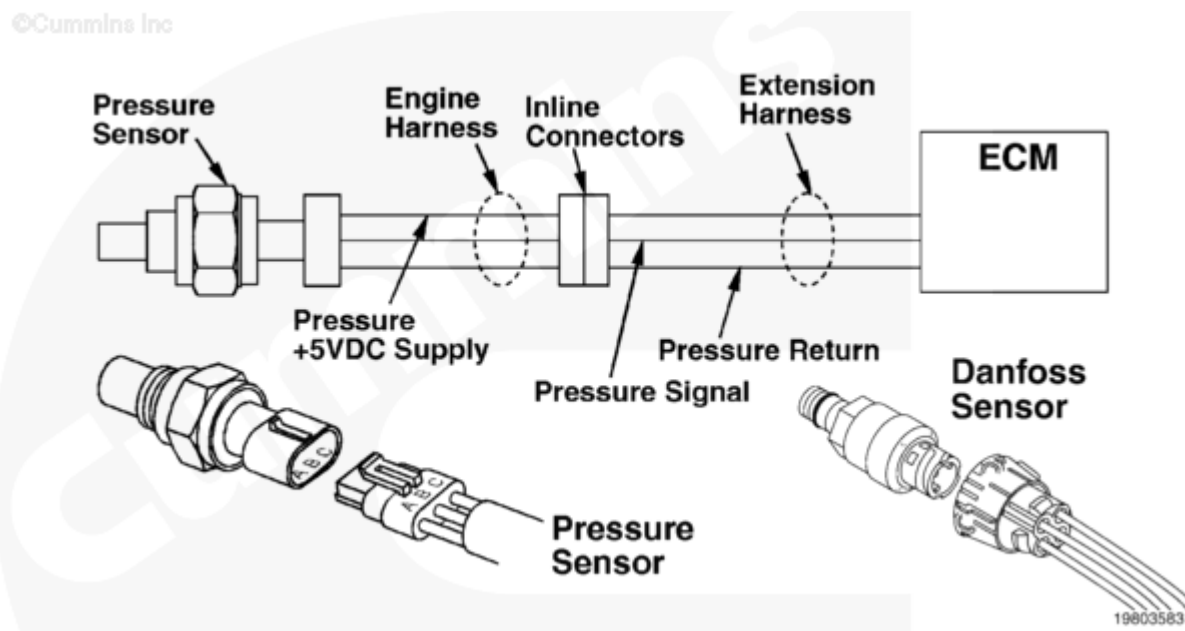
Timing Rail Pressure Sensor Circuit

The timing rail pressure sensor provides the timing rail pressure signal to the electronic control module (ECM), through the engine harness. The ECM uses the timing rail pressure signal to monitor the timing fuel pressure going to the injector's timing chamber from the control valve body.
