Microchip Studio Release Notes

Microchip Studio Release Note

Microchip Studio for AVR® and SAM Devices is an integrated development platform from Microchip. It provides a modern and powerful environment for doing AVR® and Arm® development.

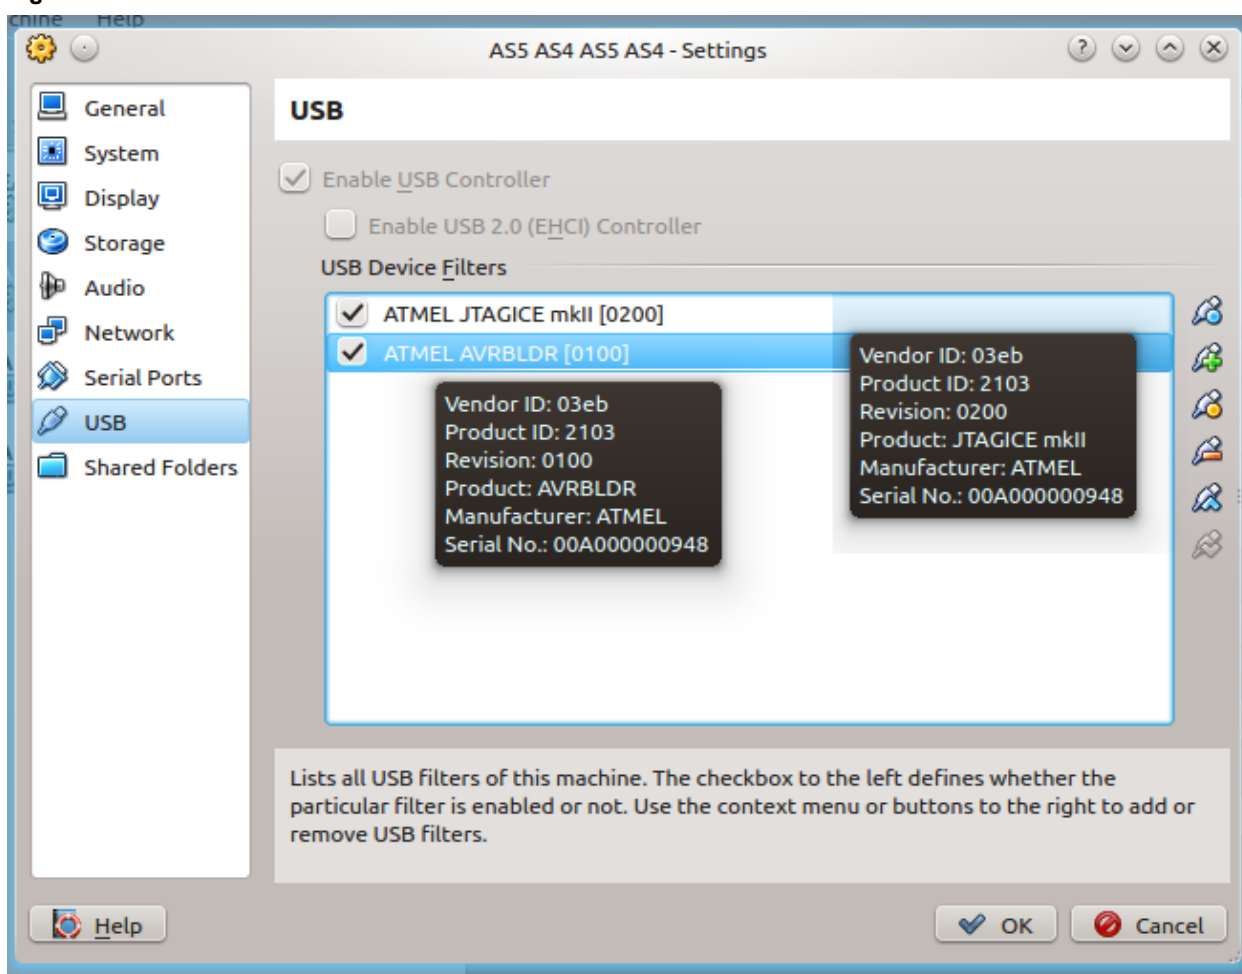
Figure 2-1. VirtualBox USB Filter

Make two filters similar to the two shown in the figure below.

Note that the example in the figure above is specific to the JTAGICE mkII. There is one entry for the tool, here the JTAGICE mkII, and one for *AVRBLDR*, which is the firmware upgrade mode for the tool. The name, serial, Vendor ID, and Product ID may be different for your tool, so change those values accordingly.

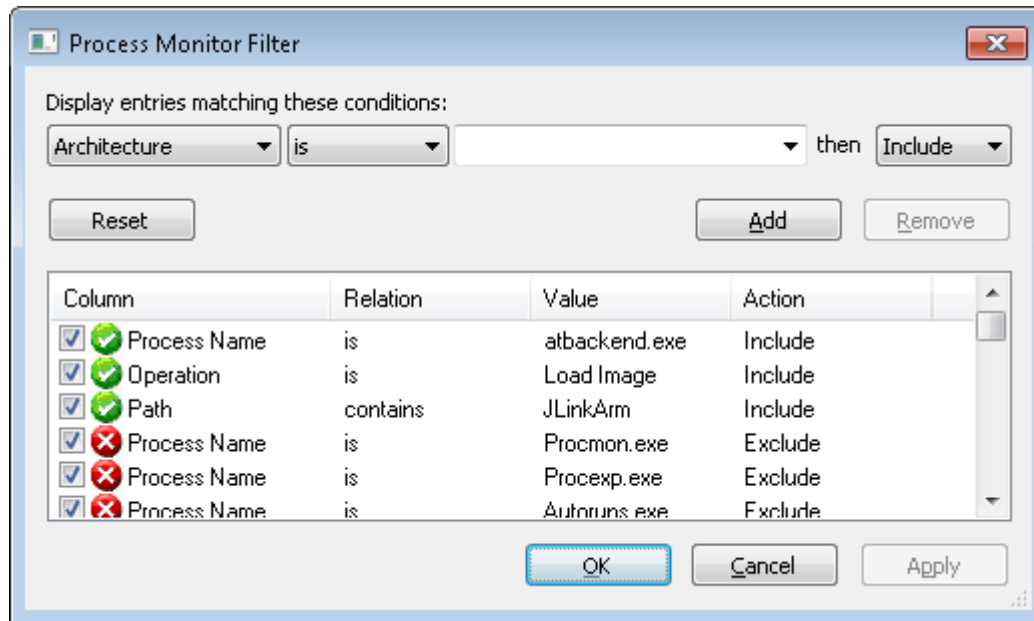
Figure 2-2. Procmon Filter Configuration

Download the Procmon tool, open it, configure the filter, as shown in the figure below, and start Microchip Studio. A couple of seconds after Microchip Studio has started, one line may become visible, showing the path from where the dll is being loaded. It may be loaded from the `atbackend` folder inside the Microchip Studio installation directory.

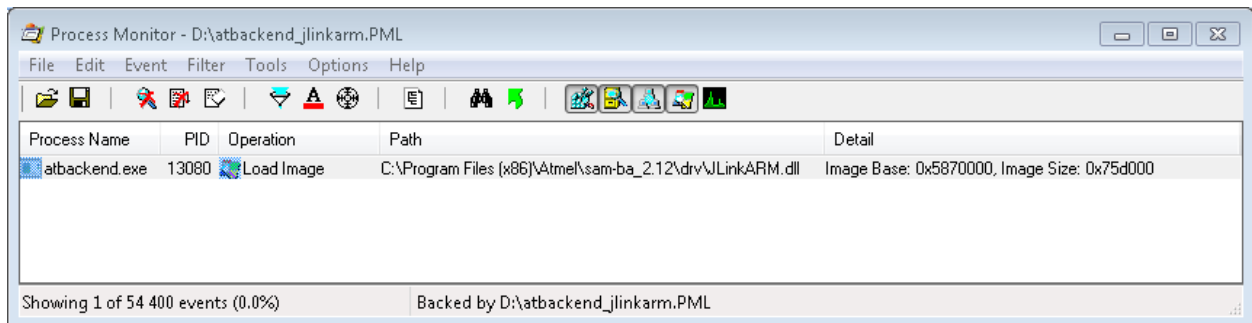
Figure 2-3. Procmon Filter Configuration

If the path of the dll is different, it means that Microchip Studio has picked up the wrong dll, and this dll is incompatible with the dll shipped with Microchip Studio. See the figure below for an example of this.

To solve the above issue, we recommend backing up the dll being loaded and then replacing it with the `JLinkArm.dll` found in the `atbackend` directory inside the Microchip Studio installation directory. This can be done given the assumption that the dll bundled with Microchip Studio is newer than the loaded one, and the dll is backward compatible.
