Fault Code: 497

Multiple Unit Synchronization Switch Circuit - Data Erratic, Intermittent, or Incorrect

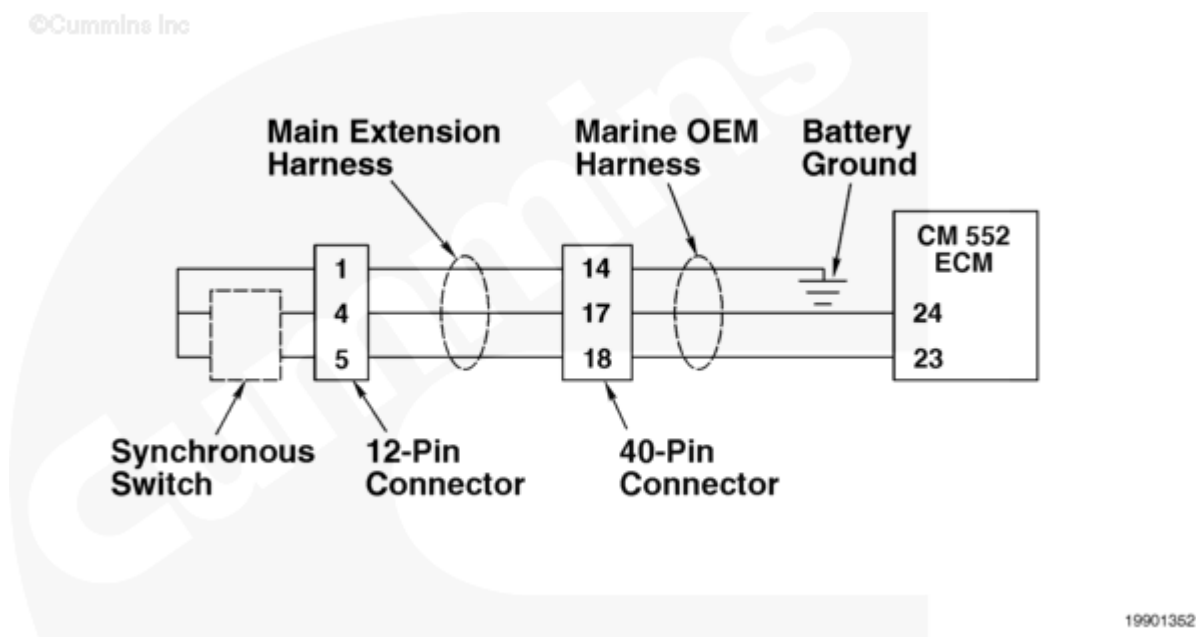
Multiple Unit Synchronization Switch Circuit

The multiple unit synchronization circuit uses a complimentary switch to provide two opposite signals into the electronic control module (ECM). A double-pole, double-throw switch is used to activate synchronization mode on both engines.

The multiple unit synchronization switch is used to activate the engine synchronization function. The ECM expects to see the engine synchronization on/off and engine synchronization on/off complimentary switch toggle state once the feature is activated. Typical fail modes which can generate this fault are:

- Wires are dislodged from the rear of the switch.
- Intermittent connections are in the signal path.
- A switch has failed.
- Contaminated connections at the synchronization switch or in the circuit path.
- This fault can occur when a “C-Cruise” enabled ECM calibration is improperly loaded in an engine that is not intended to use multiple unit synchronization switch and does not have a synchronization switch installed. In this situation, realibrating the ECM with the correct non “C-Cruise” calibration will eliminate the fault.

Refer to Troubleshooting Fault Code t05-497 (</qs3/pubsys2/xml/en/procedures/07/07-t05-497.html>)
