Technical Service Bulletin: tsb100117

Released Date: 28-Jan-2002

Rocker Lever Housing Gasket Changes

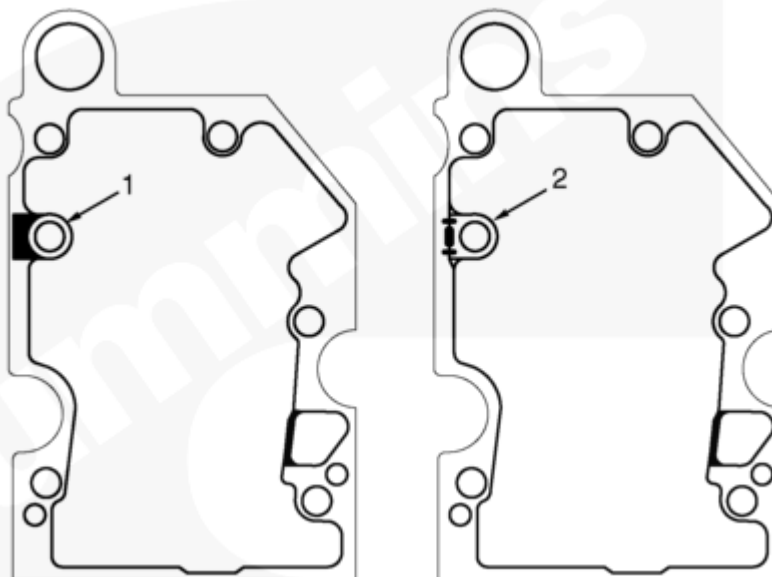
03600015

Fig. 1, Rocker Lever Housing Gaskets (1) Flexible Metal Ring (new) and (2) Rigid Metal Ring (old)

Reports from the field of oil and coolant leaks resulted in the following revisions to the gasket:

- Coining of the steel portion of the gasket was made wider and thicker to distribute the loading, which had caused some of the old gaskets to split.

- The seal for a capscrew hole that is inside the housing (**always** nearest the intake valves) was changed to a metal washer that is bonded with an elastomer to the steel portion of the gasket. The previous version had **only** the elastomer.
- The two capscrew holes nearest the water passage were changed to add more steel so that approximately half of the seal circumference is steel and half is elastomer.

When installing the gasket, make certain that all sealing surfaces are aligned properly, particularly around the large water transfer hole. This should be done by looking at the gasket from the side/edge before installation. If the gasket is **not** flat (i.e., has 'twist' in it) or is distorted, do **not** use it. Also, check the gasket, once it has been installed, to make certain that all of the holes are aligned.

The revised gasket, Part Number 3630839, is the **only** gasket now available from the supplier. The following service kits will contain the revised gasket:
