Foundational Blocks for Smart Grids

Implementation of Smart Pillar Box With Digital Communication in LT Distribution System

Company name: CESC Limited

Scope: Generation & Distribution of electricity across 567 sq. km in Kolkata & Howrah in West Bengal

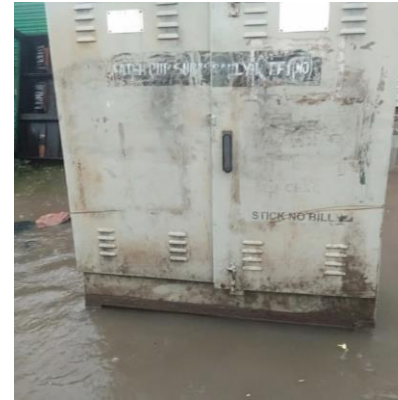
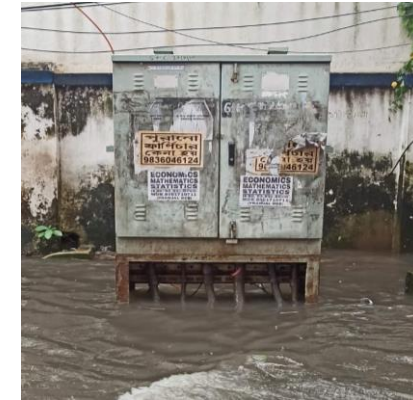
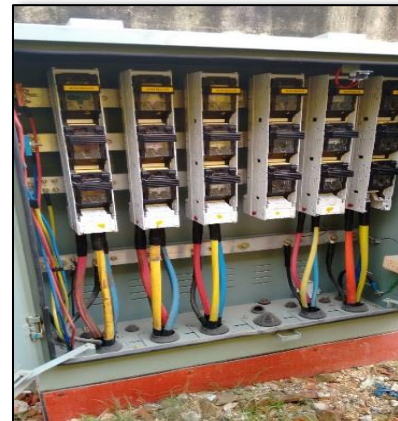
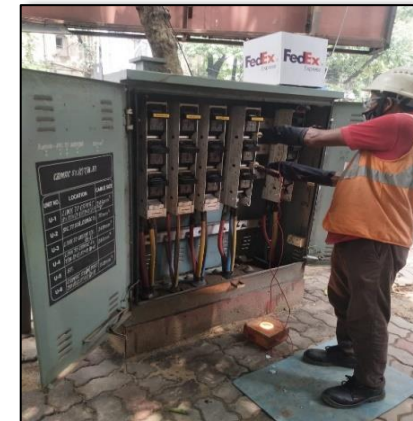
1. Submergence of bottom of Pillar Box under water during any deluge subsequently the body of the Pillar Box becoming alive.
2. Longer restoration time due to LT HRC Fuse failure in transformers resulting in revenue loss
3. Revenue loss due to delay in restoration of Pillar Box HRC Fuse Failure

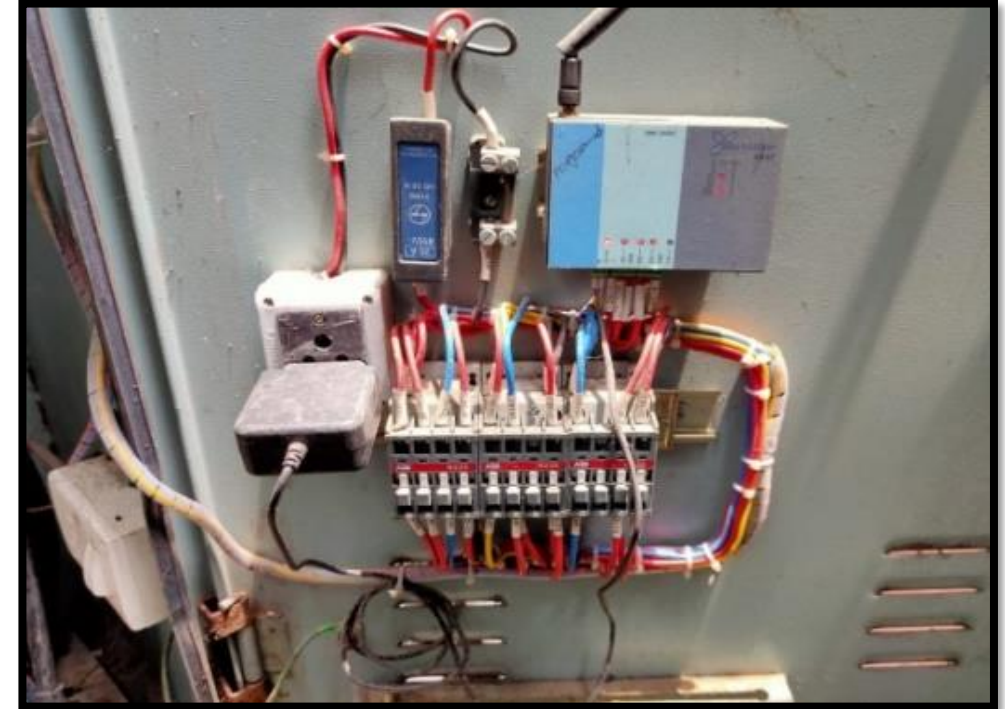
DTR LT HRC Fuse Failure Indicator inside Pillar Box

- ☐ Introducing Sensors for measuring the voltage of the incomer cables emanating from DTR
- ☐ Installing GSM based communication module
- ☐ Flagging out SMS during missing potential for any one or two phases simultaneously
- ☐ Mitigating staggered movement
