Technical Service Bulletin: tsb100132

Released Date: 27-Sep-2001

Lubricating Oil Pump Sourcing Change

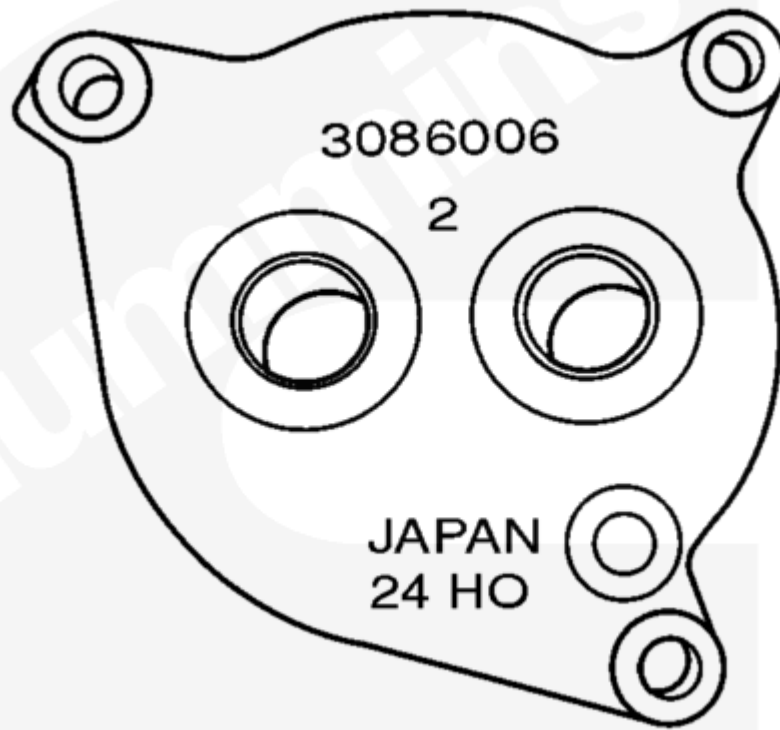
07400209

Fig. 1, Old K19 Lubricating Oil Pump Front Face, Part Number 3047549

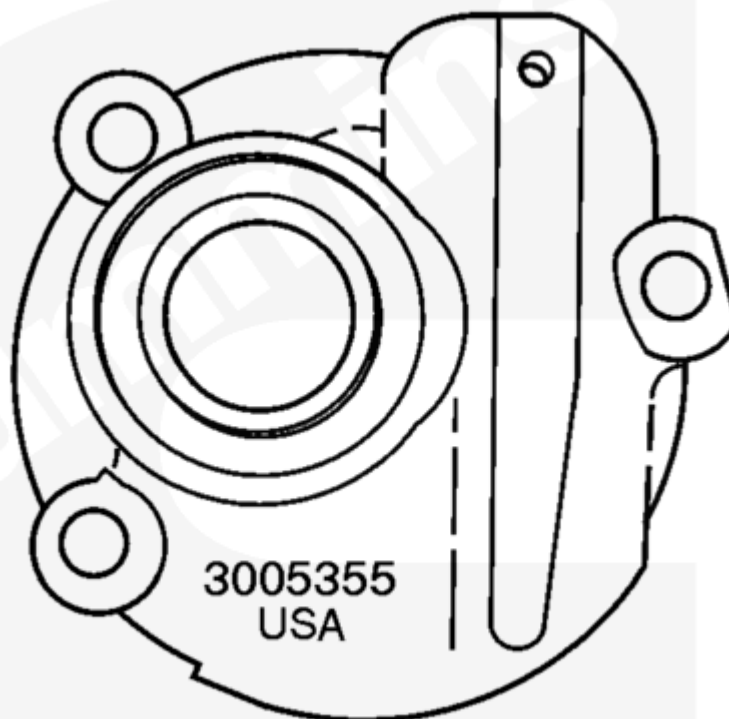
07400210

Fig. 2, New K19 Lubricating Oil Pump Front Face, Part Number 3047549

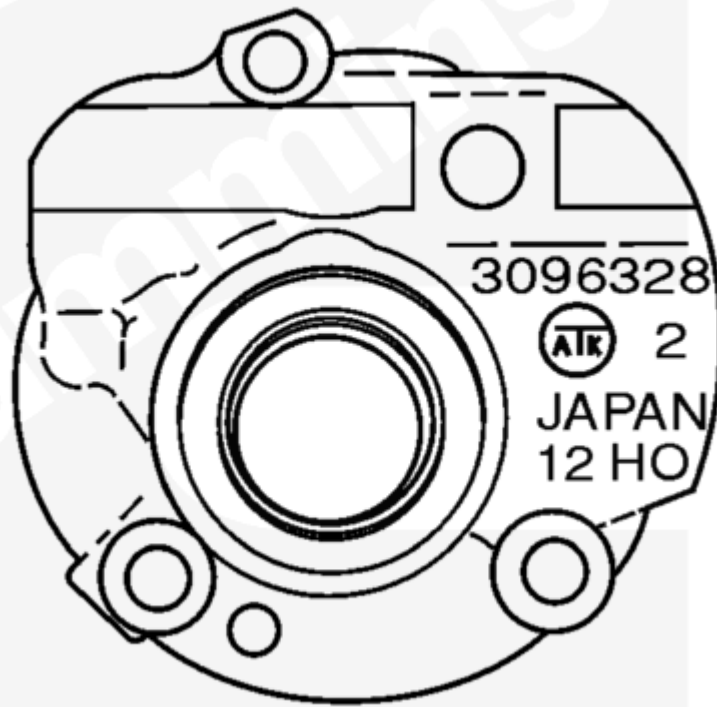
07400211

Fig. 3, Old QSK19 Lubricating Oil Pump Back or Gear Drive Side, Part Number 3096326

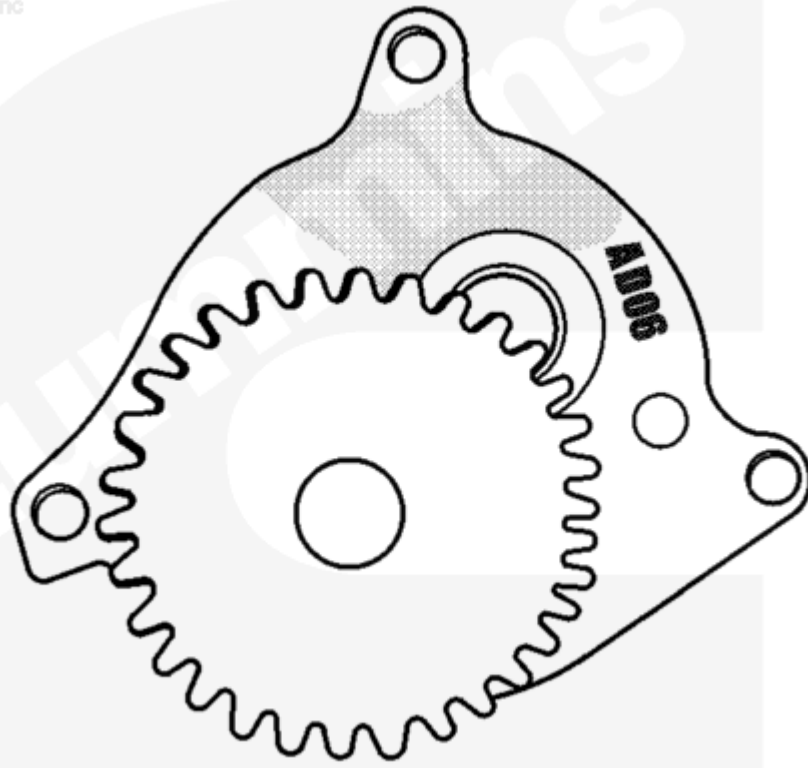
07400212

Fig. 4, New QSK19 Lubricating Oil Pump, Back or Gear Drive Side, Part Number 3096326

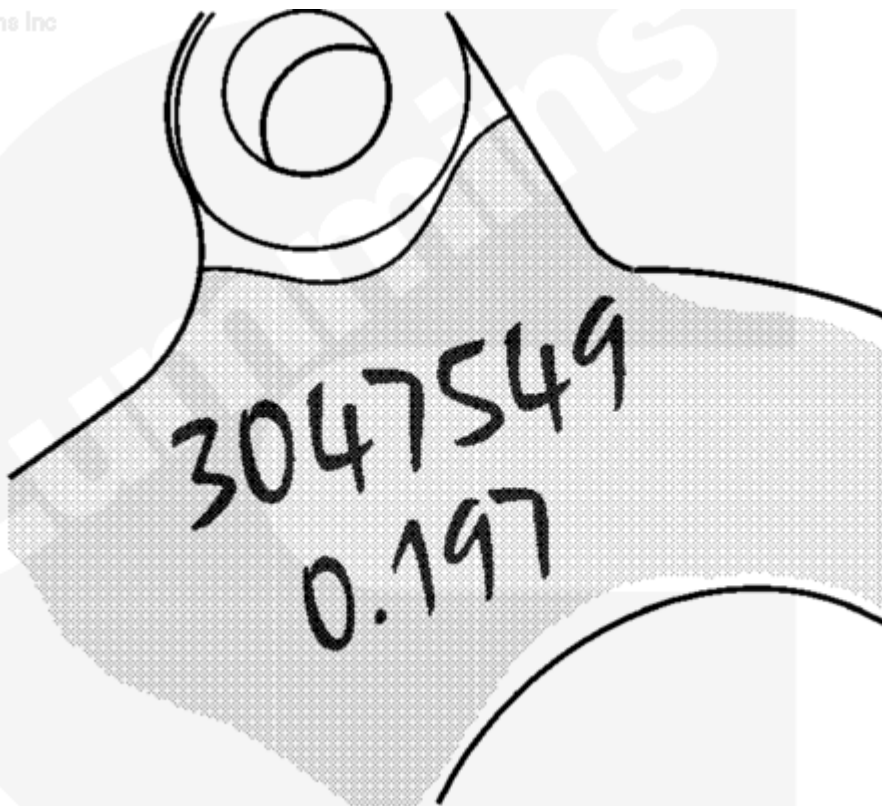
07400213

New K19 lubricating oil pumps will have an orange dykem in the locations shown in Fig. 5 and Fig. 6. The date code is stamped in white in Fig. 5.

Fig. 5, K19 Lubricating Oil Pump with Date Code AD06

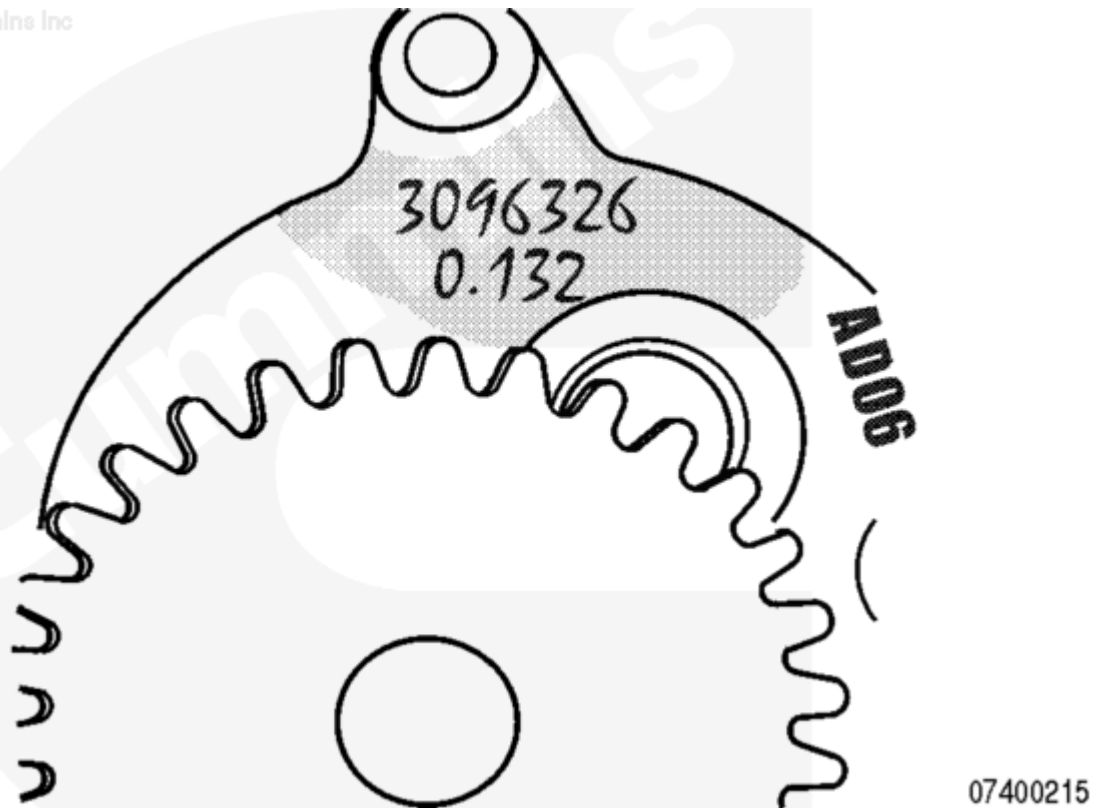
New QSK19 lubricating oil pumps will have a yellow dykem mark with the date code stamped in white.

Fig. 7, QSK19 Lubricating Oil Pump with Yellow Dykem Mark, Part Number, End Clearance, and Date Code Stamped in White
