Technical Service Bulletin: tsb100374

Released Date: 02-Aug-2005

CM870 Shutoff Solenoid Groove

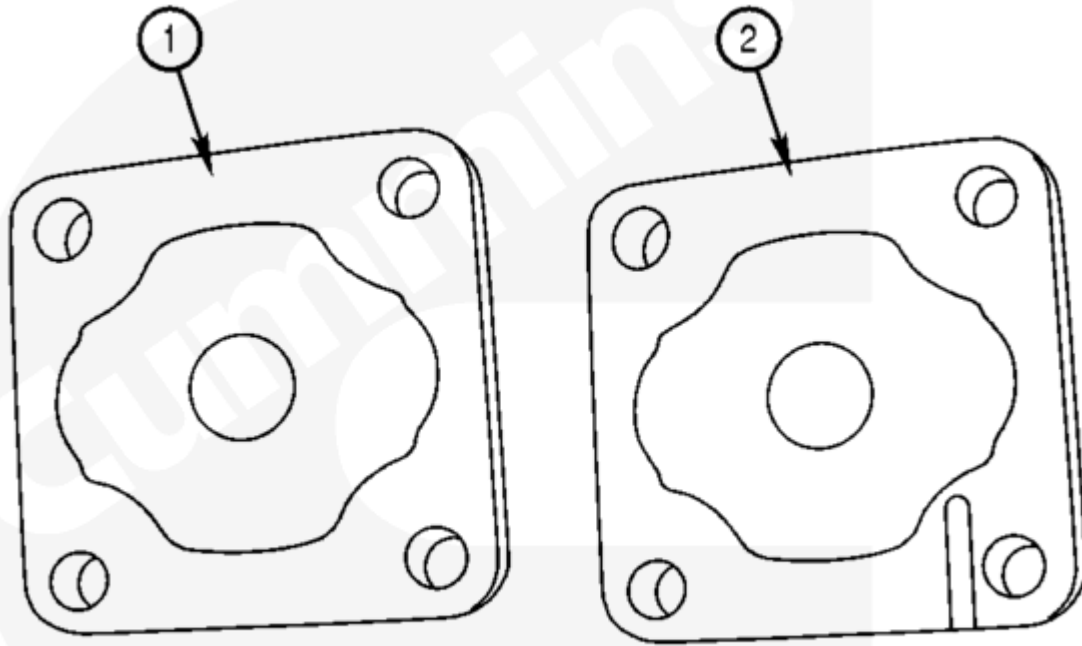
05c00234

This Technical Service Bulletin provides information on the new shutoff solenoid stator for the Signature and ISX with CM870, and QSX15 series engines. The shutoff solenoid stator incorporates a new groove located on the shutoff valve coil. A groove has been added to the face of the fuel shutoff solenoid stator to improve the assembly process. The groove will help detect missing shield gaskets during assembly of the integrated fuel system module. The revision is functionally transparent to the field; however a difference on the face of the solenoid stator will be seen.

Illustrated below are the old shutoff solenoid stator (1) and the new shutoff solenoid stator (2) with the groove.

Engines built after March 8, 2005 will use the new single post shutoff solenoid stator with the groove. Shutoff Solenoid Kit, Part Number 3408421 RX/NX, which has **not** changed, was implemented in production on March 8, 2005.
