Nakuja Project

Week 6 Progress Report

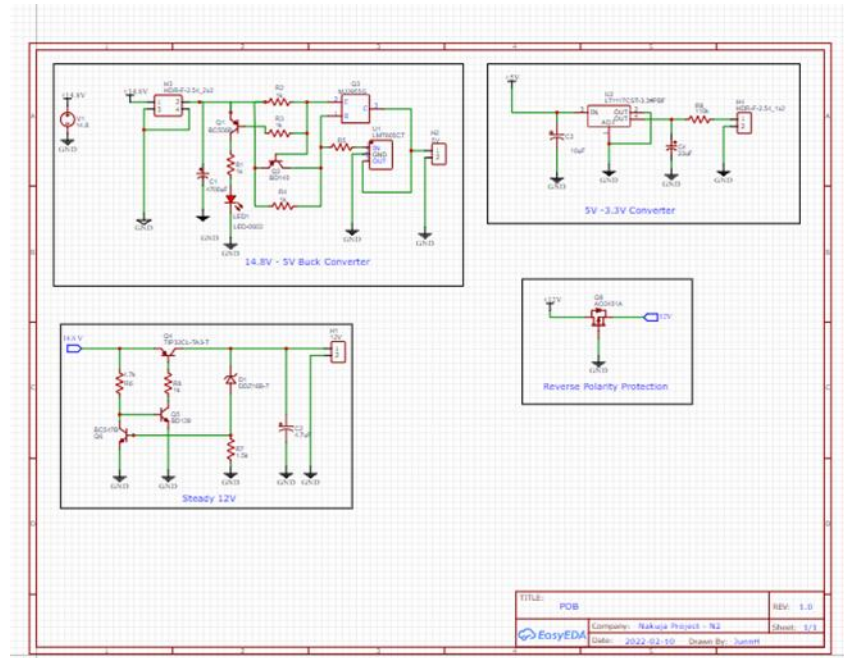
[#Issue 83] : Power Management

- The design of the power distribution board is done and is currently under review
