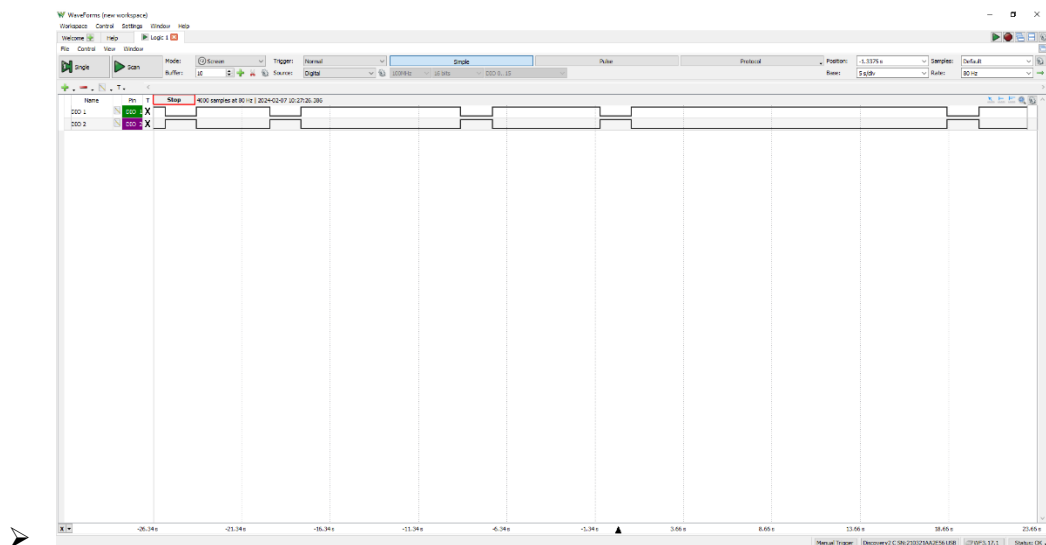
1. Why can't you use both pins PA0 and PC0 for external interrupts at the same time?
  - PA0 and PC0 are in the same group which is SYSCFG\_EXTICR1, which is on a single multiplexer with the output routed to the EXTI0 input.
2. What software priority level gives the highest priority? What level gives the lowest?
  - 0 – 3 where 0 is the highest and 3 is the lowest.
3. How many bits does the NVIC have reserved in its priority (IPR) registers for each interrupt (including non-implemented bits)? Which bits in the group are implemented?
  - 8 bits for each IPR, but only bits[7:6] are implemented.
4. What was the latency between pushing the Discovery board button and the LED change (interrupt handler start) that you measured with the logic analyzer? Make sure to include a screenshot in the post-lab submission.
  - 1.85 seconds.
