Technical Service Bulletin: tsb100497

Released Date: 09-Aug-2006

New Fuel Lift Pump Gasket

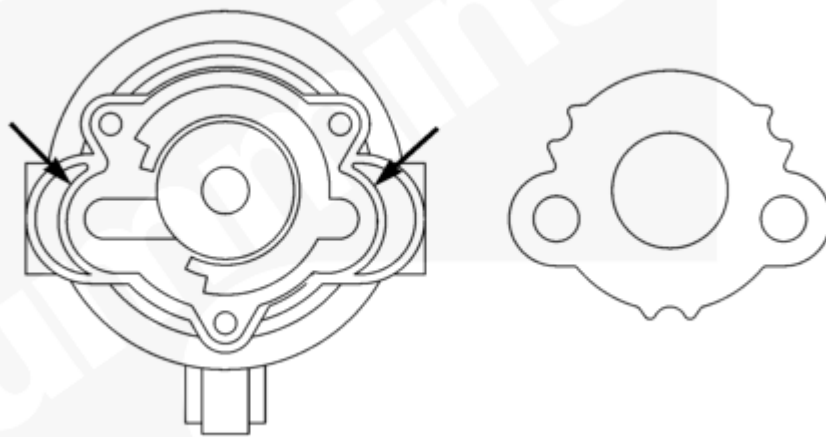
Early-Style Lift Pump Gasket

This lift pump housing takes gasket Part Number 4928511.

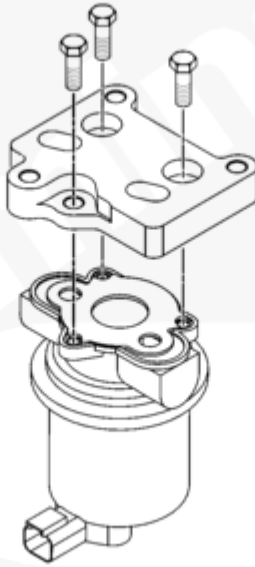
New-Style Lift Pump Gasket

This lift pump housing takes gasket Part Number 4928512.

The gasket is located between the adapter and the lift pump housing.

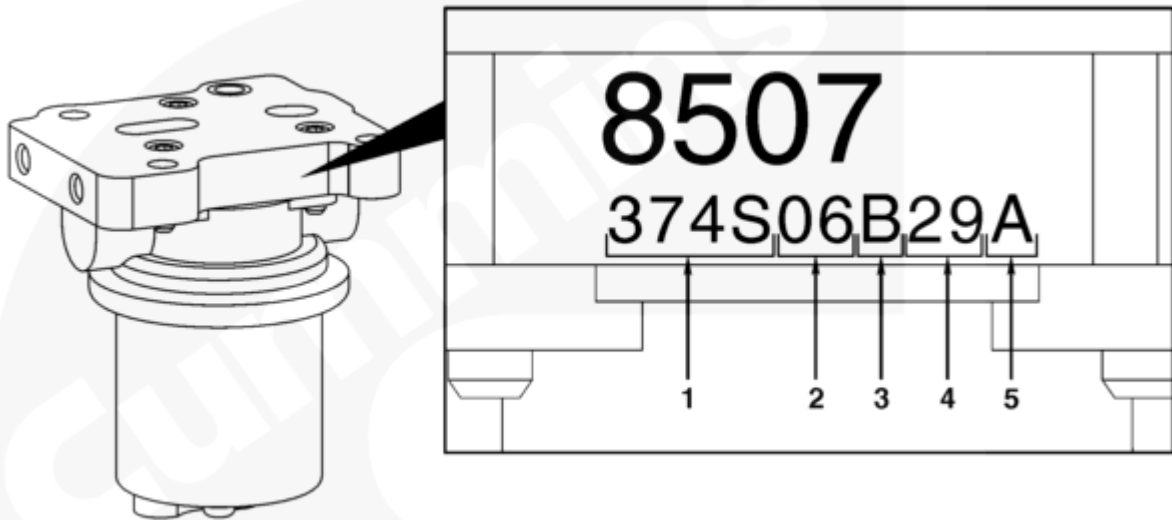
ISX Fuel Lift Pump Serial Number

The correct gasket can also be determined by the lift pump serial number located on the side of the lift pump housing or on the lift pump mounting adapter.

The ISX lift pump serial number is interpreted as follows:

1. Last four characters of the supplier part number
2. Year
3. Month
4. Day
5. Shift

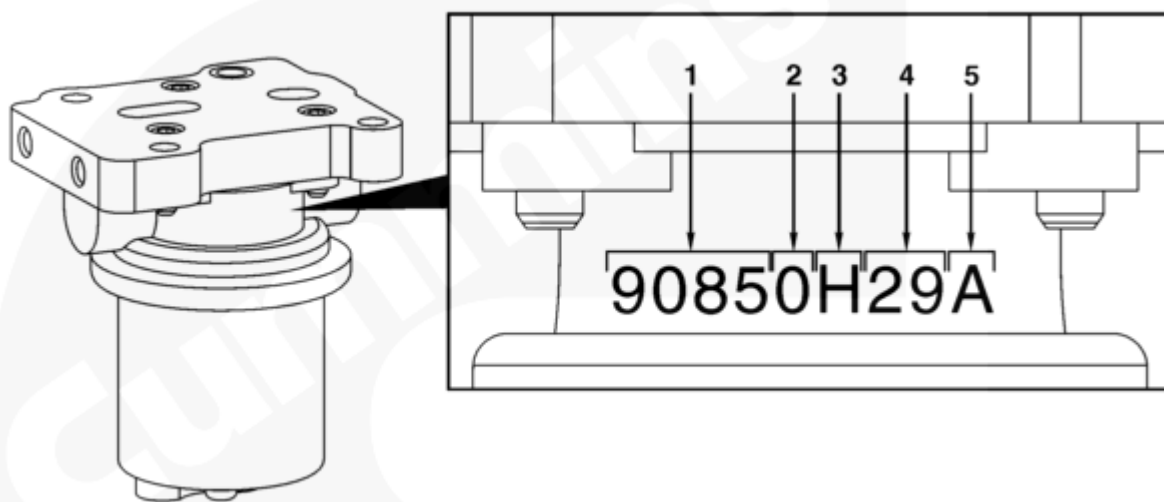
ISC/ISL Fuel Lift Pump Serial Number

The ISC/ISL lift pump serial number is interpreted as follows:

1. Last four digits of the Cummins part number
2. Year
3. Month
4. Day
5. Shift
