Fault Code: 212

Engine Oil Temperature Sensor 1 Circuit - Voltage Above Normal or Shorted to High Source

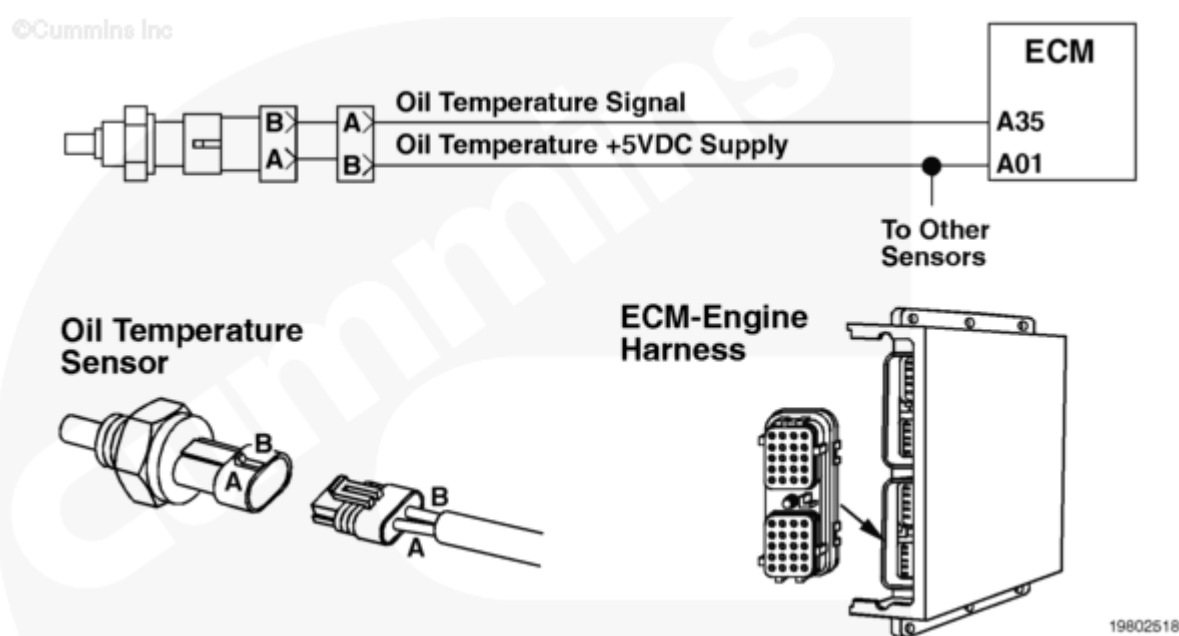
Oil Temperature Sensor Circuit

Codes	Reason	Effect
Fault Code: 212 PID(P): 175 SPN: 175 FMI: 3 Lamp: Yellow SRT: 00-501	Engine Oil Temperature Sensor 1 Circuit - Voltage Above Normal or Shorted to High Source. High voltage detected on SIGNAL pin 35 of the main harness A ECM connector.	Fault Code 214 is disabled.

The oil temperature sensor circuit provides the oil temperature signal to the ECM. The resistance of the oil temperature sensor varies with temperature. The ECM detects the change in resistance of the oil temperature sensor by monitoring the voltage across an internal resistor that is in series with the oil temperature sensor. The change in voltage across the internal resistor is translated into a temperature change.

Refer to Troubleshooting Fault Code t05-212 (</qs3/pubsys2/xml/en/procedures/81/81-t05-212.html>)
