Data Analysis and Insights Generation using Python

AxionRay assignment – Task 2

Summary Report:

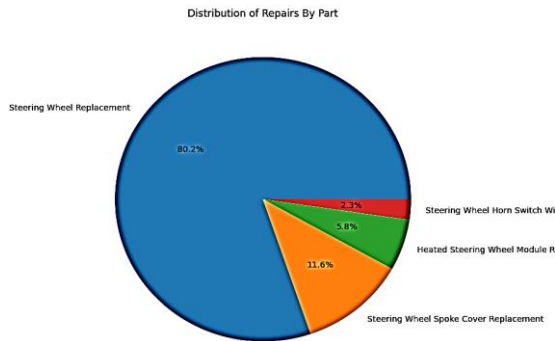
1. Distribution of Repairs By Labor code (Part):

This pie chart shows the distribution of repairs by part. The majority of repairs involve Steering Wheel Replacement (80.2%), followed by Steering Wheel Spoke Cover Replacement (11.6%), Heated Steering Wheel Module Replacement (5.8%), and Steering Wheel Horn Switch Wiring Harness Replacement (2.3%).

1. Pie chart revealed that **80%** repair activity was associated with **Steering Wheel Replacement**, indicating frequent issues with these components.

1. **Dominant Repair Type:** The majority of repairs involved **Steering Wheel Replacement**, accounting for 80.2% of all repairs. This indicates a potential recurring issue or a high wear-and-tear part. It also calls for Root Cause analysis as quality seems to be compromised and an opportunity to investigate and improve the durability of this part.

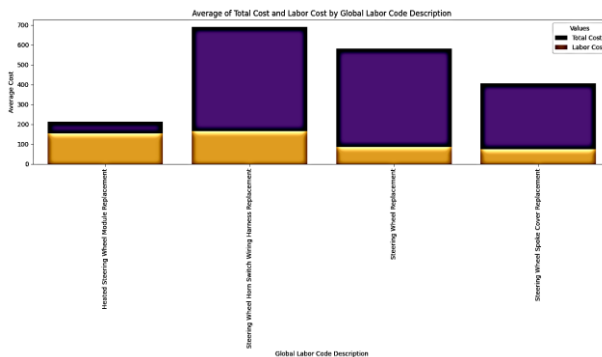
2. Average of Total Cost and Labor Cost by Global Labor Code Description:

This bar chart displays the average total cost and labor cost for different types of repairs categorized by global labor code descriptions I.e. Kind of part repaired or replaced. The costs are broken down to show the proportion of labor costs within the total repair costs.

- Focus on improving the **quality and material of steering wheel components** to reduce the frequency of these repairs.
2. Average total cost by labor code shows that certain repairs, such as the **Steering Wheel Horn Switch Wiring Harness Replacement** and **Steering Wheel Replacement** incur higher average costs compared to other repairs. Average labor cost was also high for these repairs indicating that these repairs are time consuming and complex in nature.

2. **Highest Costs:** Total cost and labour cost associated with Steering wheel replacement and Steering Wheel Horn Switch Wiring Harness Replacement respectively emphasizes its financial impact and potentially complex repair process.
