## Fault Code: 2154

### Post-Oil Filter Pressure Sensor Circuit - Voltage Above Normal or Shorted to High Source

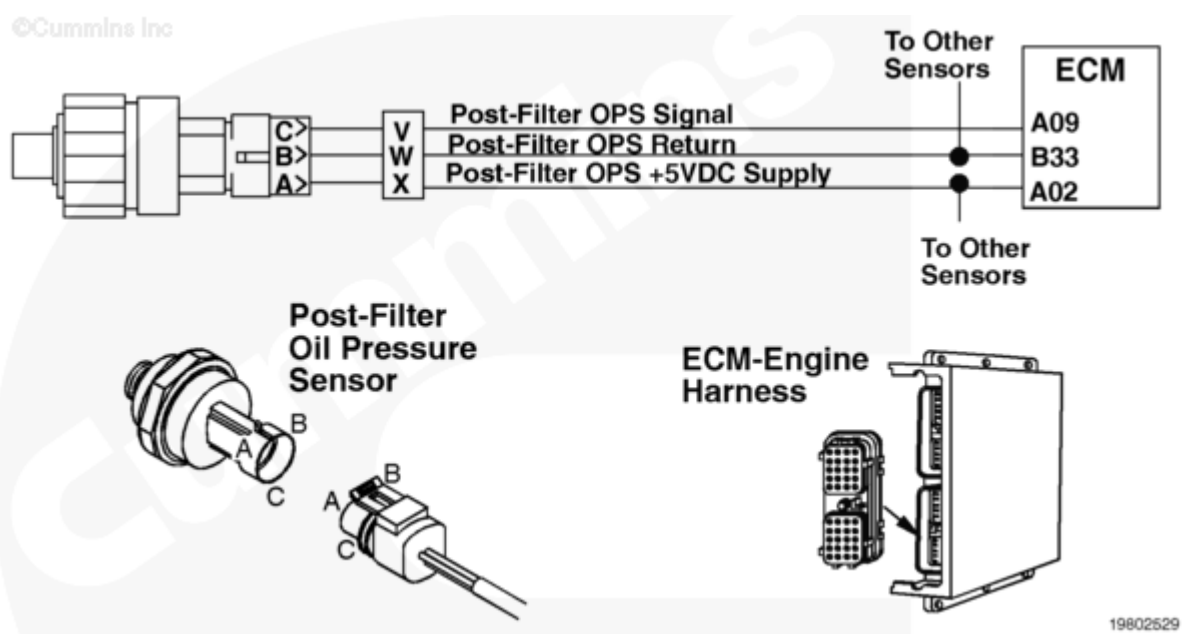
Post-Filter Oil Pressure Sensor Circuit

| Codes | Reason | Effect |
|---|---|---|
| Fault Code: 2154<br><br>PID(P): 100<br>SPN: 611<br>FMI: 3<br>Lamp: None<br>SRT: 00-686 | Post-Oil Filter Pressure Sensor Circuit - Voltage Above Normal or Shorted to High Source. High voltage detected on SIGNAL pin 09 of the main harness A ECM connector. | Fault Code 612 is disabled. |

- If the fault occurs **only** in a cold environment, allow the oil to warm up and see if the fault becomes inactive.
