DTC	B2797	COMMUNICATION MALFUNCTION NO.1
-----	-------	--------------------------------

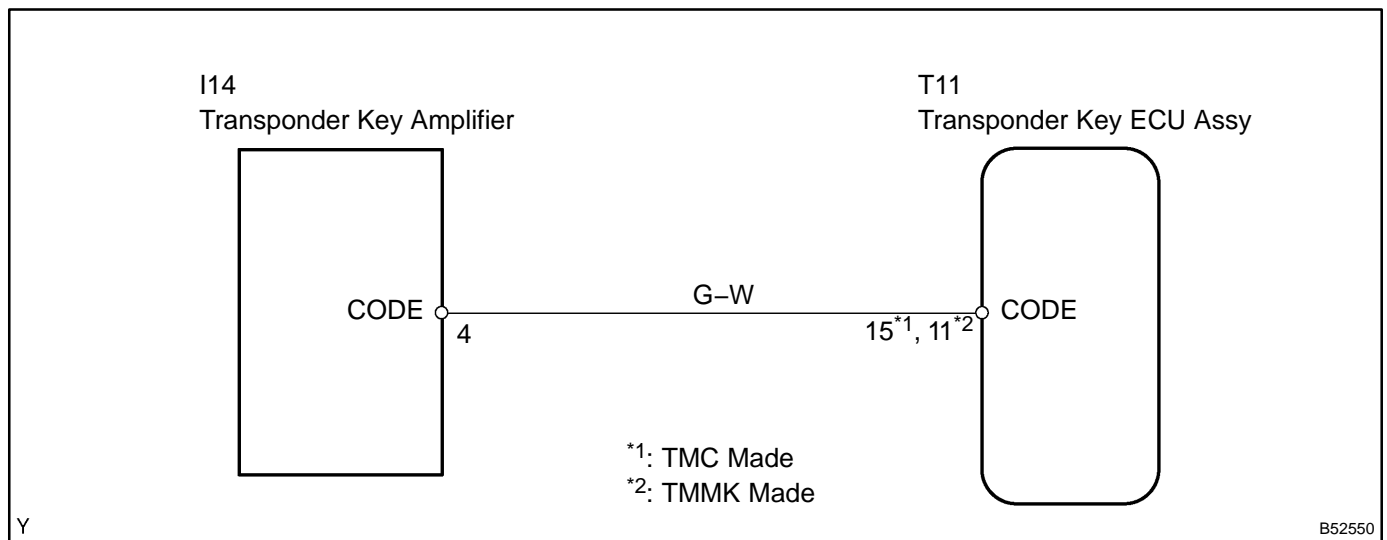
WIRING DIAGRAM

CIRCUIT DESCRIPTION

This DTC is output when an error occurs in normal communication.

DTC No.	DTC Detection Condition	Trouble Area
B2797	Keys are positioned too close to each other, or noise occurred in communication line	<ul style="list-style-type: none">• Key• Wire harness• Transponder key amplifier (Transponder key coil)• Transponder key ECU Assy
