Fault Code: 716

Exhaust Gas Temperature Deviation High for Cylinder 12 - Data Valid But Above Normal Operating Range - Moderately Severe Level

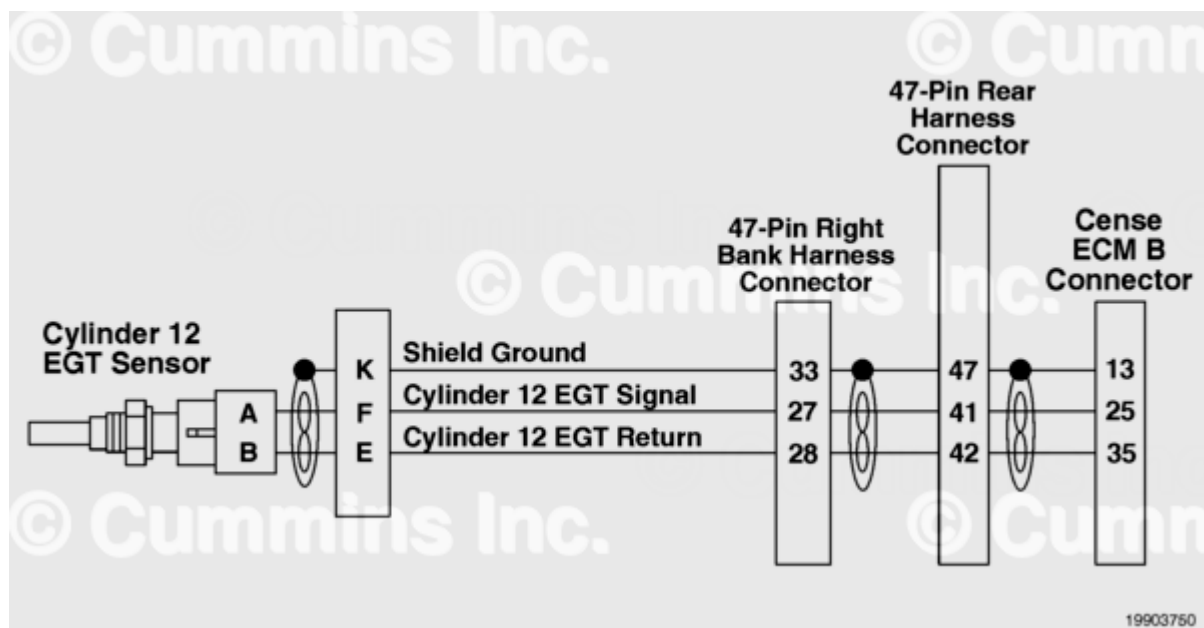
Exhaust Gas Temperature Sensor Circuit Cylinder 12

The exhaust gas temperature sensor circuit monitors exhaust gas temperature for cylinder 12 and passes the information to the CENSE™ engine control module (ECM) through the engine harness. The ECM monitors the temperature and compares it to the exhaust gas temperatures of

The exhaust gas temperature sensor for cylinder 12 is located at the cylinder head-to-exhaust manifold interface.

Refer to Troubleshooting Fault Code t05-716 (/qs3/pubsys2/xml/en/procedures/81/81-t05-716.html)
