LXT971A/972A PHY Transceivers

Specification Update

May 2002

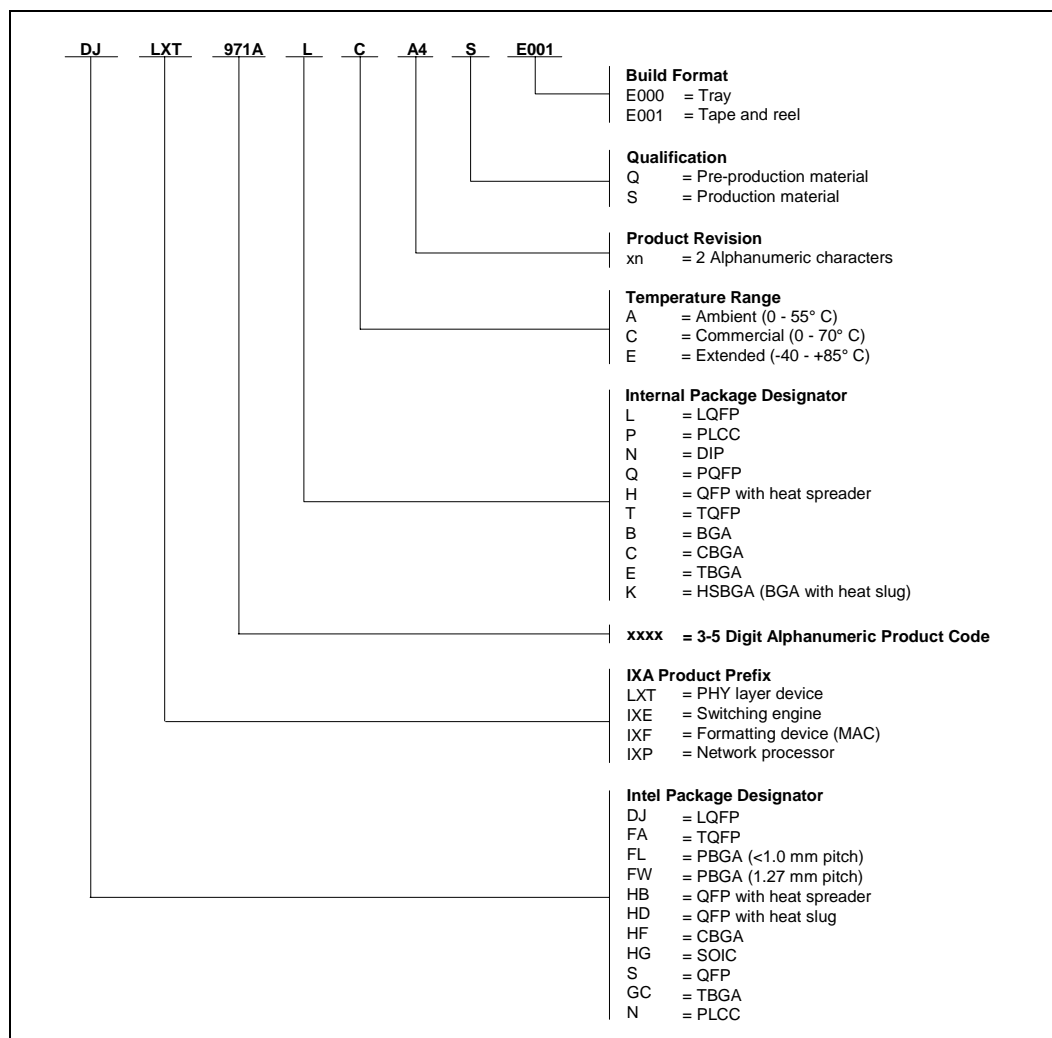
Figure 1. Ordering Information - Sample

Number	Revision	Qualification	Tray MM	Tape & Reel MM
DJLXT971ALC.A4	A4	S	834105	834916
DJLXT971ALE.A4	A4	S	835676	835791
FLLXT971ABC.A4	A4	S	834103	834926
FLLXT971ABE.A4	A4	S	834104	835080
DJLXT972ALC.A4	A4	S	834109	834917
