Fault Code: Multiple C

Multiple Fault Code C

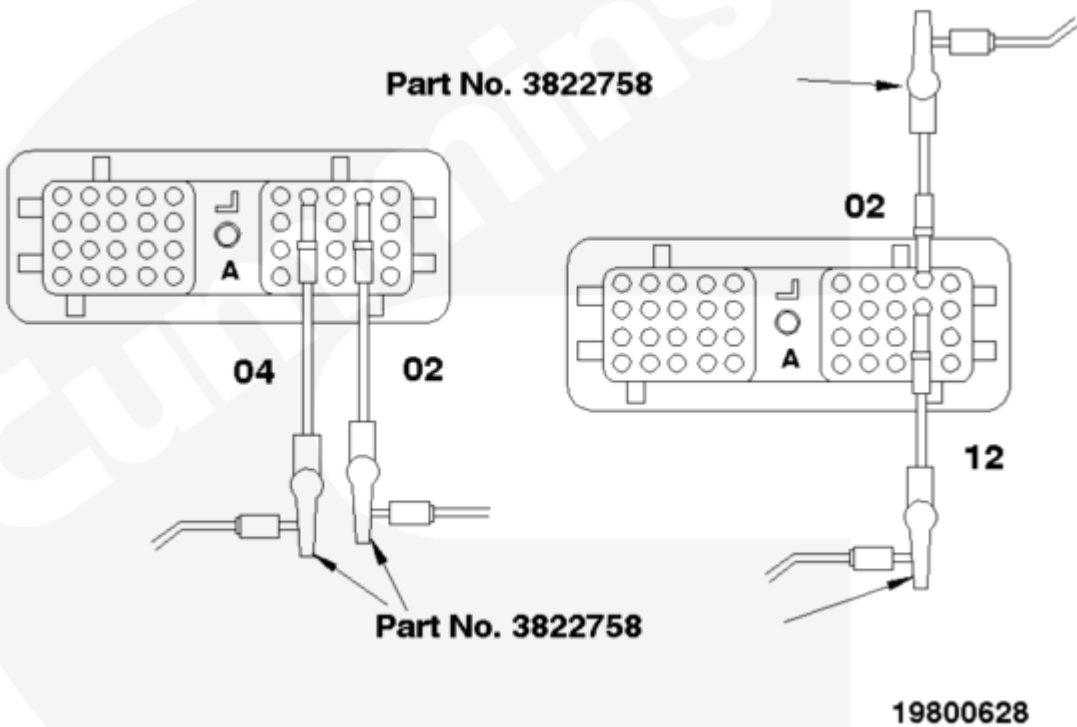
Codes	Reason	Effect
Fault Code: Multiple PID(P): SPN: FMI: Lamp: SRT: 00-517	Sensor power supply A02 is shorted to +24 VDC.	Multiple sensor Fault Codes 128, 136, 159, 163, and 2154 simultaneously occur.

The electronic control module (ECM) supplies sensors on the CENSE™ harness with +5 VDC from either pin 01 or pin 02 on the ECM A connector. The ECM has common returns for all pressure sensors on pin 33 of the ECM B connector. A failure on this circuit will cause multiple fault

Look for open circuits, short circuits, or shorts to ground in the supply or return wires or a defective ECM power supply.

Refer to Troubleshooting Fault Code t05-mfc03 (</qs3/pubsys2/xml/en/procedures/81/81-t05-mfc03.html>)
