OpenCPI

FSK Digital Radio Controller App Guide

Version 1.5

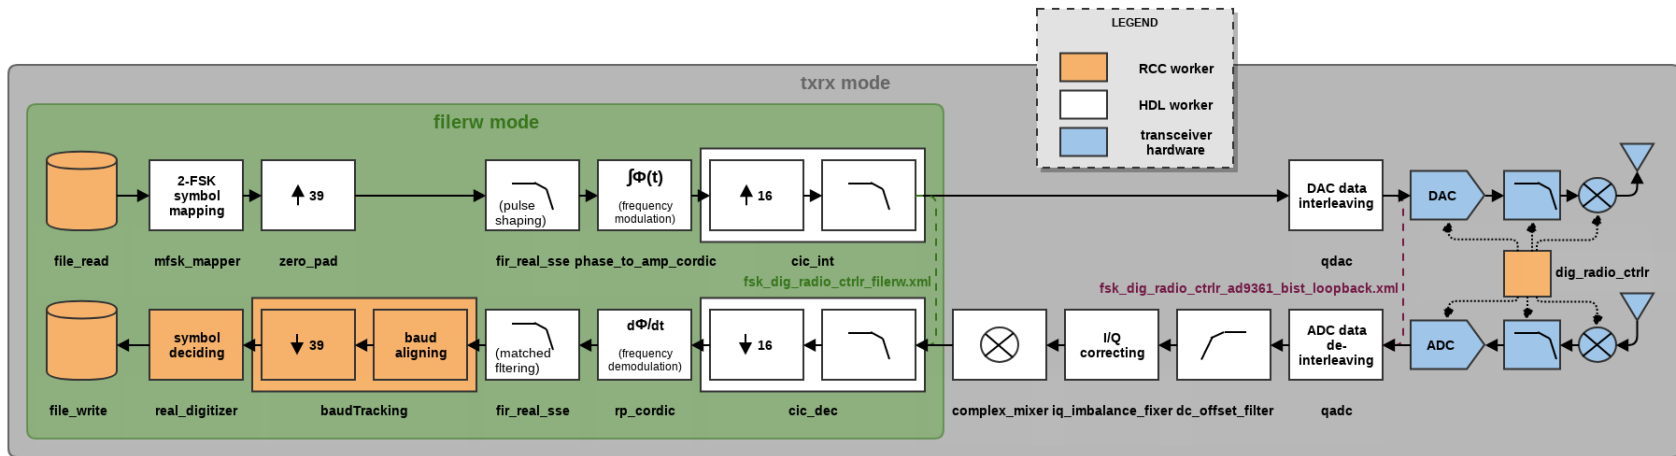
The application may be run in either the *filerw* or *txrx* mode. The application XML filename is sent as the last argument to the application executable. This filename is in the format `<description>_<mode>.xml`, e.g. `foo_txrx.xml` would force the executable to use the *txrx* mode. The *filerw* mode uses `file_read` and `file_write` workers to process the input using only application workers (platform-agnostic) in a purely digital fashion. The *txrx* mode is the full transceiver mode of the application. This mode transmits input file data as the radio RF TX output and inputs RF RX radio input that is written to file.

Figure 1: Application block diagram.

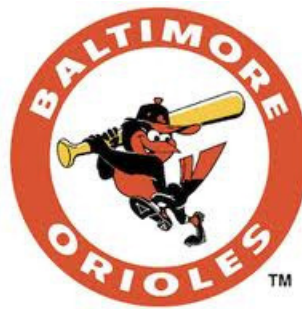
The output file should appear as follows.

Figure 2: Expected output file's image for filerw and txrx modes.

The demodulation algorithm currently suffers from limited carrier recovery ability which can cause the output image to be corrupted or non-existent when using the *txrx* mode. If using an SMA loopback for *txrx* mode on an RF transceiver where the RX and TX data stream's LOs are sourced by the same clock (which is the case on FCOMMS2/3), carrier recovery is not expected to be an issue.
