Service Bulletin Number: 3666243-01

Catalyst Muffler for Service Use Only

This Service Bulletin introduces a new service design for the diesel catalyst in the B and C Series diesel engines.

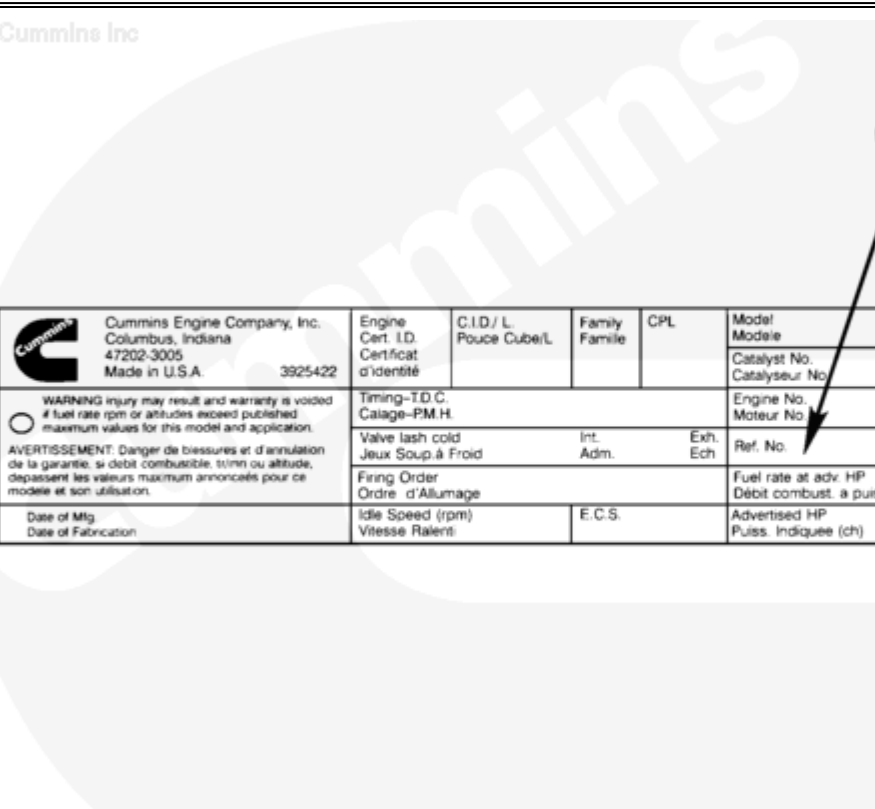
Automotive Engine Dataplate

The following configurations are covered by field fix number 226 since they are certified products that are no longer in production. The dataplate **must** be stamped with field fix number 226 (FF226) in the box that reads “Reference Number” (1) whenever a service use **only** catalyst muffler (Part Number 32434) is installed on an engine.
