Technical Service Bulletin: TSB100603

Released Date: 24-Oct-2012

QSK19 High Pressure Injection Turbocharger Mounting Hardware

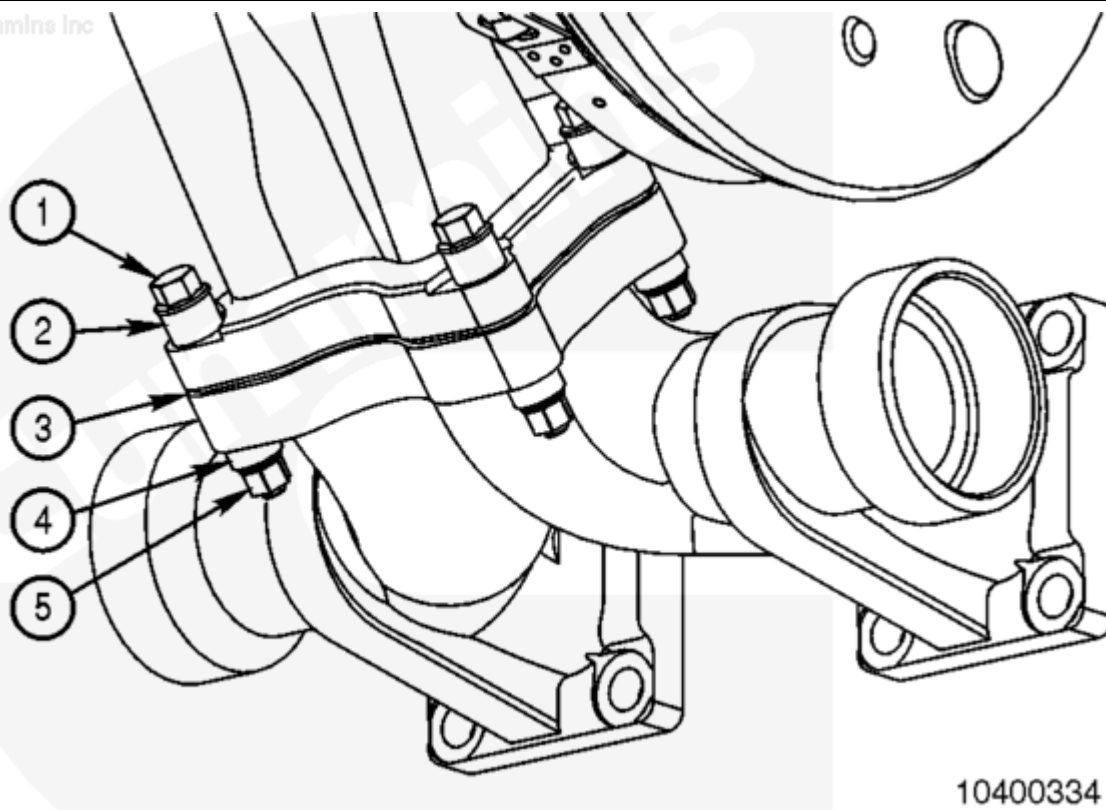
Turbocharger Mounting

A serious quality problem project (SEY-11005) closed that resulted in the implementation of modular common rail system turbocharger mounting hardware on all 19 liter high pressure injection engines, excluding rail engines and engines with wastegated turbocharger effective 05 May 2011.

1. Mounting Capscrew
2. 12.7 mm [0.50 in] spacer
3. Gasket
4. 9.6 mm [0.38 in] spacer
5. Locking Nut

In the event of a failure of the high pressure injection turbocharger mounting hardware, the modular common rail system mounting hardware should be installed. The installation of the modular common rail system mounting hardware results in a more robust bolted joint over the current high pressure injection hardware.

The correct mounting configuration for the modular common rail system hardware is illustrated below.

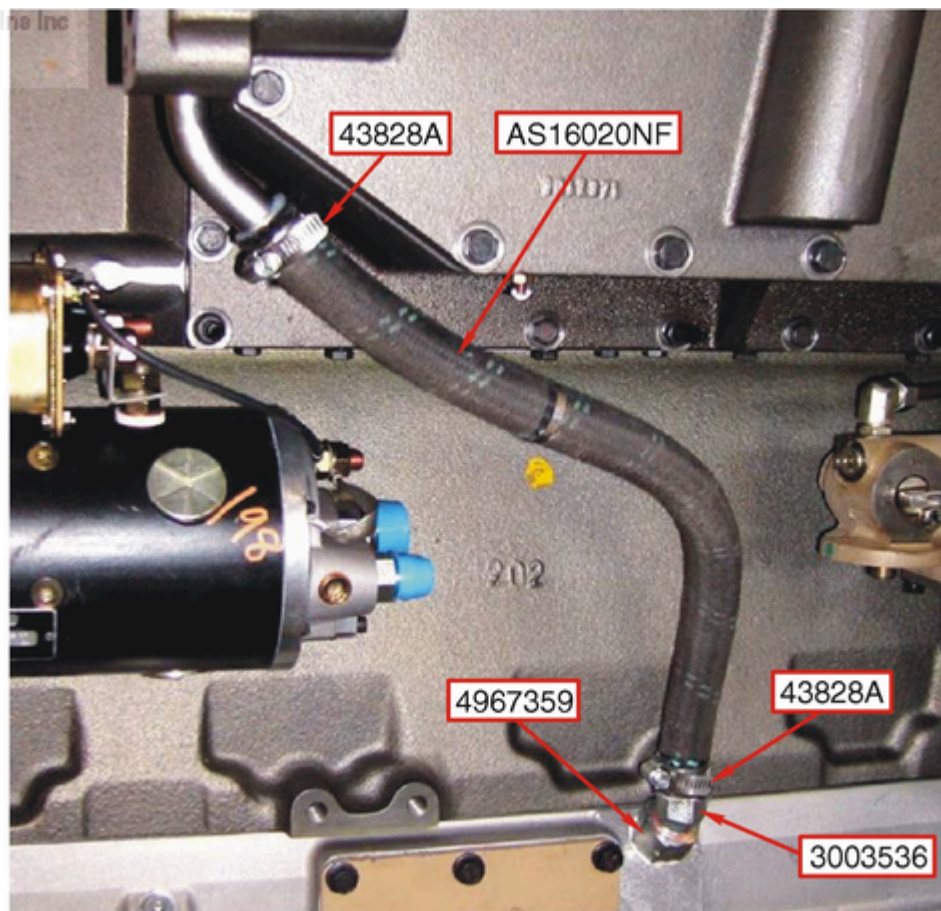
In the event of a turbocharger mounting hardware failure on a rear-out turbocharger arrangement with an on-engine torque converter cooler, it is also necessary to replace the turbocharger drain line connection, if modular common rail system hardware is installed.

1. Place the gasket on the oil drain connection. Install a capscrew with a lock washer up through the connection.

2. Position the turbocharger drain tube connection with gasket to turbocharger. Hand start the first capscrew with a lock washer up through the tube connection into the turbocharger. Install the second capscrew with a lock washer up through the tube connection into the turbocharger.

Torque Value: 45 N-m [33 ft-lb]

3. Apply Loctite™ 5699 RTV Silicone, Part Number 3164067, or equivalent, to the hose coupling on the elbow and on the oil drain tube. Slide a hose clamp over each end of the flexible hose. Push one end of the hose onto the elbow hose coupling and the other end onto the oil drain tube.
