Assessment and Characterization of Volcanic Ash Threat to Gas Turbine Engine Performance

Multiple volcanoes erupt yearly propelling volcanic ash into the atmosphere and creating an aviation hazard. The plinian eruption type is most likely to create a significant aviation hazard. Plinian eruptions can eject large quantities of fine ash up to an altitude of 50,000 m (164,000 ft). While large airborne particles rapidly fall, smaller particles at reduced concentrations drift for days to weeks as they gradually descend and deposit on the ground. Very small particles, less than 1 μm , can remain aloft for years. An average of three aircraft encounters with volcanic ash was reported every year between 1973 and 2003. Of these, eight resulted in some loss of engine power, including a complete shut-down of all four engines on a Boeing 747. However, no crashes have been attributed to volcanic ash. The major forms of engine damage caused by volcanic ash are: (1) deposition of ash on turbine nozzles and blades due to glassification (2) erosion of compressor and turbine blades (3) carbon deposits on fuel nozzles. The combination of these effects can push the engine to surge and flame out. If a

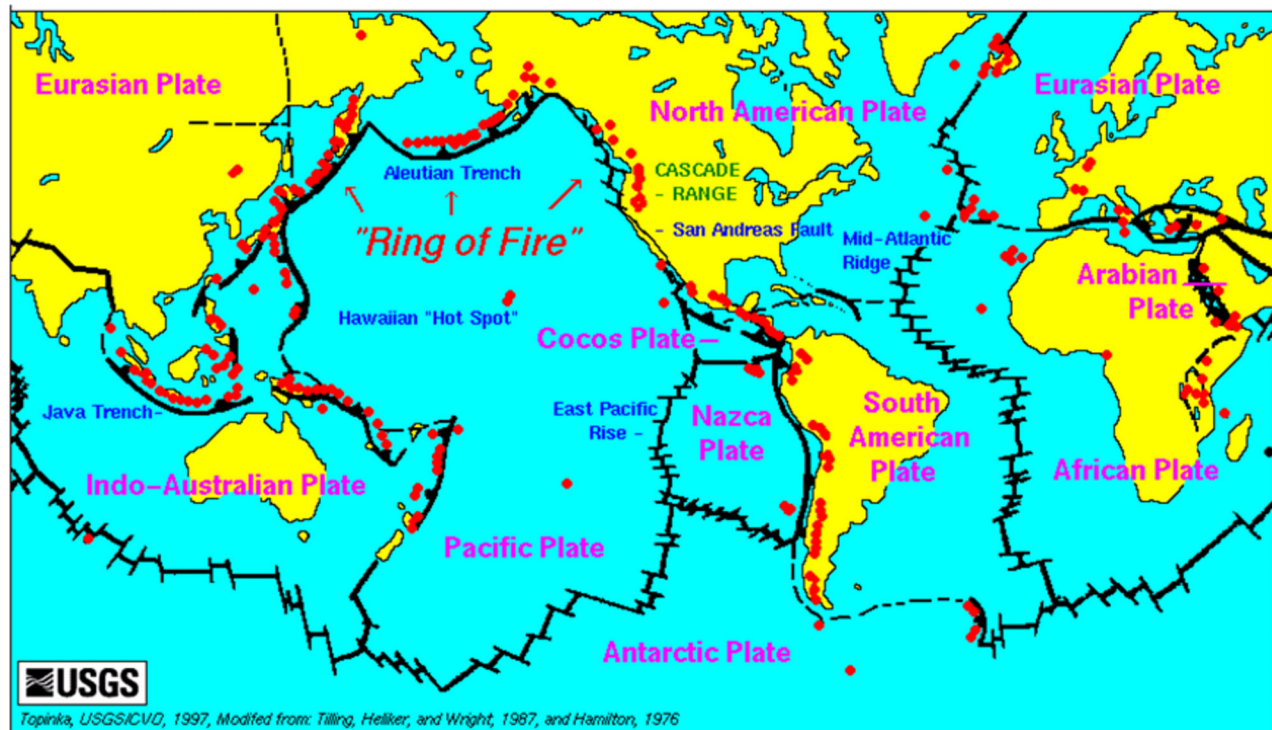
Fig. 2 World map showing volcanic "hot spots" (red dots) and tectonic plate boundaries (black lines) [7]

Volcano Activity. The solid surface of our planet is made up of noncontinuous tectonic plates, which move relative to one another. The boundaries of these plates form less stable regions that are more prone to earthquakes and volcanoes. Figure 2 shows the major tectonic plates and volcanoes around the world. Most of

the volcanoes form along the plate boundaries. At convergent plate boundaries, one plate is pushed down under the adjoining plate where it is melted back into the core and is referred to as a subduction zone. The Aleutian Trench, seen in Fig. 2, is one example. At divergent plate boundaries, such as the Mid-Atlantic Ridge, two plates move apart and new crust is formed to fill the ensuing gap. The Icelandic volcanoes are a result of this action. At a transform fault two plates slide horizontally past each other. The San Andreas fault zone in California is an example of this type.

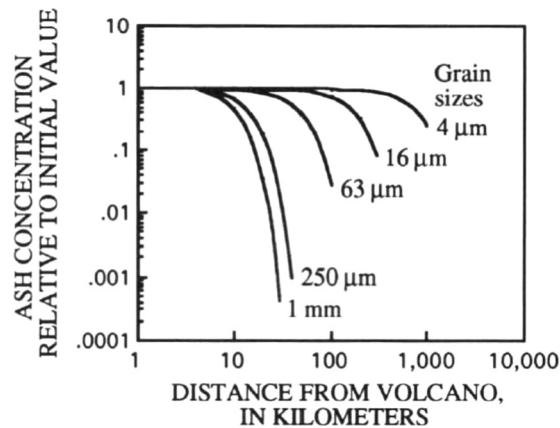
Fig. 4 Modeled ash dispersal in the absence of wind and aggregation for a plume height of 22.8 km [12]

Bursik et al. modeled ash dispersal and looked at factors including particle size, wind speed, plume height, and aggregation [12]. This paper provides a basis for modeling ash dispersal. Not surprisingly, increased wind and plume height increased the dispersal distance while increased particle size and aggregation decreased it. Figure 4 gives their results and indicates that relative to the initial concentrations 4 μ m particles can still be a significant factor 1000 km from the volcano. Such plots provide guidance only as the wind direction and initial conditions in the eruption strongly influence the dispersal.

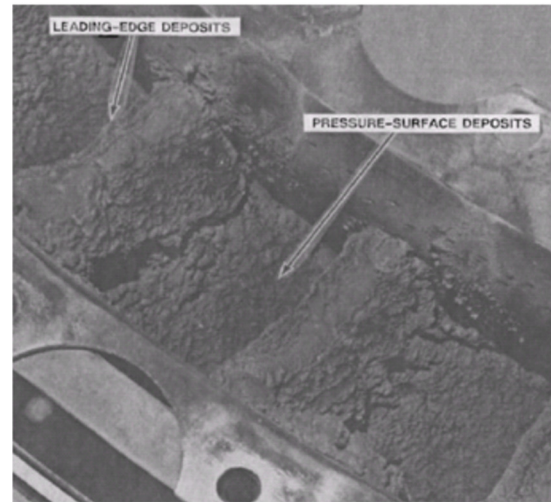
Fig. 6 Upstream view of first stage NGV deposits as a result of dust exposure (with black scoria) on a GE YF-101-100 engine [23]

As the ash passes through the core of the engine, it can melt. The melting point for volcanic ash depends on silicate content and can be as low as 960 °C but is usually closer to 1100 °C. The TIT in modern aviation gas turbine engines often surpasses these temperature thresholds. Melting causes particles to agglomerate and adhere to surfaces which are impacted and this is often referred to as glassification. At low temperatures these deposits are brittle and can be easily removed by hand. The high pressure turbine NGVs are the first significant flow intrusions after the combustor, immediately followed by the HPT rotors. Consequently most of the glassification occurs in these locations as shown in Figs. 6 and 7. Glassification can also occur downstream of the first stage

HPT, affecting multiple turbine stages. This was found during testing at the Calspan facility on a GE YF-101-100 engine [23].

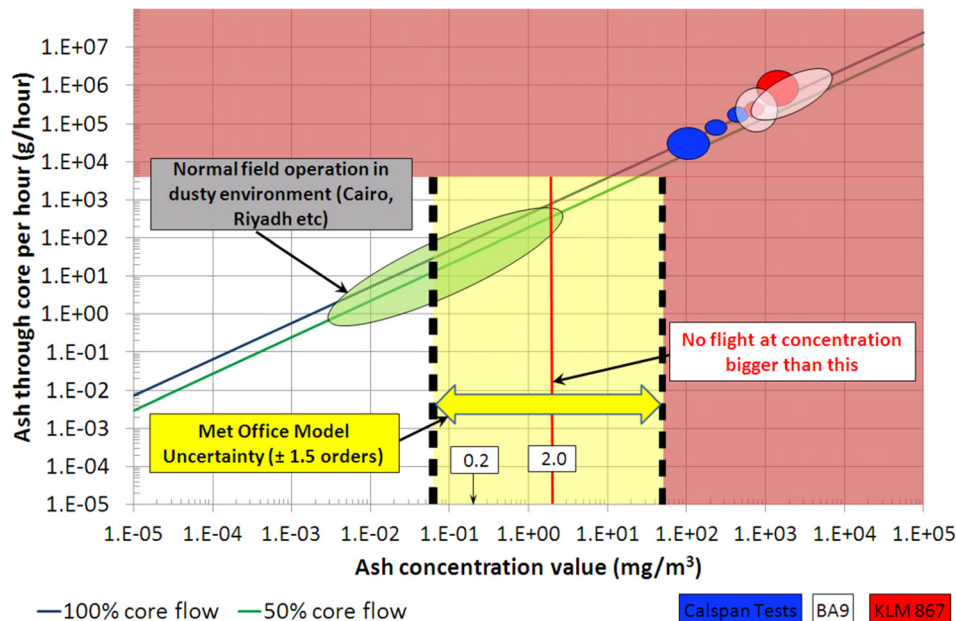
Fig. 8 Various incidents and current envelopes of operation in dust-laden environments from Rolls Royce, May 17, 2010 (adapted from [27])
