Technical Service Bulletin: TSB110121

Released Date: 21-Apr-2011

Common Cylinder Liners for C and ISC Series Engines

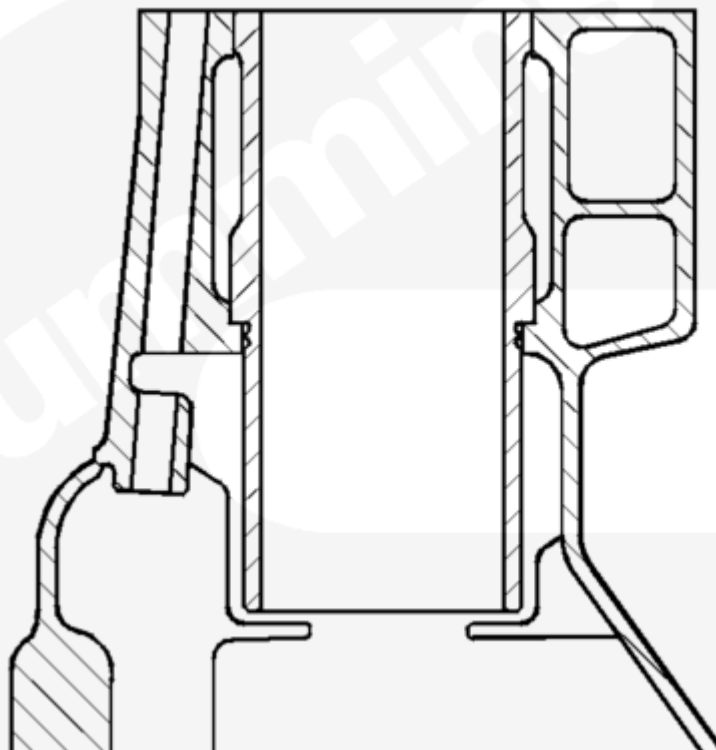
The ISC liner, Part No. 3944344, is 3-mm shorter than the C liner, Part No. 3919937. For this reason the old C block, Part No. 3928964, is designated for the shorter liner. To accept the shorter liner, block machining has been modified to stop 3-mm shorter than the old block (refer to Fig. 1 and 3). **When replacing C Series blocks, the liner must also be replaced.** Old liners in a new block will sit above the head deck by about 3 mm, which is unacceptable (refer to the Fig. 3). The ISC block, Part No. 3945063, will remain the same. Refer to the table below.

Note : Replace cylinder liner with like cylinder liner. Only use new cylinder liner on C series blocks that are new.
