From: Wang, Daniel
Sent: Monday, February 12, 2024 10:03 PM
To: 5mm Lap Top Level
Cc: RSM-DMP1 Energy
Subject: EB215-1514189 scrap break down

Yield Breakdown	
Model:	EB215
Shop Order:	1514189
P/N:	101476434
Lot Size:	1920
Type:	PRD
Date Completed:

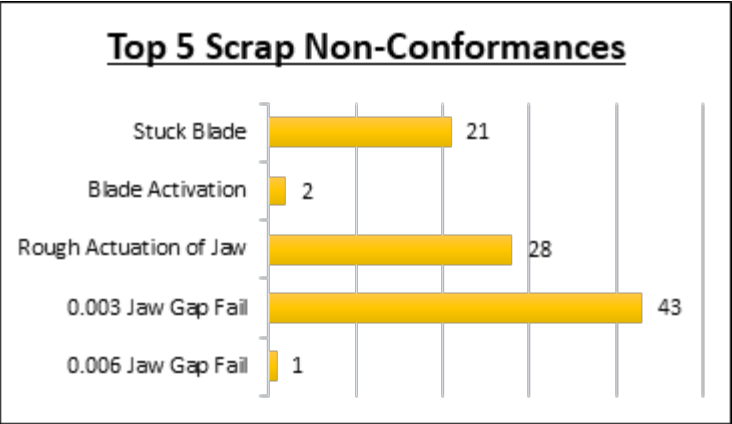
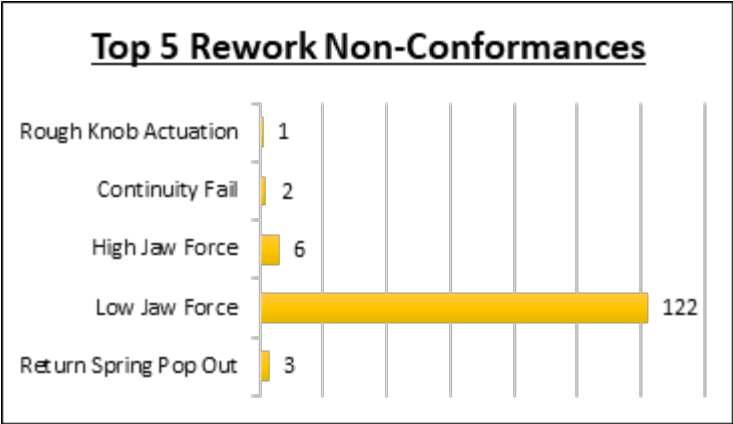
Results		
Accepted:	1897	90.0%
Scrap:	210	10.0%
Rework:	150	7.1%

Scrap Non-Conformance	Initial Build	1st Rework	2nd Rework	3rd Rework	Total	Scrap %	Comments
Stuck Blade	19	2	0	0	21	0.9%	
Blade Activation	2	0	0	0	2	0.1%	
Rough Actuation of Jaw	28	0	0	0	28	1.2%	
0.003 Jaw Gap Fail	40	3	0	0	43	1.9%	
0.006 Jaw Gap Fail	1	0	0	0	1	0.0%	
Front Stops Not Touching	5	0	0	0	5	0.2%	
Middle Stops Not Touching					0	0.0%	
Front and Middle Stops Not Touching					0	0.0%	
Blade Does not Pass Front Stop					0	0.0%	
Jaw Short					0	0.0%	
Insulation Damage	18	0	1	0	19	0.8%	
Incorrect Insulation Orientation	32	0	0	0	32	1.4%	
Missing Jaw Crimp					0	0.0%	
Blade Pusher Coming Out	2	0	0	0	2	0.1%	
Damaged Harness	0	0	3	0	3	0.1%	
Device Key Not Reading Device					0	0.0%	
Incorrect/Missing Weld	5	0	1	0	6	0.3%	
Cosmetic Defect					0	0.0%

Rework Non-Conformance	Initial	1st Rework	2nd Rework	3rd Rework	Total	Rework %	Comments
Rough Knob Actuation	1	0	0	0	1	0.0%	
Continuity Fail	2	0	0	0	2	0.1%	
High Jaw Force	6	0	0	0	6	0.3%	
Low Jaw Force	57	61	4	0	122	5.4%	
Return Spring Pop Out	1	2	0	0	3	0.1%	
Fuse Switch					0	0.0%	
Blade Lever Stop Pop Out					0	0.0%	
Scratched Logo					0	0.0%	
Misassembled	8	1	0	0	9	0.4%	
Missing Component					0	0.0%	
Cosmetic Defect	5	0	0	0	5	0.2%	
Particulate Matter	2	0	0	0	2	0.1%	
Engineering Sample					0	0.0%	
Total	82	64	4	0	150	7.1%
