CK721-A

Network Controller

Software Release Notes

CK721-A VERSION 2.10 SOFTWARE RELEASE NOTES

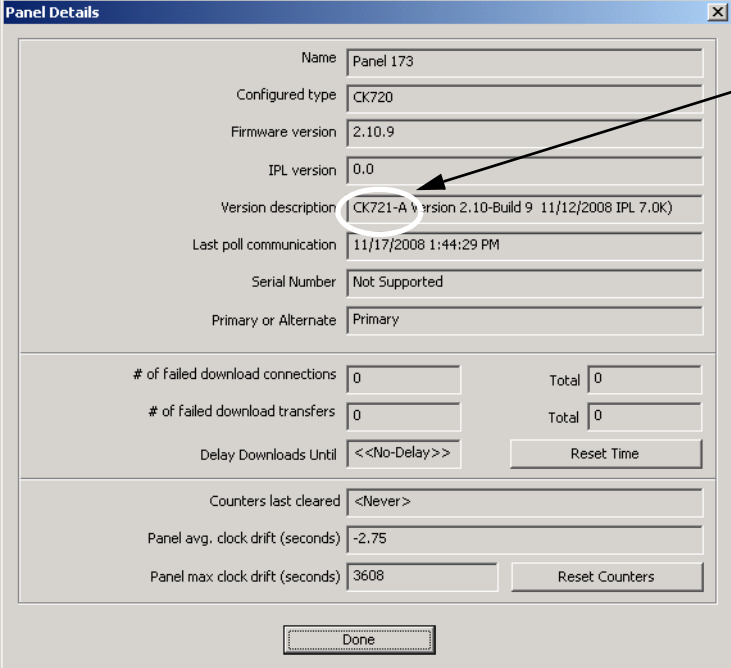
You can verify the controller type from the P2000 host system by checking the “Version description” field in the Panel Details dialog box (accessed from the System Status window).

The image shows a screenshot of the "Panel Details" dialog box. The "Version description" field is circled, and an arrow points from the text "Panel Type: CK721-A" to it. The dialog box contains the following information:

Field	Value
Name	Panel 173
Configured type	CK720
Firmware version	2.10.9
IPL version	0.0
Version description	CK721-A Version 2.10-Build 9 11/12/2008 IPL 7.0K
Last poll communication	11/17/2008 1:44:29 PM
Serial Number	Not Supported
Primary or Alternate	Primary

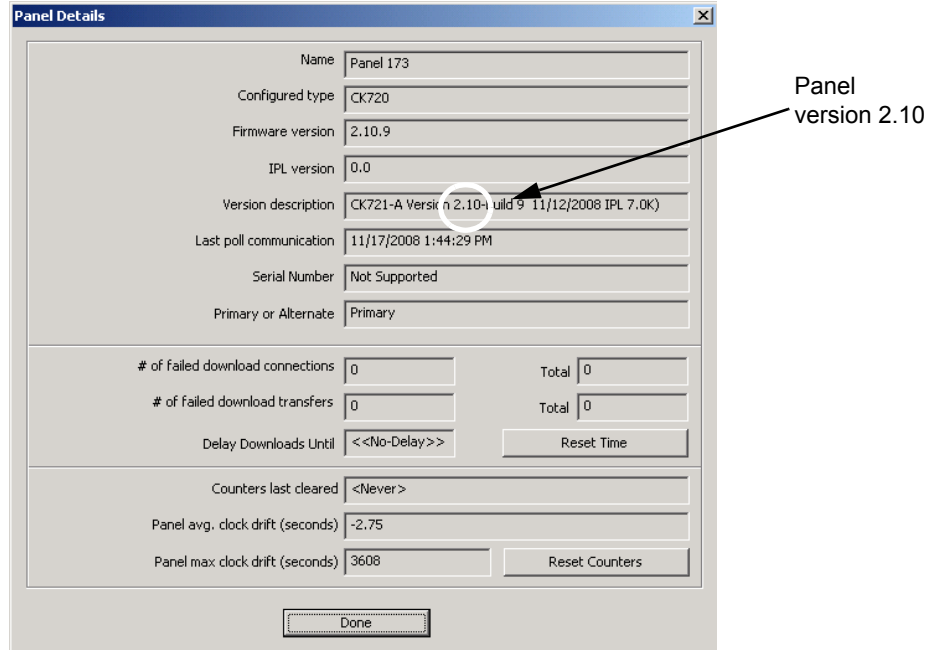
12. You will see a panel version mismatch in the System Status screen. At the P2000 you need to change the panel's type to **2.5+** (or higher) in the **General** tab of the Panel Edit screen.
13. Wait until the panel is shown as "up" in the System Status screen.
14. In the System Status window, highlight the name of the upgraded panel and click the **Panel Details** button.
15. In the Panel Details window, verify the panel version.

Name	Panel 173
Configured type	CK720
Firmware version	2.10.9
IPL version	0.0
Version description	CK721-A Version 2.10 Build 9 11/12/2008 IPL 7.0K
Last poll communication	11/17/2008 1:44:29 PM
Serial Number	Not Supported
Primary or Alternate	Primary
