Technical Service Bulletin: TSB120287

K/QSK19 Edge Molded Rubber Oil Pan Adapter Gasket

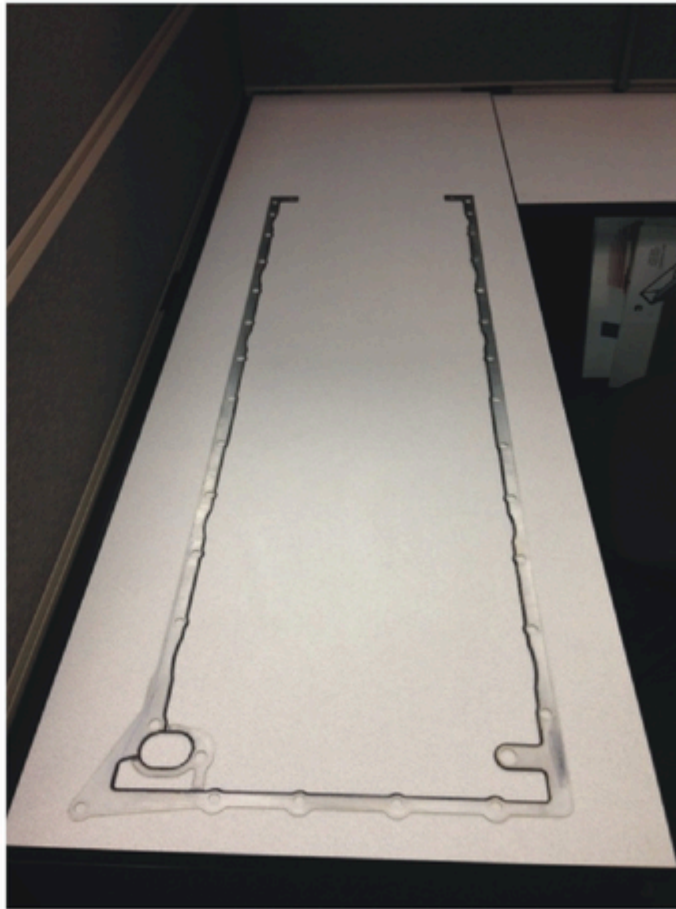
01f00011

This document announces the release of a new style oil pan adapter gasket. The new edge molded rubber gasket is being released to address oil leaks at the oil pan adapter joint. This new oil pan adapter gasket utilizes a metal carrier and edge molded rubber to prevent capscrew preload loss at the oil pan adapter joint.

New Oil Pan Adapter Gasket, Part Number 2888747

Installation of this new gasket is critical to the gasket's ability to seal properly. The proper installation procedure must be followed in order to maintain a leak free joint. The installation procedure can be found in the service manual for the engine being serviced, in Procedure 007-027 (Lubricating Oil Pan Adapter).

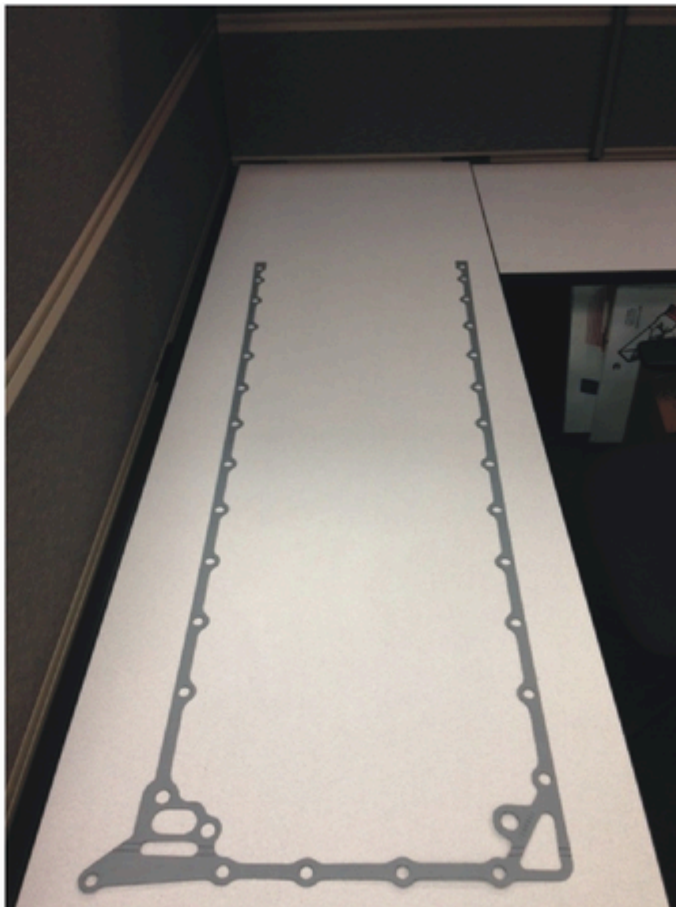
01f00012

Old Oil Pan Adapter Gasket, Part Number 4000595

Oil pan adapter gasket, Part Number 4000595, will **no** longer be used in service. All kits containing oil pan adapter gasket, Part Number 4000595, will now contain the new oil pan adapter gasket, Part Number 2888747. The effective date for this change at the Part Distribution Centers is 12/15/2012. It is important to note that oil pan adapter gasket, Part Number 2888747, can be installed on K series engines also.
