Technical Service Bulletin: TSB180043

New Lubricating Oil Filter Head and Lubricating Oil Cooler Cover Gasket

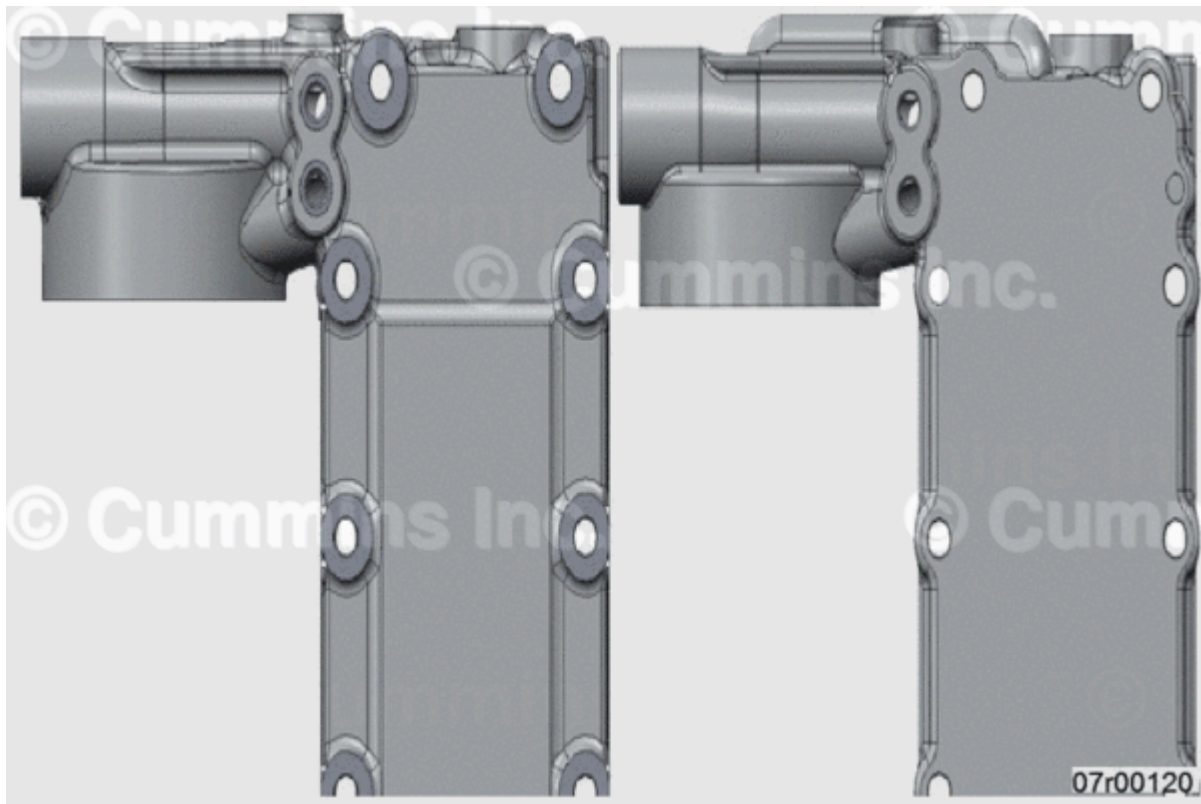
Figure 1: Left: Lubricating Oil Filter Head. Right: Existing Lubricating Oil Filter Head.

- A new lubricating oil filter head and lubricating oil cooler cover gasket are available.
- Lubricating oil filter head increases sealing flange and front wall thickness.
- Lubricating oil cooler cover gasket coating material was changed and embossments were added around sealing perimeter.

- Lubricating oil filter head was improved to reduce lubricating oil filter head cracking and external lubricating oil leaks.
- Lubricating oil cooler cover gasket was improved to reduce external lubricating oil leaks.

- New lubricating oil filter head can be identified by added capscrew machined bosses (see Figure 1).
- New lubricating oil cooler cover gasket can be identified by embossments around sealing perimeter (see Figure 2).

- If existing lubricating oil filter head has malfunctioned, replace with new lubricating oil filter head.

- New lubricating oil cooler cover gasket **must** be used with new lubricating oil filter head.
- If existing lubricating oil cooler cover gasket has malfunctioned, replace with existing part number.
