MAGNETIC FLUX LEAKAGE INSPECTION PROCEDURE

(SOP-SCI-008)

Jasa Konsultansi Inspeksi & Engineering Tangki Kondensat F-6104**LEMBAR PENGESAHAN****PT. PEMBANGUNAN ACEH & PT SUCOFINDO**

Jasa Konsultansi Inspeksi & Engineering Tangki Kondensat F-6104

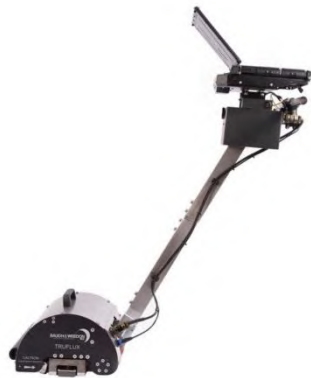
- 1 Unit Magnetic Flux Leakage (Brand BW Truflux)

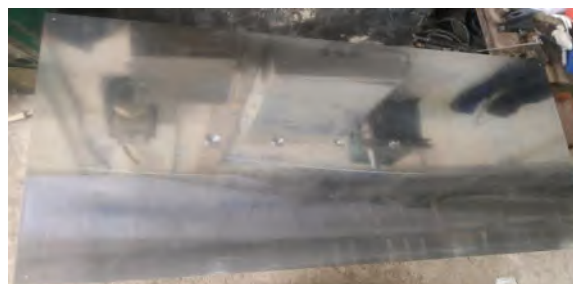
- Pelat Kalibrasi yang sesuai standard (menyesuaikan tebal pelat)

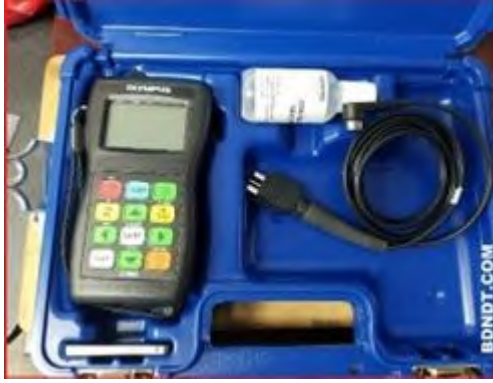
- 1 Unit *Ultrasonic Thickness Gauge*

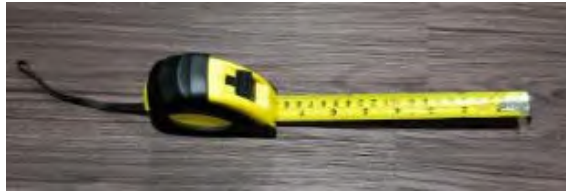
- Peralatan ukur (penggaris, pita meteran, Pit Gauge dan lain – lain)

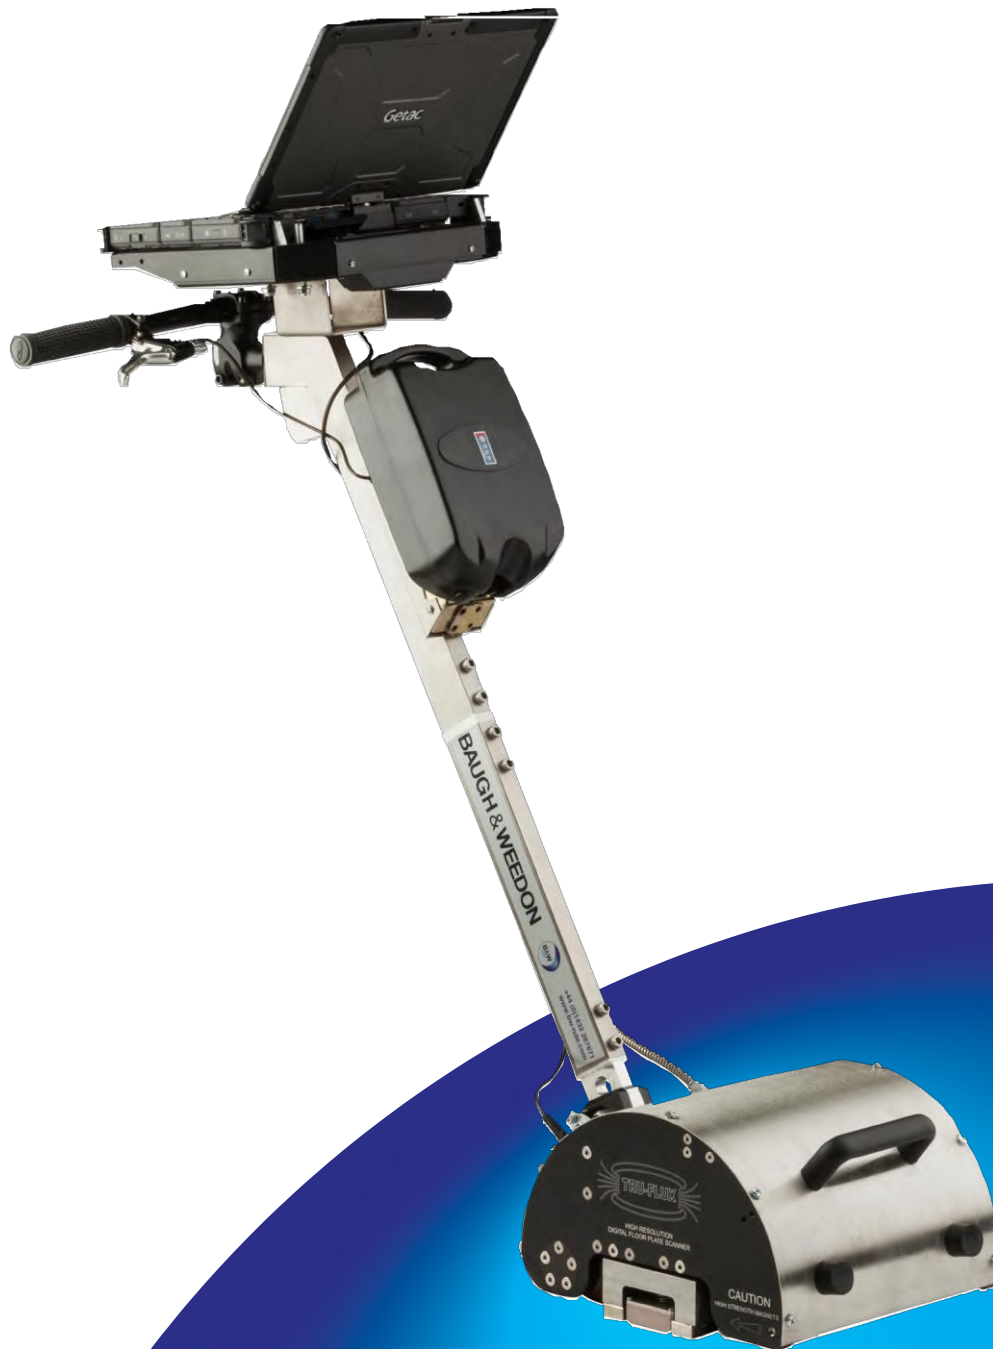
TRUFLUX

High Resolution Digital Tank Floor Plate Scanner

The Truflux is a new concept in Magnetic Flux Leakage (MFL) tank floor plate inspection, incorporating a new level of user sophistication in its innovative design. The TruFlux has the benefits of advanced features and practicality.

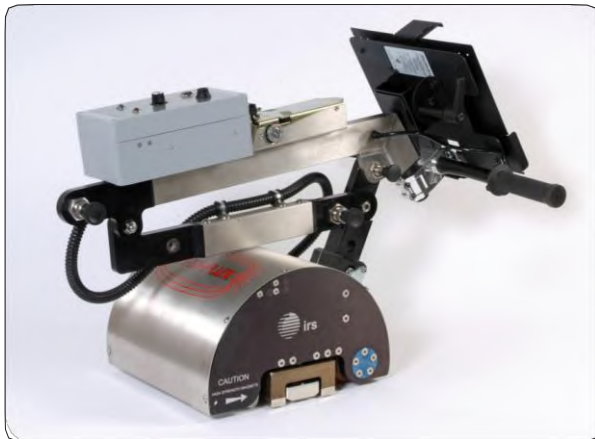
The TruFlux system is easy to use and highly practical. For ease of shipping the whole unit folds down easily for transportation, see below. With its reduced physical size and lower weight, handling and set-up require little effort, making life easier for the operator in the field.

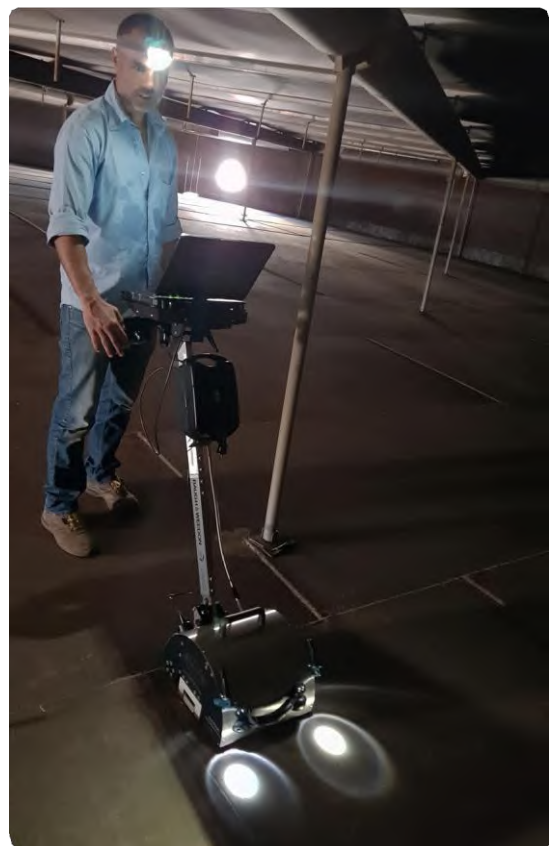
Battery Design Feature

The Truflux uses Lithium-ion battery technology with push-pull hot swappable capability. A fast recharge function and four batteries per unit provides 24hr utilisation.

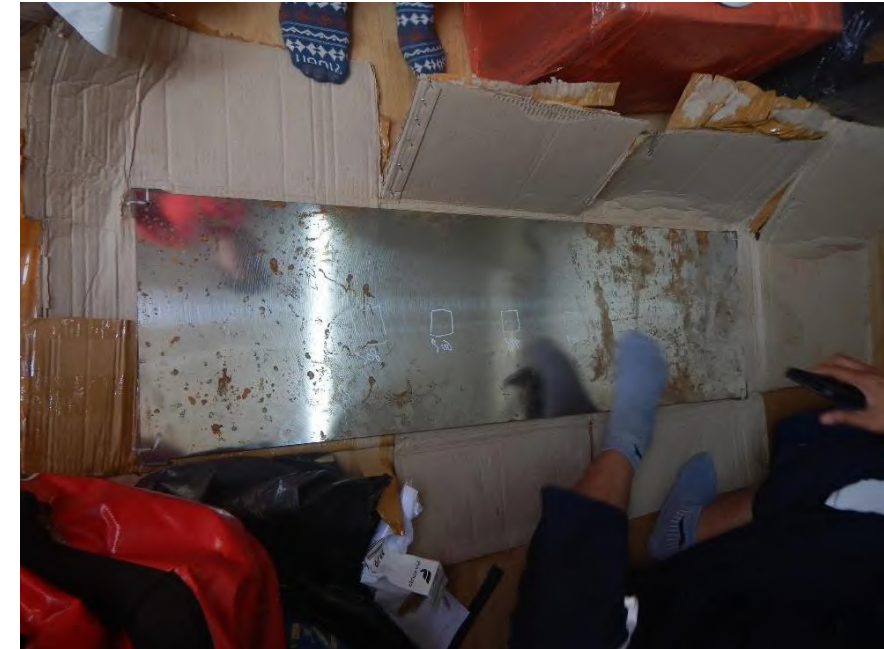
Defect	Aktual (UT Thickness) (mm)		
	Thickness Plate	Remaining Thickness	Depth
20%	10.05	7.98	2.07
40%	10.05	5.94	4.11
60%	10.05	4.00	6.05
80%	10.05	2.15	7.90

Nilai remaining thickness diatas adalah nilai ketebalan pelat dikurang kedalaman cacat. Nilai diatas hasil dari NDT UT Thickness measurement.

Reference steel plate w/ artificial defects

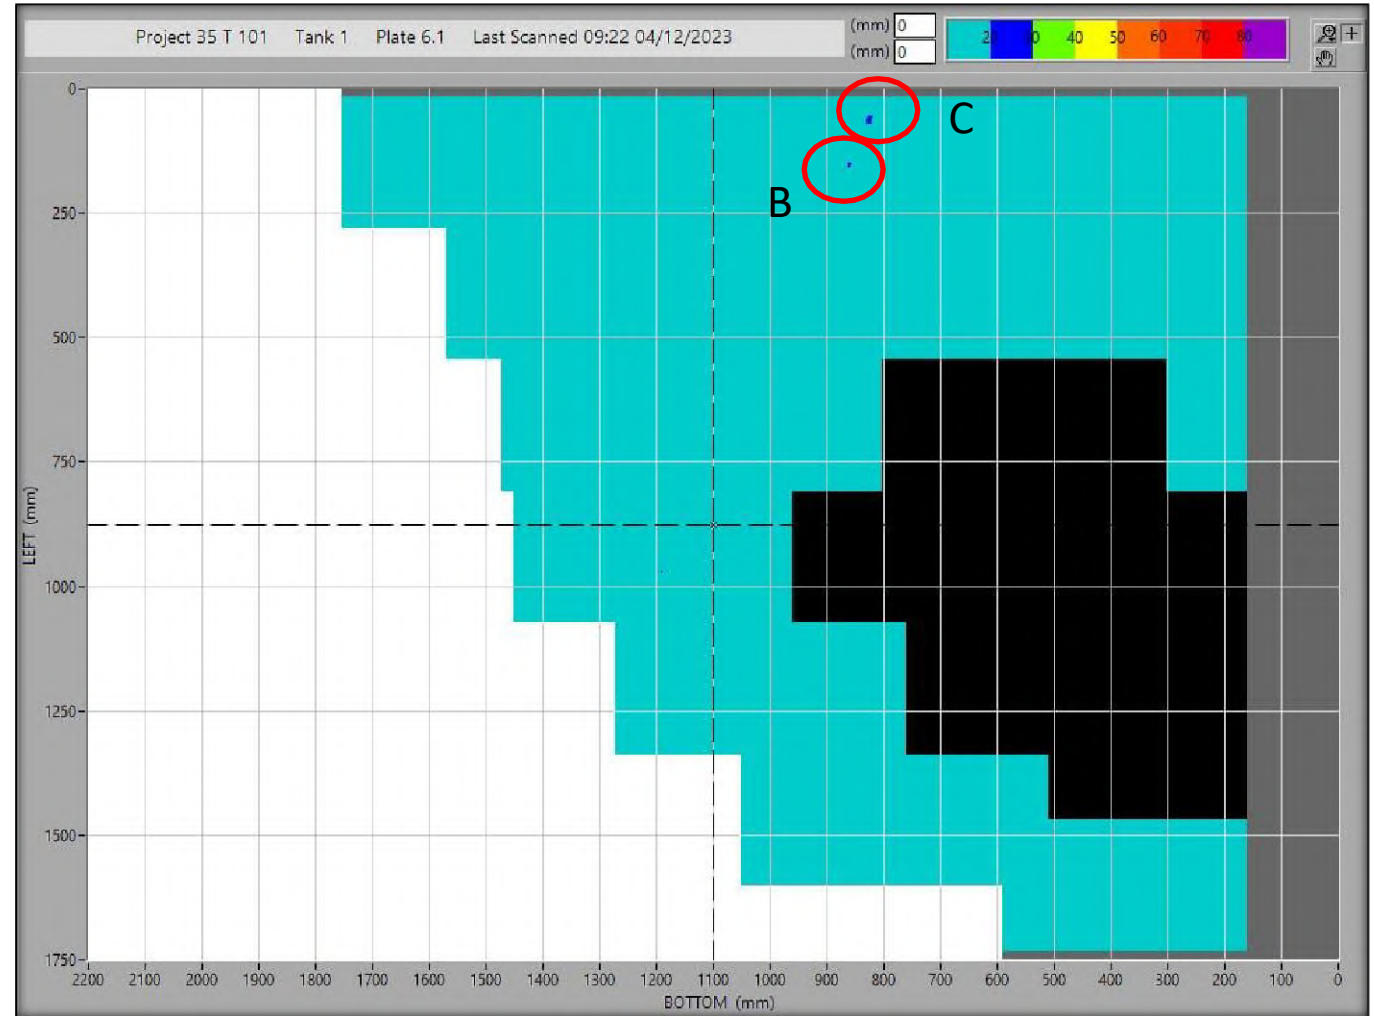
UT Thickness Verification of defect (B)

MFL result under 20% discontinuity (general corrosion)

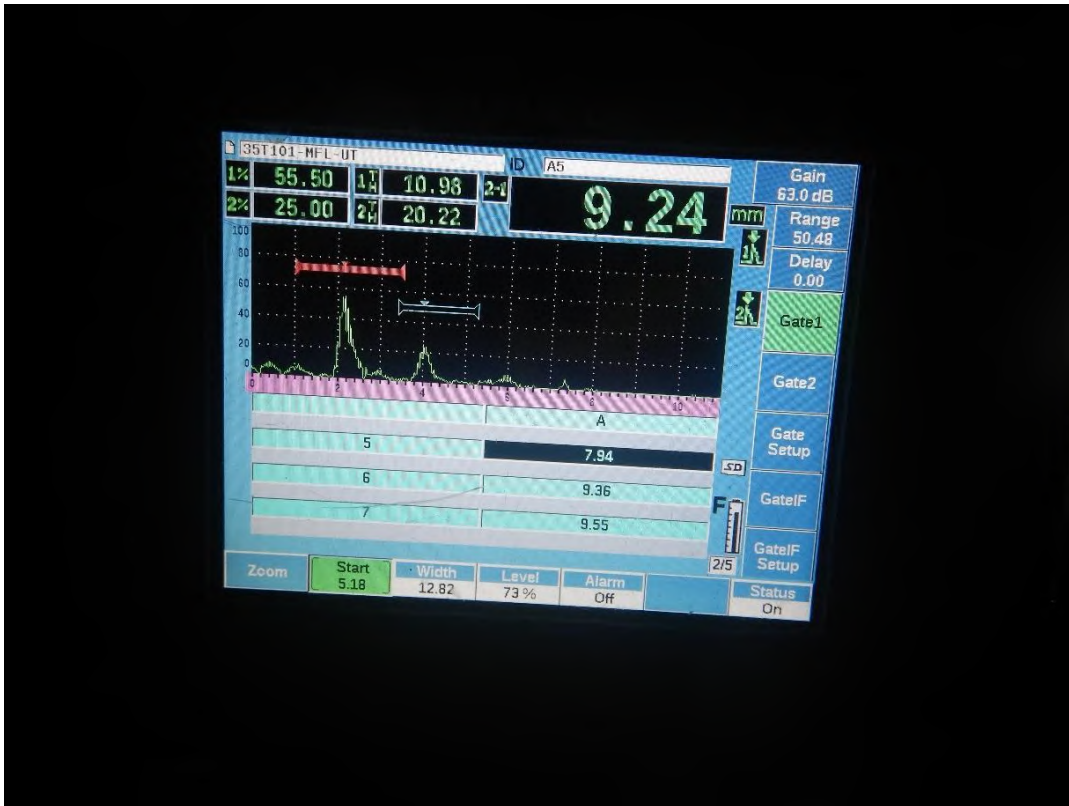
Then, the remaining thickness of the defect is 9.24 mm
(Thickness nominal 10.00 mm)

The depth of pitting is 1.57 mm (C)

MFL result 20%-30% discontinuity (pitting corrosion)

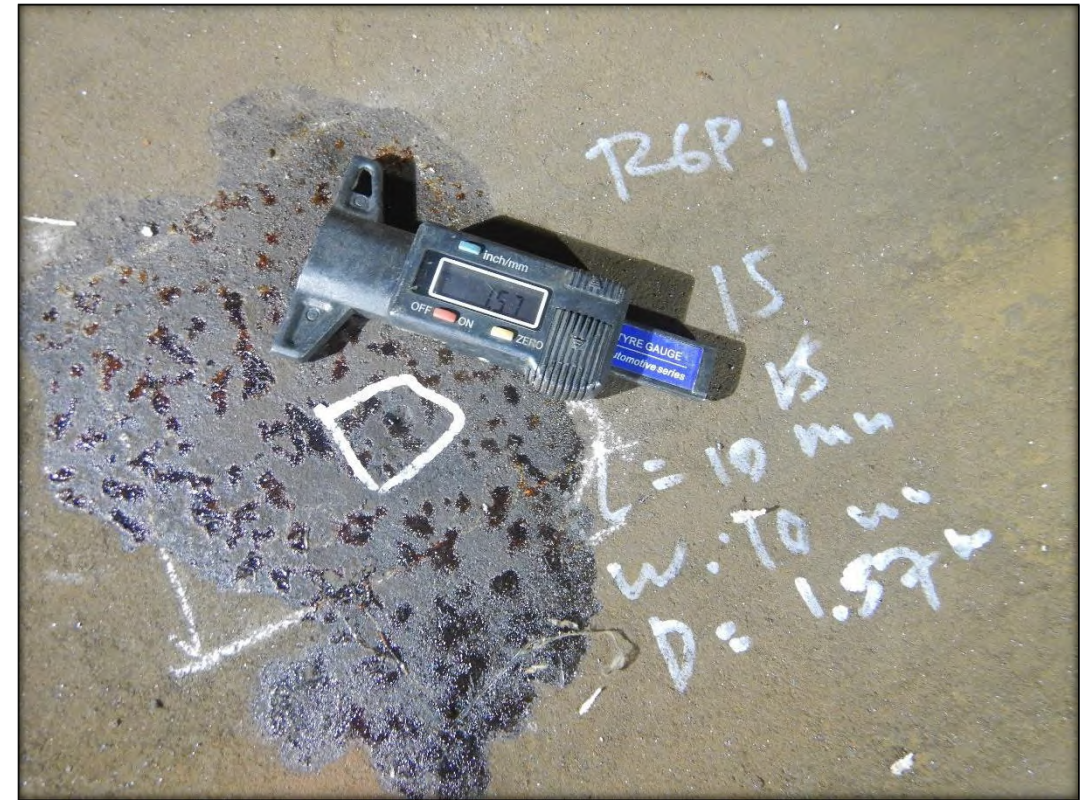
Then, the remaining thickness of the defect is $10.00 - 1.57 \text{ (mm)} = 8.43 \text{ mm}$
